#### Airworthiness Directives; Bell Helicopter Textron Canada Model 407 Helicopters

**ACTION:** Notice of proposed rulemaking (NPRM).

**Bell Helicopter Textron Canada:** Docket No. 2001-SW-53-AD. Supersedes AD 2000-06-10, Amendment 39-11651, Docket No. 99-SW-75-AD.

**Applicability:** Model 407 helicopters, serial number (S/N) 53000 through 53475 with tailboom, part number (P/N) 407-030-801-101, -105, or -107, installed, certificated in any category.

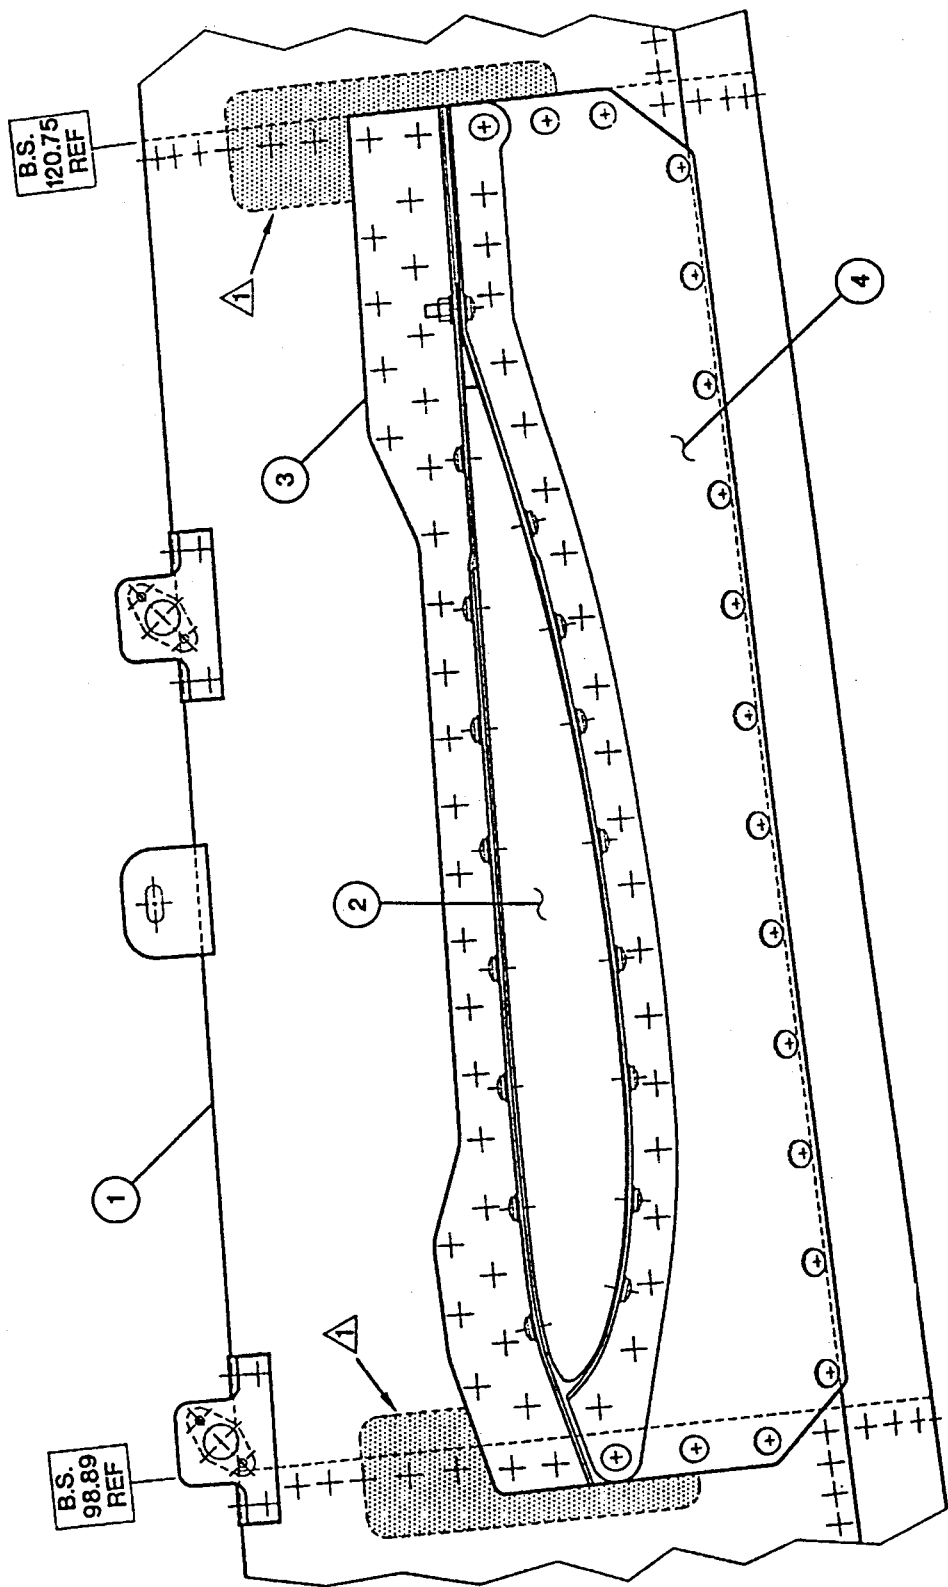
Figure 1. Preflight Check of the Tailboom

On March 21, 2000, the FAA issued AD 2000-06-10, Amendment 39-11651 (65 FR 16804, March 30, 2000), to require preflight checking and repetitively inspecting the tailboom for a crack and replacing the tailboom if a crack is found. That action was prompted by four reports of cracks on the tailboom in the area of the horizontal stabilizer. The requirements of that AD are intended to prevent

(a) Before further flight and thereafter before the first flight of each day, check the tailboom for a crack in accordance with Figure 1 of this AD. If a crack is found,

- 1. Examine these areas for cracks on left side of tailboom only.
- 2. Horizontal stabilizer not shown for clarity.

remove the tailboom before further flight. An owner/operator (pilot) holding at least a private pilot certificate may perform the visual check required by this paragraph but must enter compliance with this paragraph into the helicopter records in accordance with 14 CFR 43.11 and 91.417(a)(2)(v). A pilot can perform this check because it involves only a visual check for a crack in the tailboom and is a part of a normal pilot preflight check.

(b) Within 25 hours time-in-service (TIS) and thereafter at intervals not to exceed 50 hours TIS, visually inspect any tailboom with 600 or more hours TIS for a crack using a 10x or higher magnifying glass in accordance with the Accomplishment Instructions, Part II, of Bell Helicopter Textron Alert Service Bulletin ASB 407-99-26, Revision B, dated June 14, 2001, except you are not required to contact Bell Helicopter Product Support Engineering. If a crack is found, remove the tailboom before further flight.

(c) Installing a tailboom, P/N 407-030-801-201, is terminating action for the requirements of this AD.
