[Docket No. FAA-2012-1135; Directorate Identifier 2012-SW-097-AD; Amendment 39-17281; AD 2012-21-52]

#### **Airworthiness Directives; Agusta S.p.A. (Type Certificate Currently Held by AgustaWestland S.p.A.) (Agusta) Helicopters**

**2012–21–52 Agusta S.P.A. Helicopters (Type Certificate Currently Held By AgustaWestland S.P.A.) (Agusta):**  
Amendment 39–17281; Docket No. FAA–2012–1135; Directorate Identifier 2012–SW–097–AD.

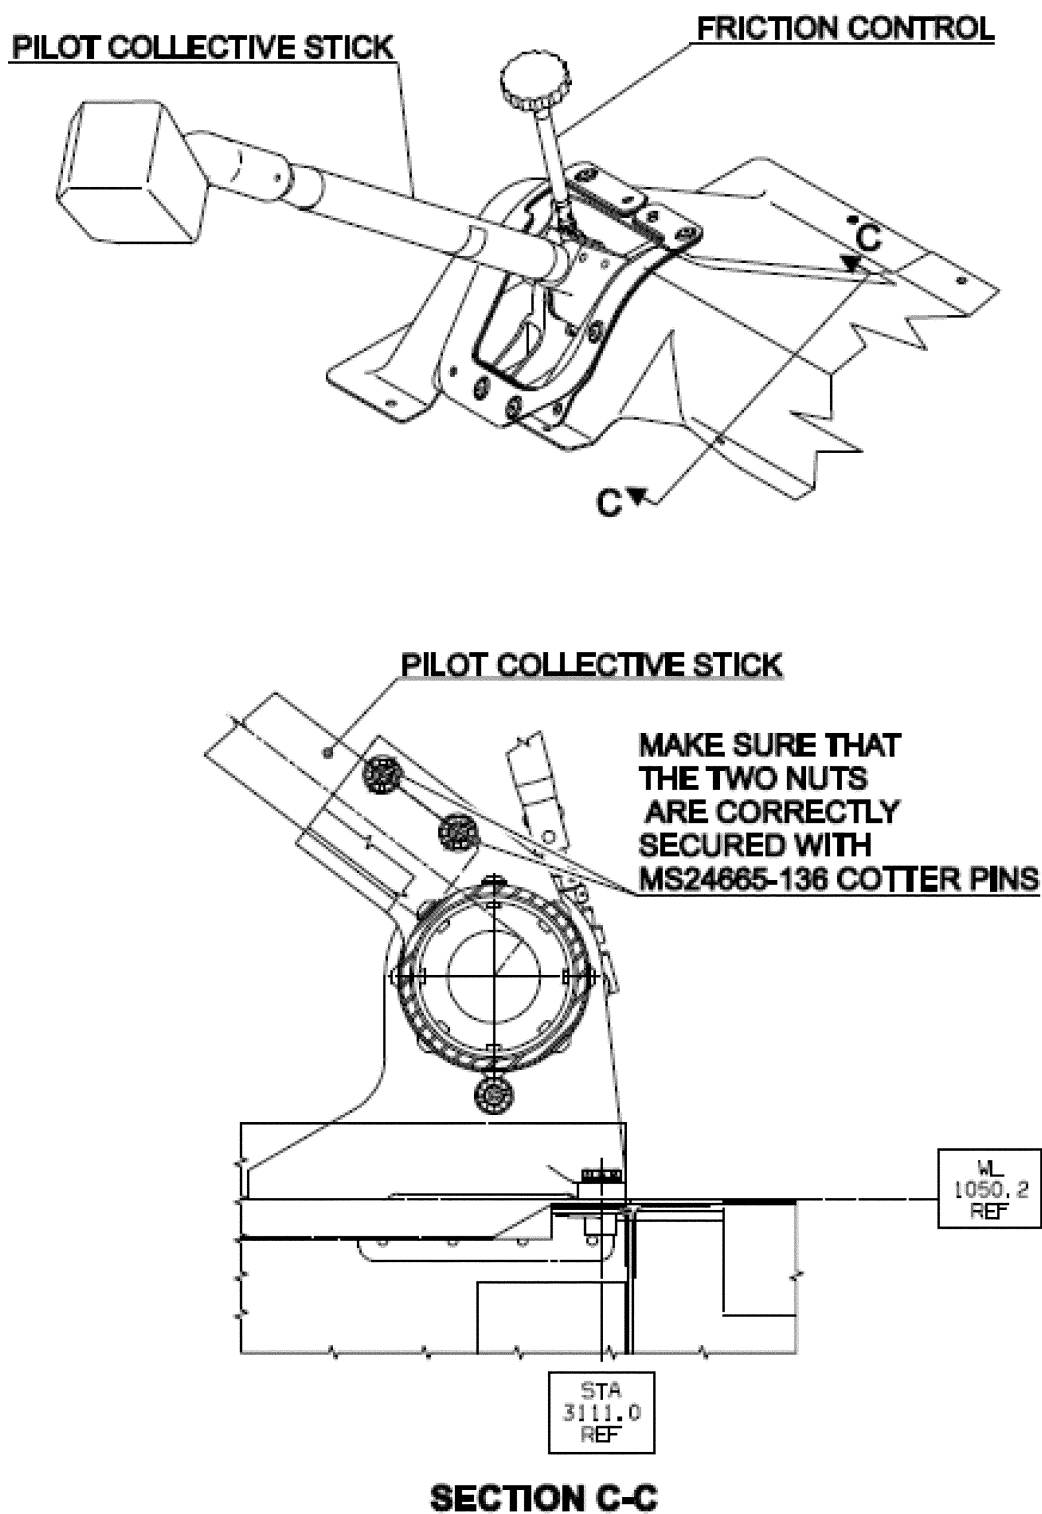
(1) Inspect the pilot collective stick installation to determine whether the self-locking nuts, part-number (P/N) MS17825–4, are secured with cotter pins, P/N MS24665–136, as depicted in Figure 1 to paragraph (e) of this AD. If the self-locking nuts are not secured with cotter pins, before further flight, reinstall the pilot collective stick.

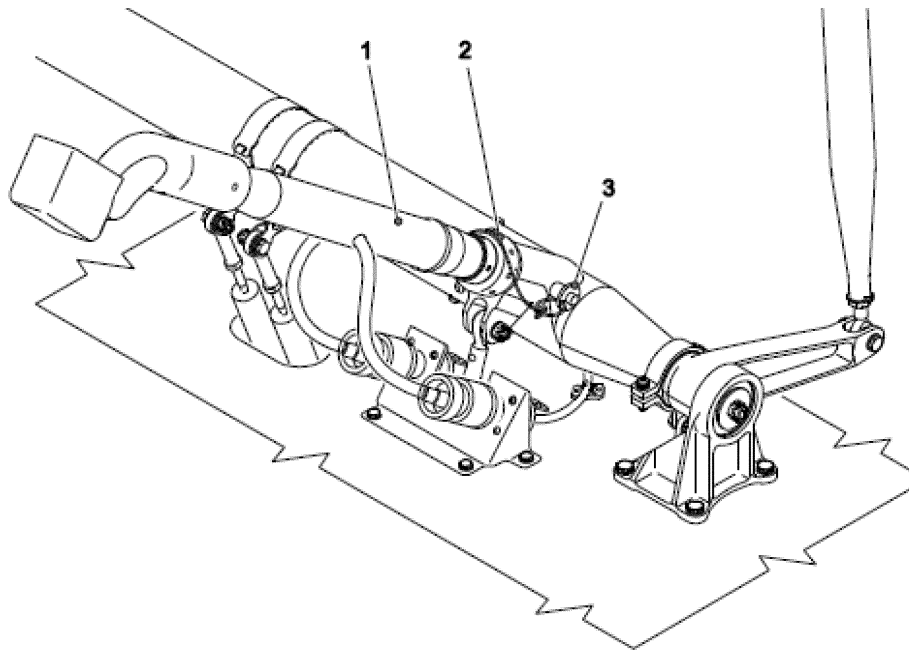
(2) Inspect the co-pilot collective stick installation to determine whether the ring nut (item 2) is loose and the quick-release pin

(item 3) is installed as depicted in Figure 2 to paragraph (e) of this AD. If the ring nut is loose or the quick-release pin is not installed,

before further flight, reinstall the co-pilot collective stick.

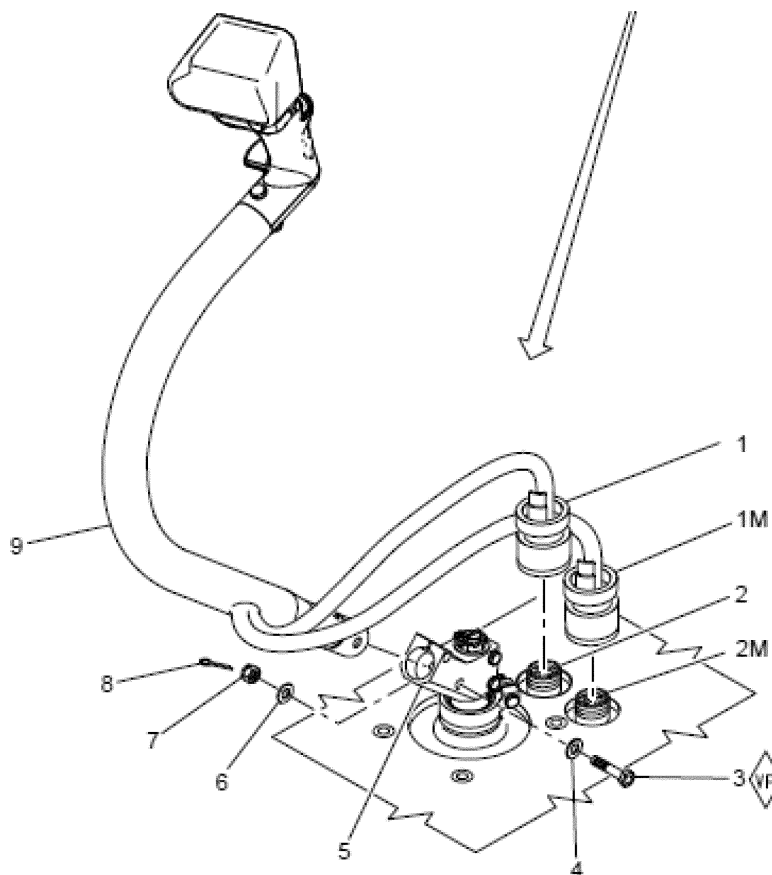
(3) Inspect the pilot cyclic stick installation for proper installation of the bolt (item 3), washer (item 4), self-locking nut (item 7),

washer (item 6), and the cotter pin (item 8), as depicted in Figure 3 to paragraph (e) of this AD. If the pilot cyclic stick is not

installed as depicted, before further flight, reinstall the pilot cyclic stick.

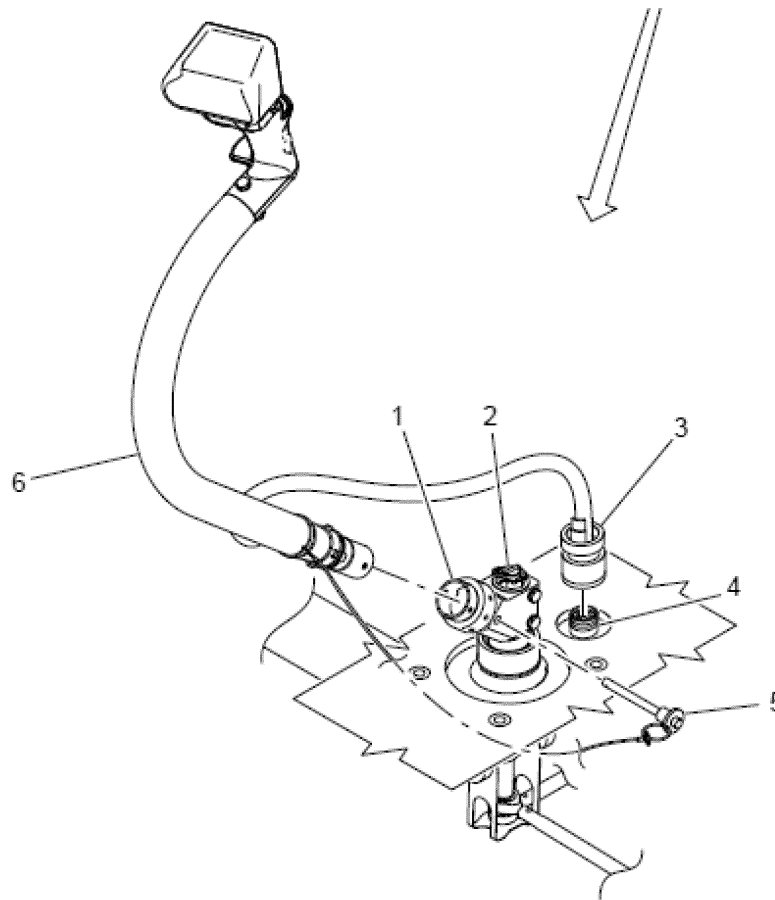
(4) Inspect the co-pilot cyclic stick installation to determine whether the ring nut (item 1) is loose and the quick-release pin

(item 5) is installed as depicted in Figure 4 to paragraph (e) of this AD. If the ring nut is loose or the quick-release pin is not installed

as depicted, before further flight, reinstall the co-pilot cyclic stick.
