[Docket No. FAA-2013-0340; Directorate Identifier 2010-SW-081-AD; Amendment 39-17630; AD 2013-21-06]

#### Airworthiness Directives; Eurocopter Deutschland GmbH Helicopters

**2013-21-06 Eurocopter Deutschland GmbH Helicopters:** Amendment 39-17630; Docket No. FAA-2013-0340; Directorate Identifier 2010-SW-081-AD.

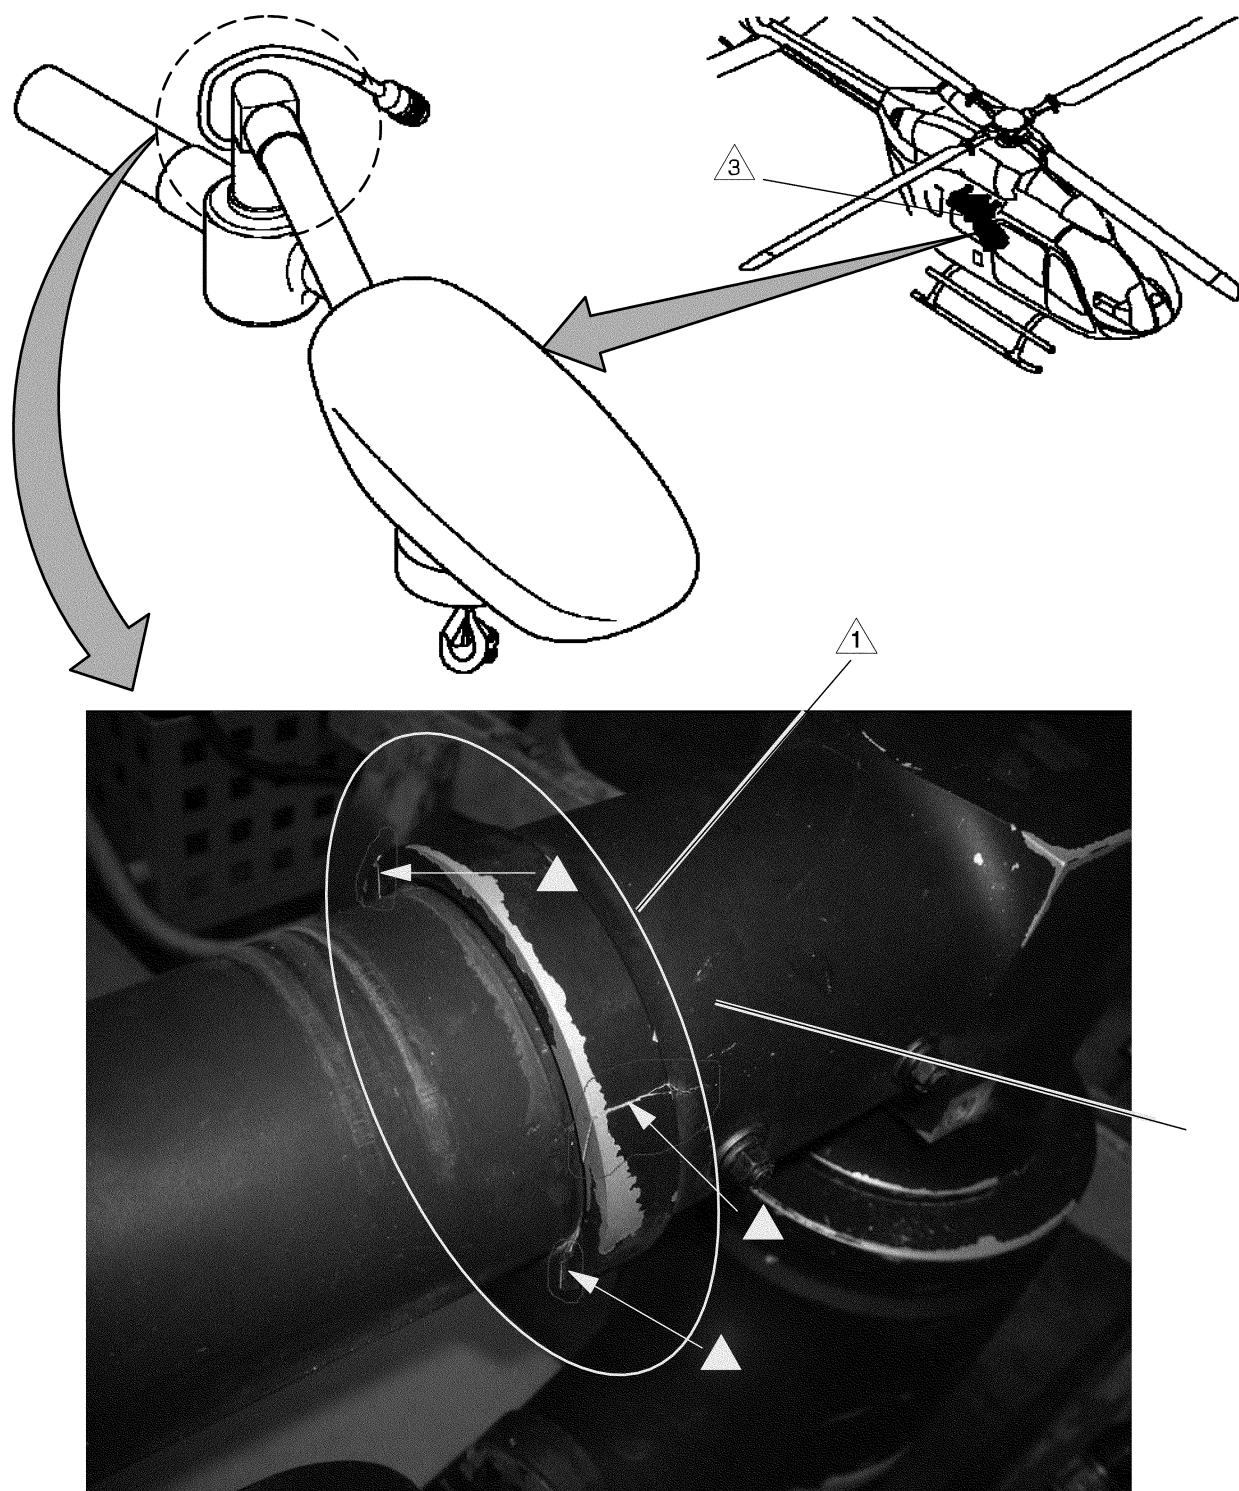
Figure 1 to Paragraph (e)

This AD defines the unsafe condition as a crack in the boom. This condition could result in loss of the boom and attached loads, and subsequent loss of helicopter control.

(1) Before further flight, and thereafter before the first flight of each day until you have performed the inspection required by paragraph (e)(2) of this AD, clean the hoist and visually check for a crack, paying particular attention to the areas that are circled as depicted in Figure 1 to paragraph (e) of this AD. The actions required by this paragraph may be performed by the owner/operator (pilot) holding at least a private pilot certificate, and must be entered into the aircraft records showing compliance with this AD in accordance with 14 CFR 43.9(a)(1)-(4) and 14 CFR 91.417(a)(2)(v). The record must be maintained as required by 14 CFR 91.417, 121.380, or 135.439.

(2) Within 30 days, perform a dye penetrant inspection of the boom in accordance with the Accomplishment Instructions, Section 2.D, of the Goodrich Service Bulletin 44307-500-03, Revision 2, dated April 30, 2010 (SB).

(3) If a crack exists in the boom, replace the cracked boom with an airworthy boom before further flight.
