Airworthiness Directives; MD Helicopters Inc. Model MD-900 Helicopters

2001-07-09 MD Helicopters Inc:

Amendment 39-12175. Docket No. 2000-SW-15-AD. Supersedes Emergency AD 99-26-20, Docket No. 99-SW-89-AD.

Applicability: Model MD-900 helicopters, with main rotor upper hub (hub) assembly, part number (P/N) 900R2101006-105 or 900R2101006-107, installed, certificated in any category.

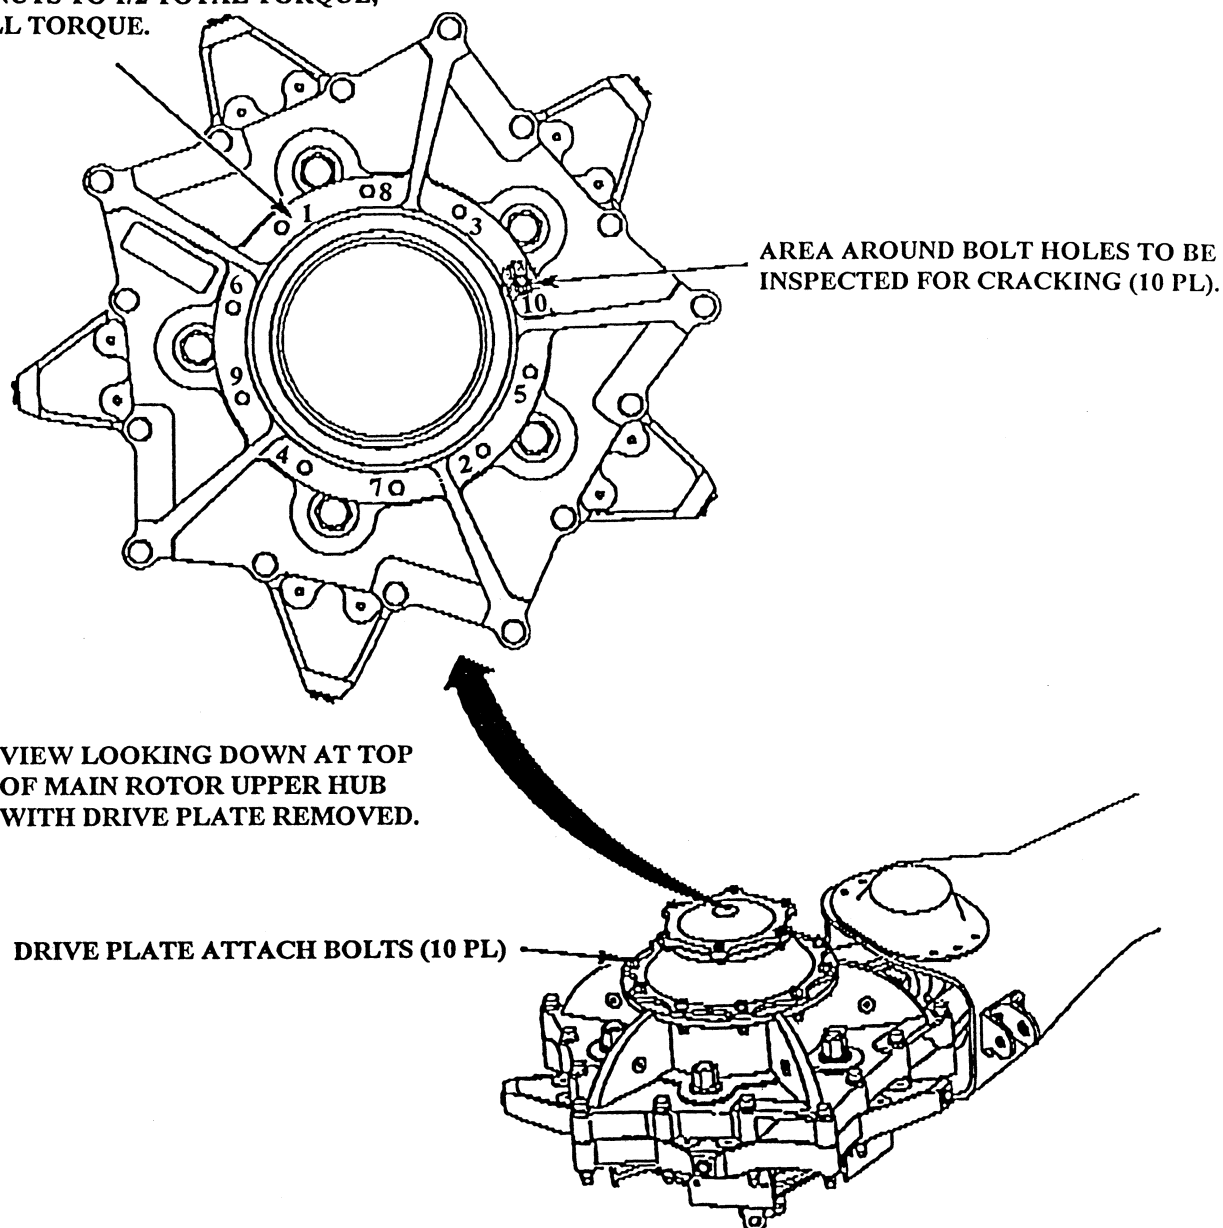
Figure 1. Main Rotor Upper Hub Assembly Inspection.

(v) Using paint stripper (Consumable Item List C313 or equivalent) and cleaning solvent (C420 or equivalent), remove the paint from the upper mating surface of the hub assembly to enable an accurate visual inspection of the drive plate attachment bolt hole (bolt hole) area for cracking (Figure 1). Ensure the paint stripper and solvent DO NOT contaminate the upper bearing and upper grease seal areas.

(vi) Using a 10-power or higher magnifying glass and bright light, inspect the mating surface area and the area around and inside the 10 bolt holes of the hub assembly for a crack. If a crack is found, prior to further flight, replace the hub assembly with an airworthy hub assembly.

(ii) Mark the main rotor hub holes, bolts, and nuts to correspond with the drive plate hole numbers (see Figure 1).

(viii) Reinstall the main rotor drive plate using 10 new sets of replacement attachment hardware. Torque the nuts to 160 inch pounds above locknut locking/run-on torque in the sequence shown (Figure 1). Record in the rotorcraft logbook, or equivalent record, the locknut locking/run-on torque for each nut.

1. MAIN ROTOR DRIVE PLATE ATTACHMENT
HARDWARE TORQUE SEQUENCE.
2. NUMBERING MAY START AT ANY HOLE.
3. TORQUE NUTS TO 1/2 TOTAL TORQUE,
THEN FULL TORQUE.
