## **DEPARTMENT OF TRANSPORTATION**

#### **14 CFR Part 39**

**[Docket No. FAA-2013-0574; Directorate Identifier 2008-SW-22-AD]**

#### **Airworthiness Directives; Bell Helicopter Textron Canada (Bell) Helicopters**

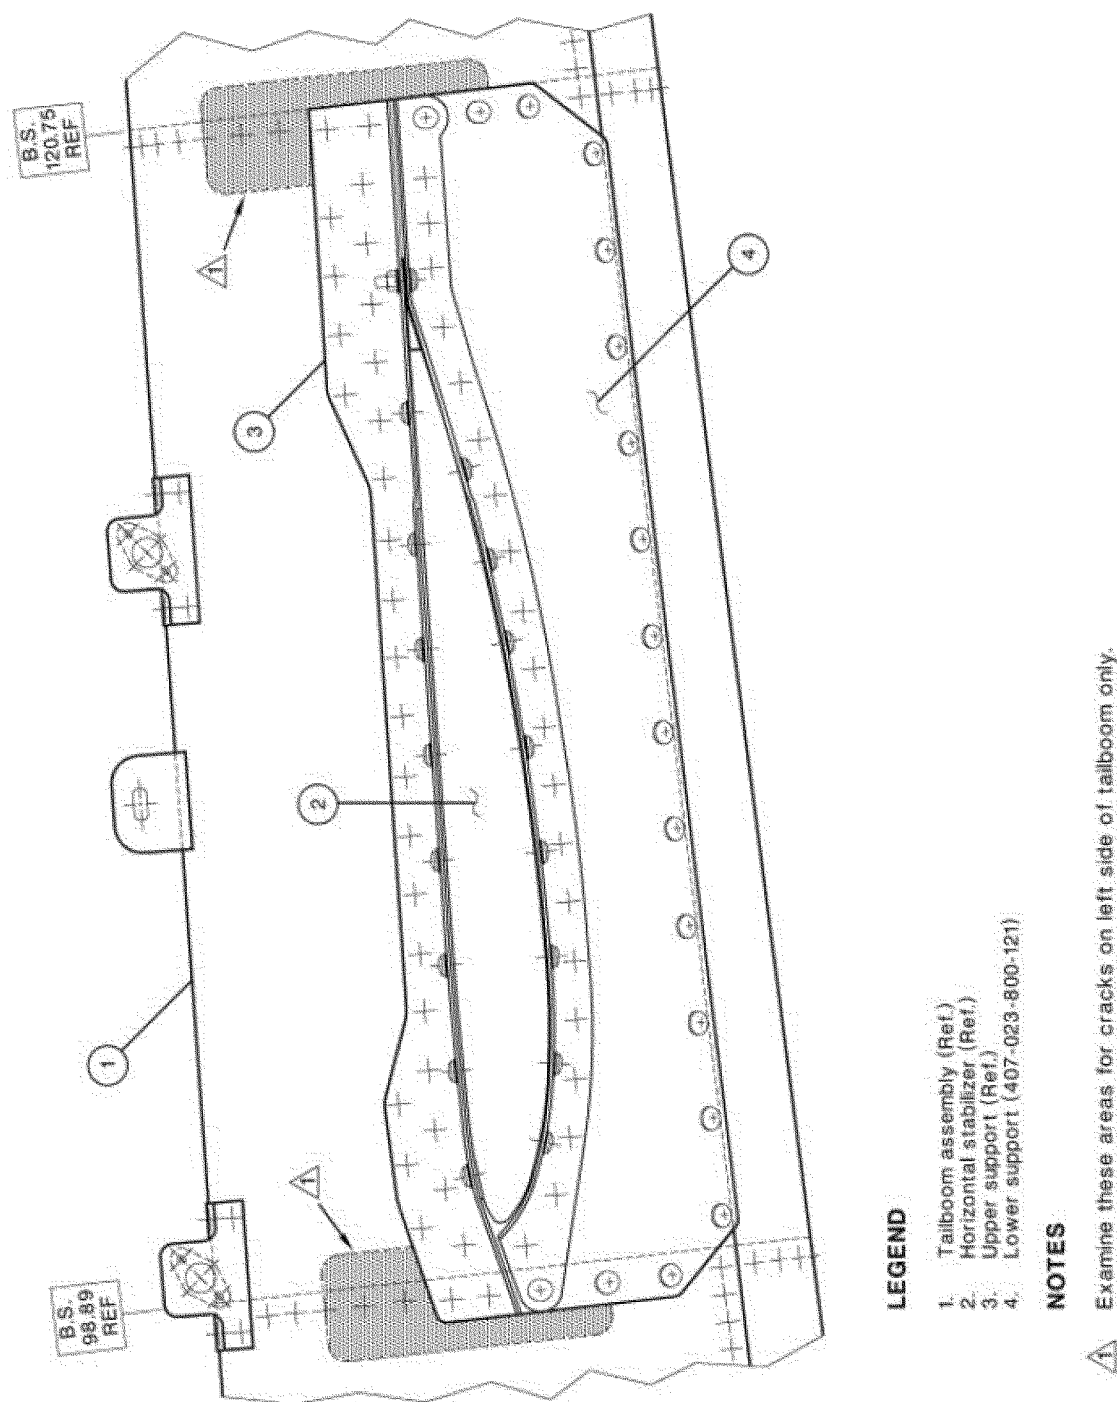
Figure 1 to Paragraph (f)(1)(i)(A)

(A) Before the first flight of each day, visually check the tailboom for a crack, as depicted in Figure 1 to paragraph (f)(1)(i)(A) of this AD.

(3) If there is a crack, before further flight, replace the tailboom.

(4) If there is no crack, make sure both of the inspection area surfaces are dry and protect each reworked area with a thin coat of clear coating.

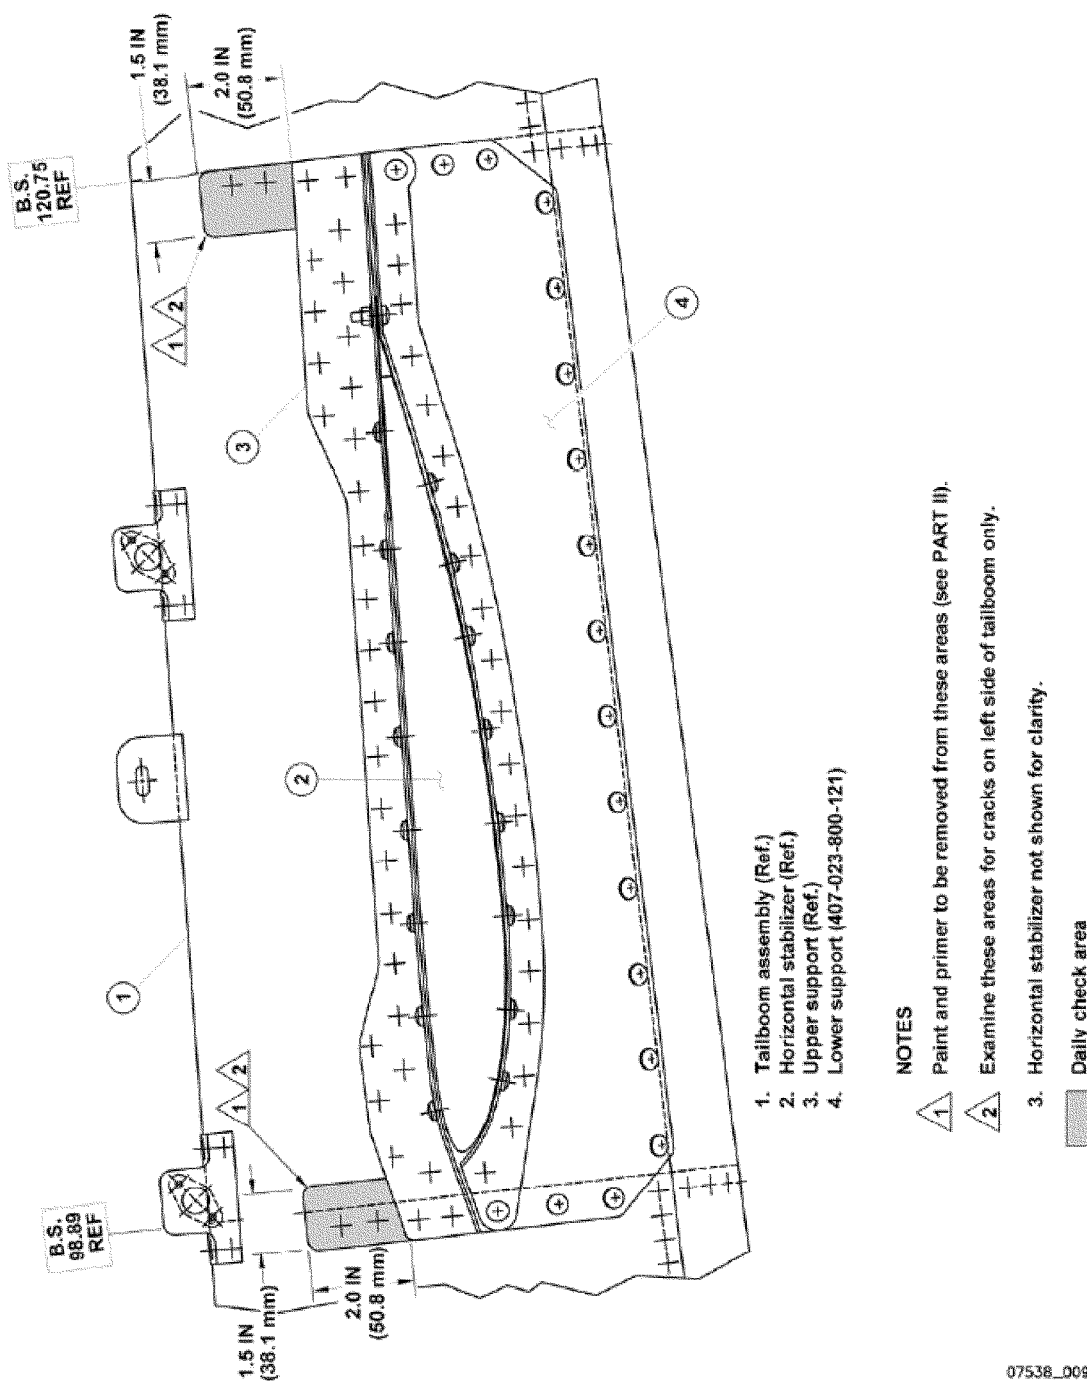
(iii) Thereafter, before the first flight of each day, clean the area on the tailboom

where paint has been removed and visually check the tailboom for a crack as depicted in Figure 2 to Paragraph (f)(2)(iii) of this AD.
