[Docket No. FAA-2013-0574; Directorate Identifier 2008-SW-22-AD; Amendment 39-17766; AD 2014-04-07]

Airworthiness Directives; Bell Helicopter Textron Canada (Bell) Helicopters

2014–04–07 Bell Helicopter Textron

Canada: Amendment 39–17766; Docket No. FAA–2013–0574; Directorate Identifier 2008–SW–22–AD.

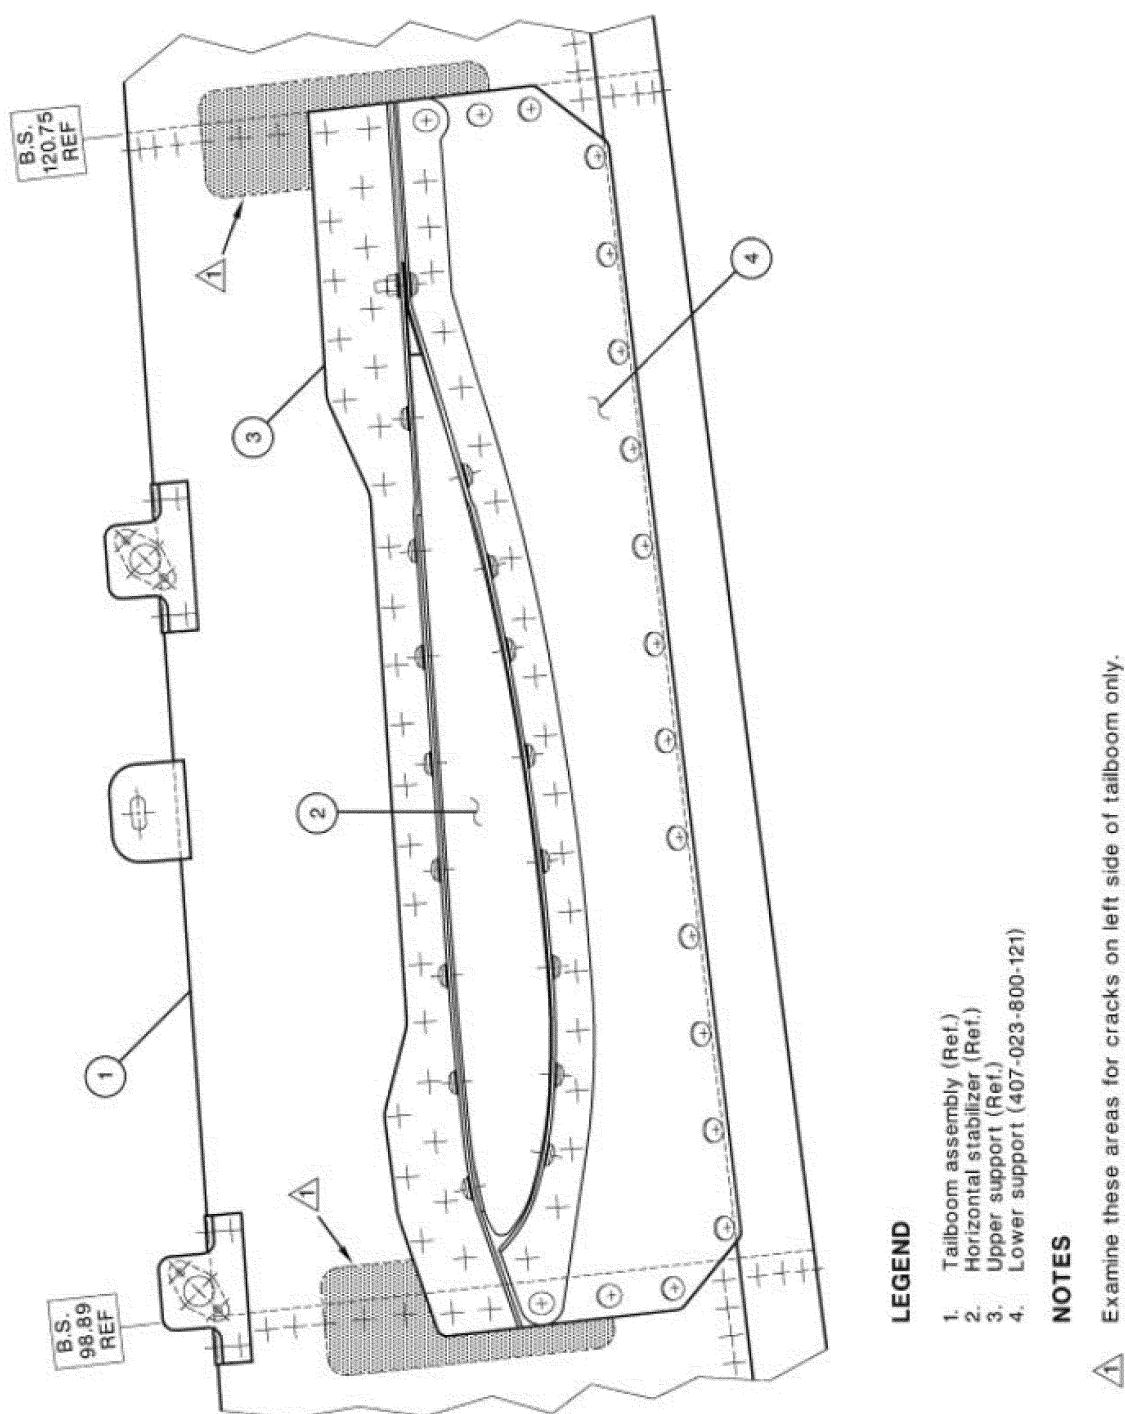
This AD defines the unsafe condition as cracks in the tailboom skin on the left side in the area of horizontal stabilizer, which could result in separation of the tailboom and subsequent loss of control of the helicopter.

(A) Before the first flight of each day, visually check the tailboom for a crack, as depicted in Figure 1 to Paragraph (f)(1)(i)(A) of this AD.

(3) If there is a crack, before further flight, replace the tailboom.
