[Docket No. FAA-2011-1158; Directorate Identifier 2010-SW-018-AD; Amendment 39-16847; AD 2011-22-05]

**Airworthiness Directives; Eurocopter France Model AS350B, B1, B2, B3, BA, C, D, and D1; and AS355E, F, F1, F2, N, and NP Helicopters**

#### 2011–22–05 EUROCOPTER FRANCE

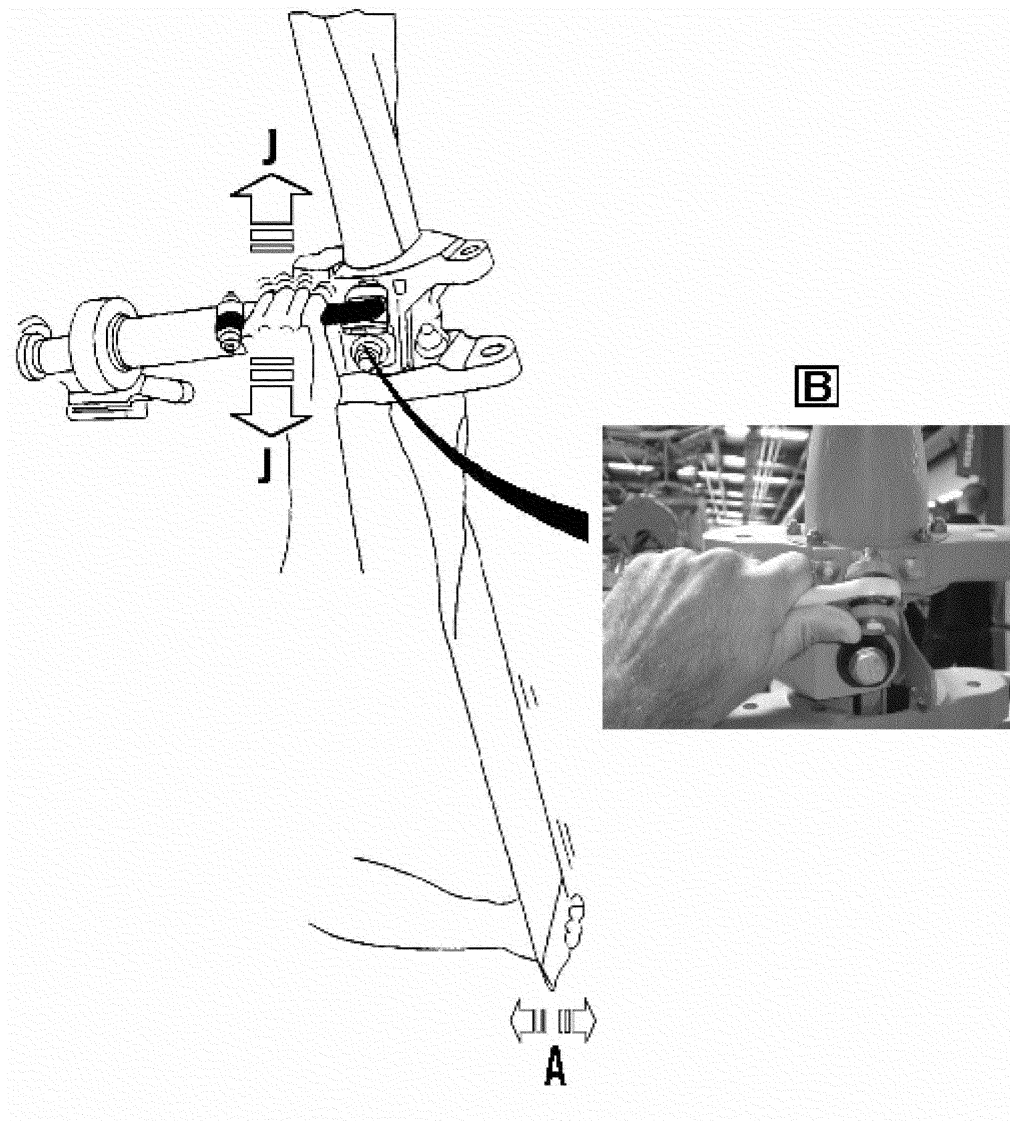
- (a) Before the first flight of each day, place the T/R pedals in the neutral position. If the helicopter is fitted with a T/R load compensator, discharge the accumulator as described in the rotorcraft flight manual. Check the control rod bearing (bearing) for play on the helicopter, by observation and feel, by slightly moving the T/R blade in the flapping axis while monitoring the bearing for movement. See the following Figure 1 of this AD. The actions required by this paragraph may be performed by the owner/operator (pilot) holding at least a private pilot certificate, and must be entered into the helicopter maintenance records showing compliance with this AD in accordance with 14 CFR 43.9(a)(1)–(4) and 14 CFR 91.417(a)(2)(v). The record must be maintained as required by 14 CFR 91.173, 121.380, or 135.439.

Figure 1: Manual Check for Play of the Tail Rotor Pitch Control Rod

(b) If the Teflon cloth is coming out of its normal position within the bearing, totally or partially, or if there is discoloration or scoring on the bearing, before further flight,

replace the control rod with an airworthy control rod.

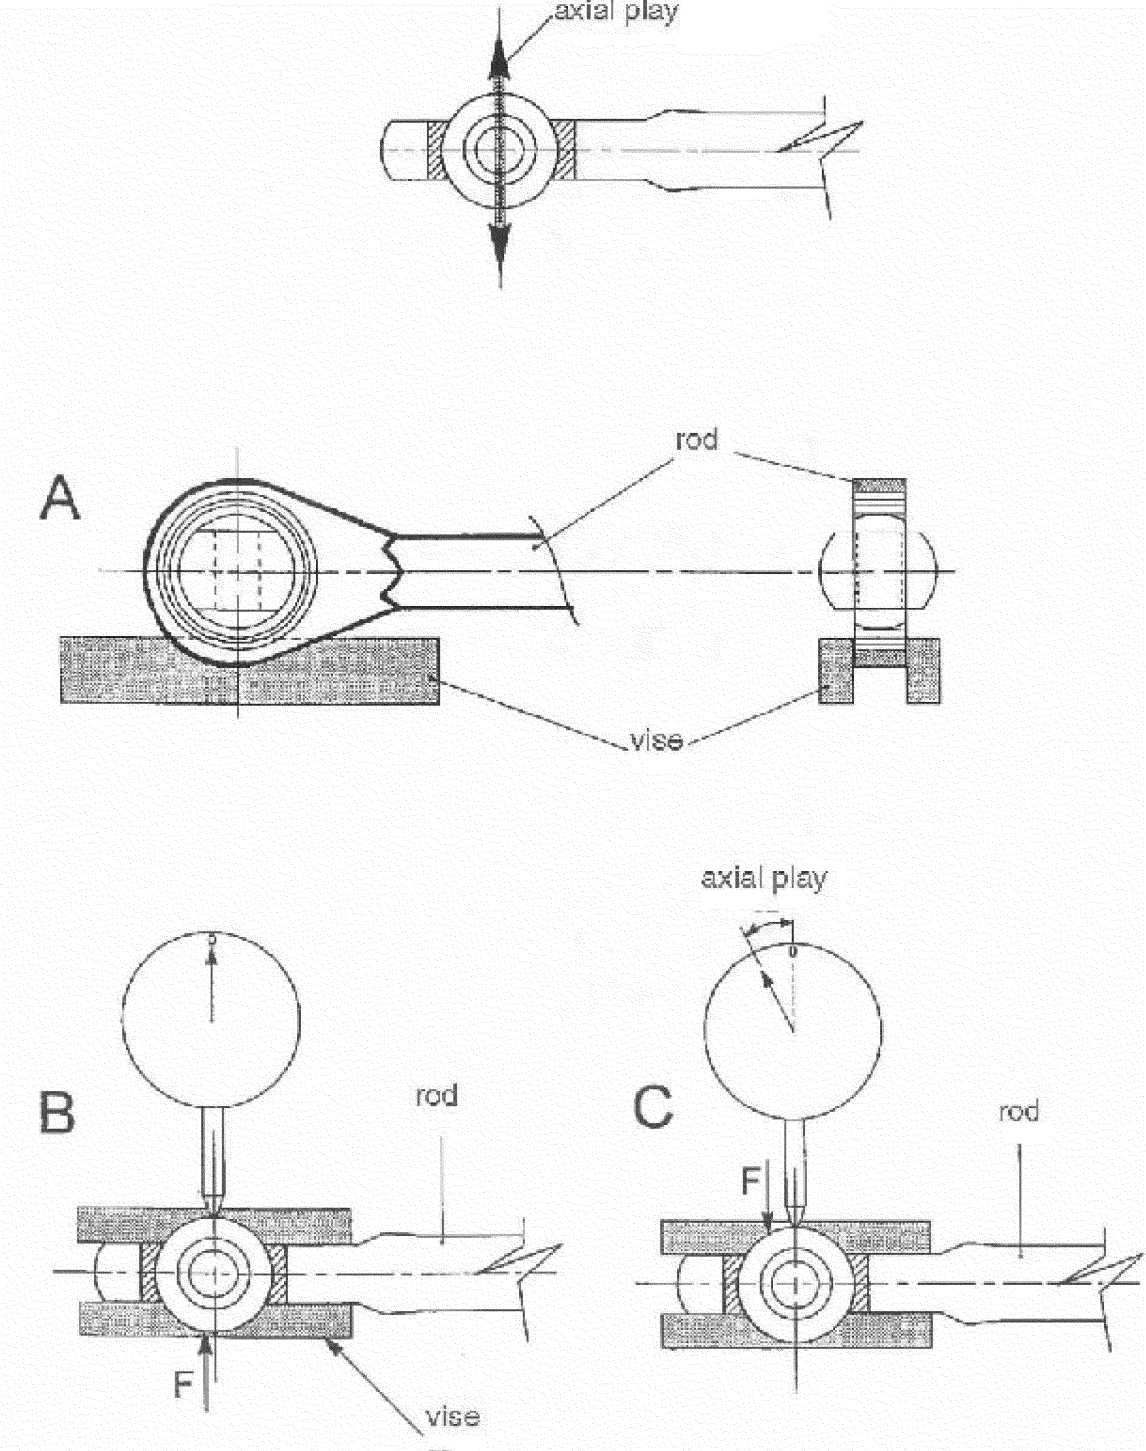
Figure 2: Measurement of the Axial Play (A) of the Bearing

(2) Mount the control rod in a vise as shown in Figure 2 of this AD.

(3) Using a dial indicator, take axial play readings by moving the spherical bearing in the direction F (up and down) as shown in Figure 2 of this AD.

(8) If the radial play exceeds 0.008 inch or axial play exceeds 0.016 inch, replace the control rod with an airworthy control rod before further flight.

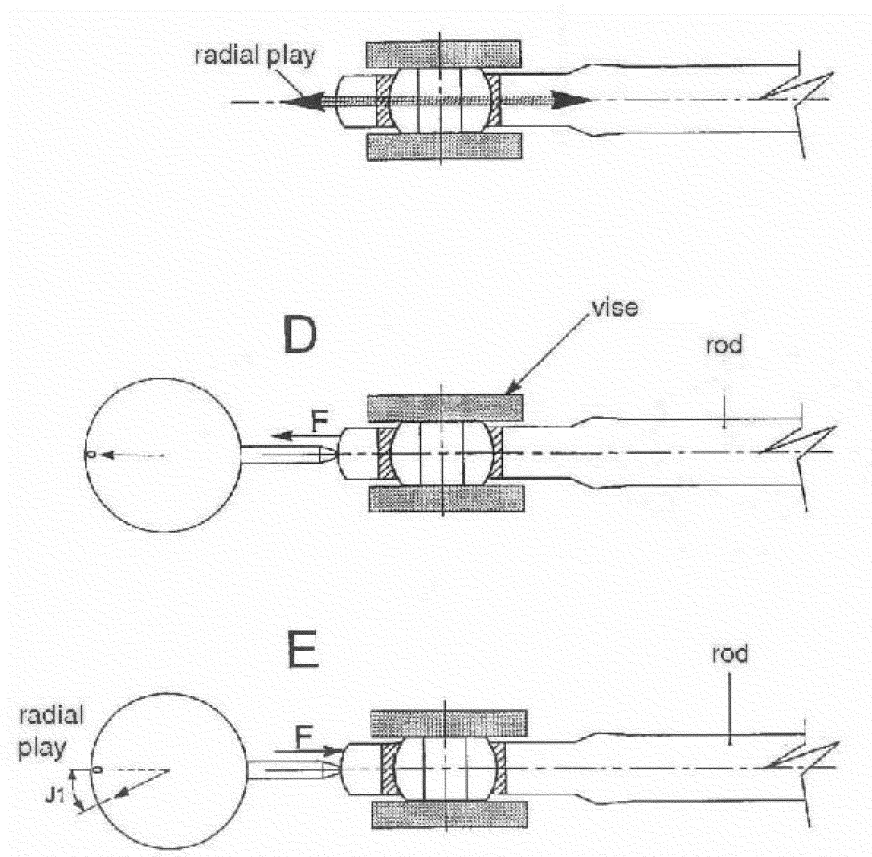
Figure 3: Measurement of the Radial Play (R) of the Bearing

(5) Mount the control rod and bearing in a vise as shown in Figure 3 of this AD.

(6) Using a dial indicator, take radial play measurements by moving the control rod in the direction F as shown in Figure 3 of this AD.
