[Docket No. FAA-2016-9254; Directorate Identifier 2015-CE-030-AD]

#### Airworthiness Directives; Piper Aircraft, Inc. Airplanes

**ACTION:** Notice of proposed rulemaking (NPRM).

**SUMMARY:** We propose to supersede Airworthiness Directive (AD) 95-26-13, which applies to certain Piper Aircraft, Inc. Models PA-28-140, PA-28-150, PA-28-151, PA-28-161, PA-28-160, PA-28-180, PA-28-181, PA-28-235, PA-28-236, PA-28R-180, PA-28R-200, PA-28R-201, PA-28S-160, PA-28S-180, PA-32-260, PA-32-300, PA-32-301, PA-32-301T, PA-32R-300, PA-32R-301 (SP), PA-32R-301 (HP), PA-32R-301T, PA-32RT-300, PA-32RT-300T, and PA-32S-300 airplanes equipped with oil cooler hose assemblies that do not meet certain technical standard order (TSO) requirements. AD 95-26-13 requires inspections, replacement, and adjustment of the oil cooler hose assemblies, as well as providing for a terminating action. Since we issued AD 95-26-13, the FAA has received requests to clarify the intent of AD 95-26-13. This proposed AD would maintain all of the actions required by AD 95-26-13 and add language to clarify those requirements. We are proposing this AD to prevent rupture or failure of the oil cooler hose assemblies, which coul

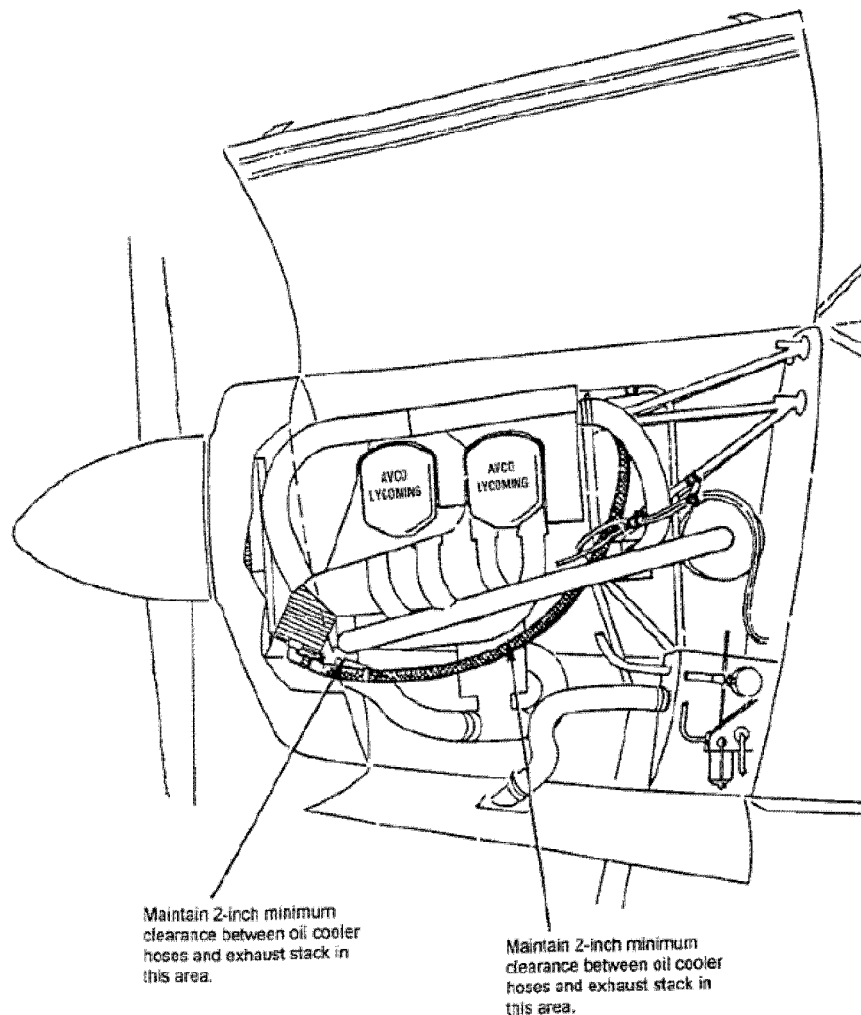
Figure 2 to paragraph (h) of this AD: Acceptable clearances

(3) Within the next 100 hours TIS after February 5, 1996 (the effective date retained from AD 95-26-13) and each time the oil cooler hose assembly is replaced for any reason or inspected following paragraph (h)(1) inspect to ensure the installation conditions in paragraphs (h)(3)(i) through (iii) of this AD are met. If the conditions listed in paragraphs (h)(3)(i) through (iii) of this AD are not met, before further flight, make any necessary adjustments. Please see figure 2 to paragraph (h) of this AD for additional information.

(i) The oil cooler hose assemblies pass underneath and behind the electrical ground cable and in front of the lower of the two engine mount.

(ii) The oil cooler hose assemblies are secured to the engine mount strut and a clearance of at least 2 inches exists between the oil cooler hose assemblies and the exhaust stack.

(iii) Oil cooler hose assemblies with a minimum outer diameter of 0.75 inch are installed with a bend radius of at least 6.5 inches.

(3) Replacement of the oil cooler hose assembly with TSO-C53a Type D oil cooler hose assembly and meeting the installation conditions listed in paragraphs (h)(3)(i) through (iii) of this AD terminate the requirements of this AD.

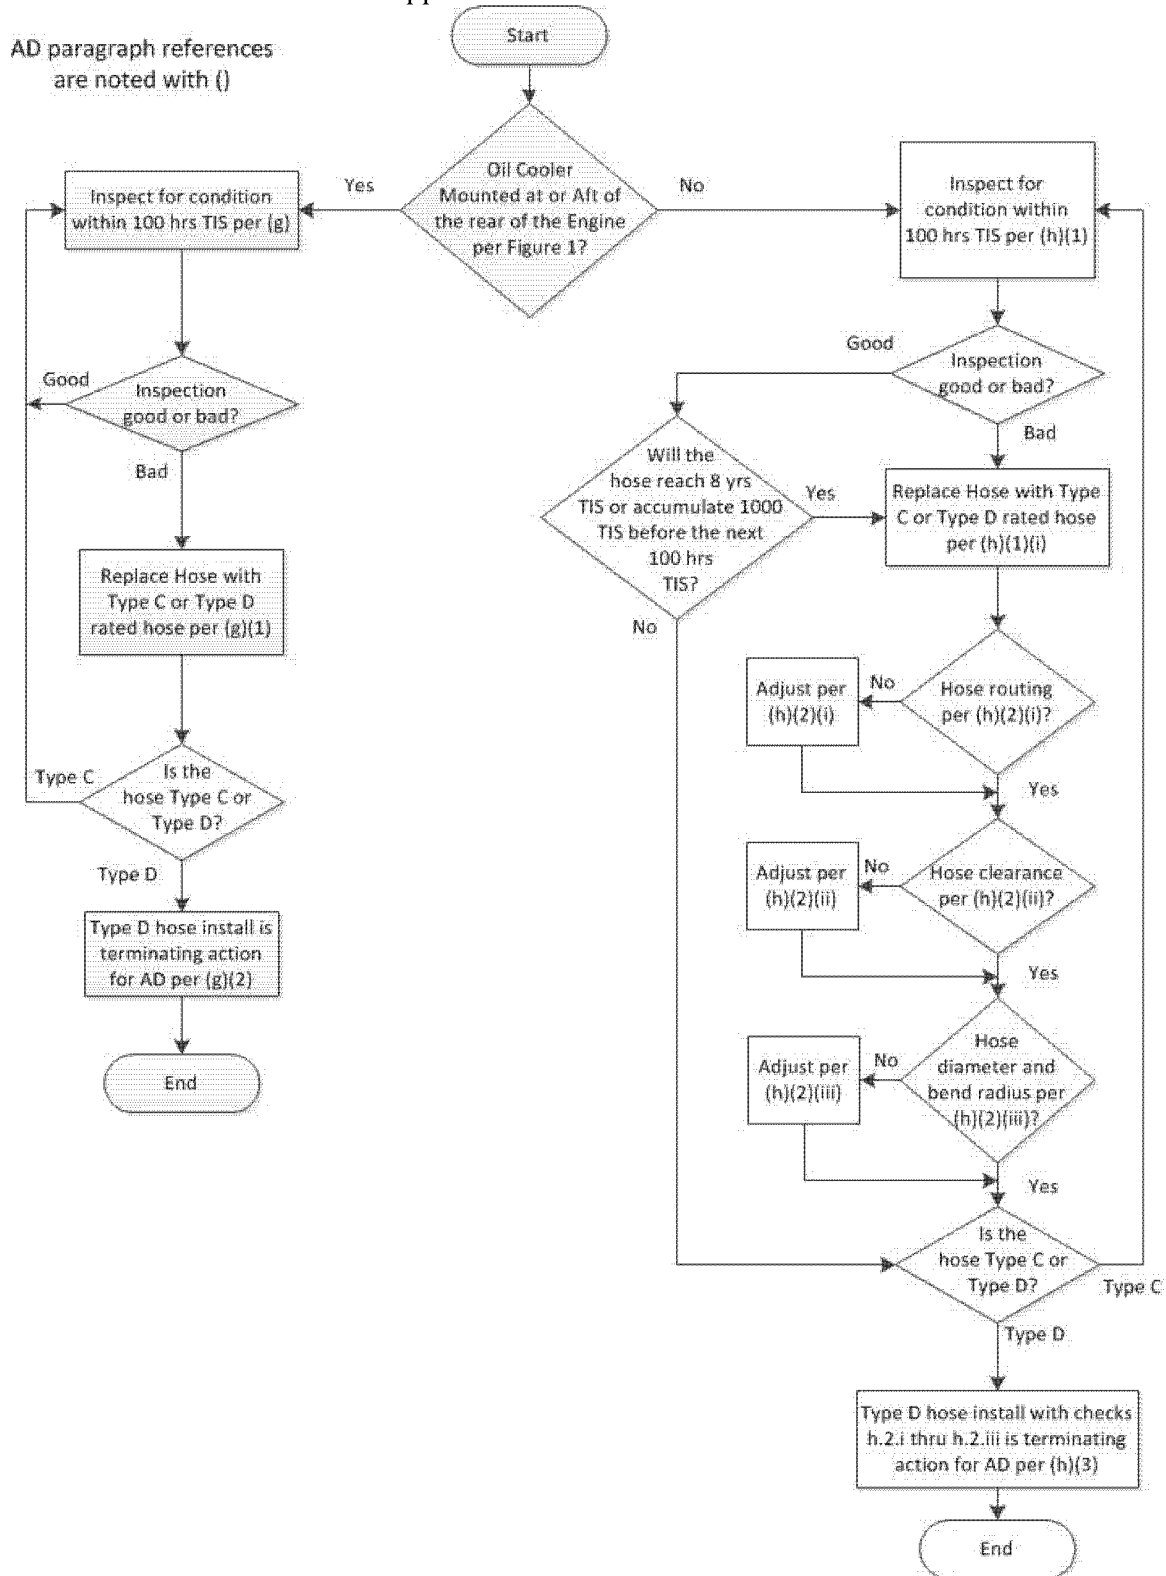
## Appendix 1 to Docket FAA-2016-9254

done. You may review the flow chart found in appendix 1 to assist you in complying with the actions of this AD.
