**DEPARTMENT OF TRANSPORTATION****Federal Aviation Administration****14 CFR Part 39**

[Docket No. FAA-2005-22481; Directorate Identifier 2004-NM-176-AD]

**Airworthiness Directives; Bombardier Model CL-600-2B19 (Regional Jet Series 100 & 440) Airplanes**

**ACTION:** Notice of proposed rulemaking (NPRM).

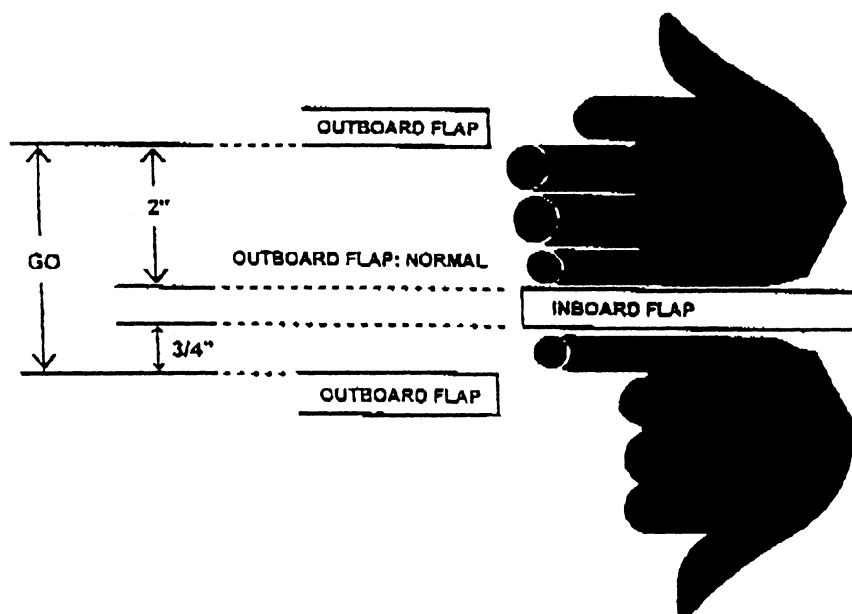
**1. FLAPS AT 8 DEGREES**

If the outboard flap position is outside the "GO" range as shown below further flight is prohibited.

Whenever the outboard flap position indicator is outside the 'GO' range as shown in Figure 2, or whenever directed to do so by the Maintenance Procedure above, perform the following procedures:
