[Docket No. FAA-2012-0182; Directorate Identifier 2012-CE-005-AD; Amendment 39-16958; AD 2012-03-52]

#### Airworthiness Directives; Mooney Aviation Company, Inc. (Mooney) Airplanes

**ACTION:** Final rule; request for comments.

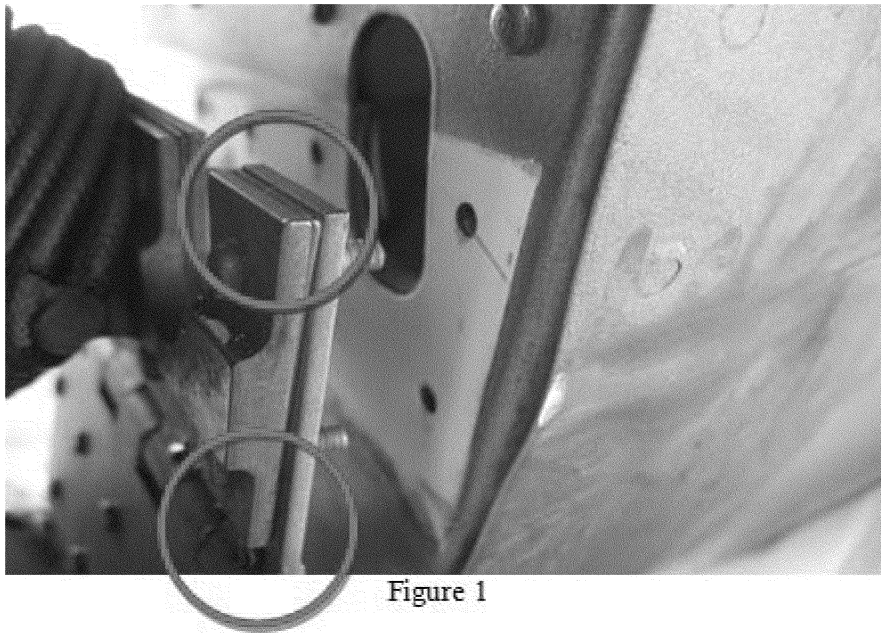
Figure 1

This aircraft was immediately inspected, and all 10 swaged collars that hold the tail trim assembly together had become unattached.

Mooney inspected several other aircraft and found that on one airplane the filler plate was incorrectly installed. The filler plate was not correctly installed between the aft side of the hinge and the bulkhead. Instead, the filler plate was located on the forward side of the hinge between the hinge and trim fitting. It was then noted the incident aircraft had the same issue, as shown in the upper circle of figure 1.

Because the hinge has a lip on the bottom, on the side toward the bulkhead (as shown in the bottom circle of figure 1), if the filler plate is not installed correctly, the hinge will not fit flush against the bulkhead, the Huck Bolt fasteners will not fit perpendicular to the bulkhead, and the collars will not swage properly. The condition also causes excessive tension pre-load on the Huck Bolts.

The incident aircraft was manufactured in 2008. Mooney has determined the incorrect installation was a manufacturing quality escape during production.

If during the inspection required in paragraph (g) of this AD you find incorrect positioning or improper attachment of the trim fitting, hinge, and filler plate of the tail pitch trim assembly; and/or you find loose or improperly installed Huck Bolt fasteners, before further flight, contact Mooney for FAA-approved repair instructions and perform the repair. Use the contact information found in paragraph (n)(2) of this AD.
