[Docket No. FAA–2016–9418; Product Identifier 2016–NE–23–AD; Amendment 39–19167; AD 2018–02–14]

Airworthiness Directives; Honeywell International Inc. Turboprop and Turboshaft Engines

2018-02-14 Honeywell International Inc. (Type Certificate previously held by AlliedSignal Inc., Garrett Engine Division; Garrett Turbine Engine Company; and AiResearch Manufacturing Company of Arizona): Amendment 39-19167; Docket No. FAA-2016-9418; Product Identifier 2016-NE-23-AD.

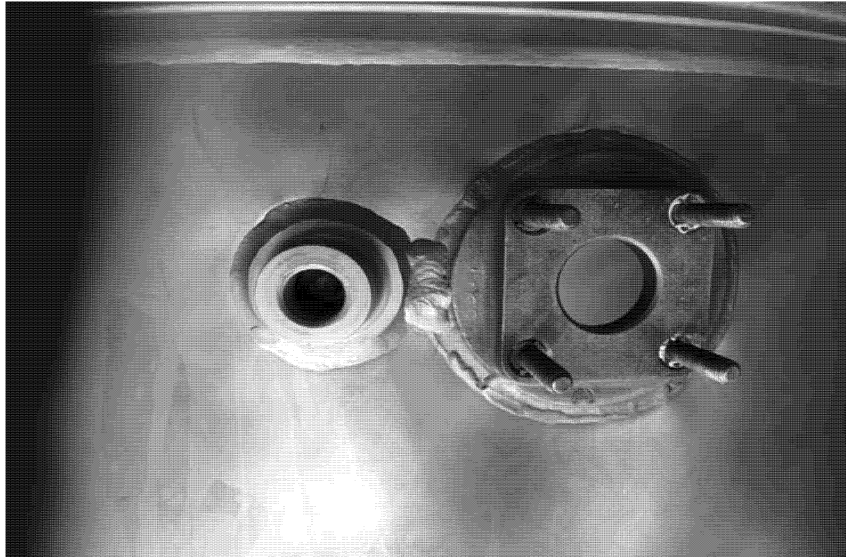
**Figure 1 to Paragraph (h) of this AD. Combustion Chamber Case Assembly
Without the One-Piece Bleed Pad with P3 Boss**

We agree. We note that five of the six combustion chamber case assemblies that ruptured were assemblies without the one-piece bleed pad. P/N 3101668-x has the one-piece bleed pad with P3 boss, which demonstrated significantly reduced cracking between the P3 and bleed boss; therefore, this combustion chamber case assembly is not affected by this AD. No further changes are needed. We did not change this AD.

TPE331 model engines modified by STC SE383CH may be defined as the "Super 1" and "Super 2" for the compressor modification of the TPE331-1 and the TPE331-2, -2U, and -2UA engines, respectively. Figures 1 and 2 to paragraph (h) of this AD illustrate the appearance of combustion chamber case assembly, P/N

893973-5, without and with, respectively, the one-piece bleed pad with the P3 boss.

(2) For TPE331-3U, -3UW, -5, -5A, -5AB, -5B, -6, and -6A engines with combustion chamber case assemblies, P/Ns 869728-1, 869728-3, or 893973-5, installed, and without the one-piece bleed pad with P3 boss; and for TPE331-1, -2, and -2UA engines modified by National Flight Services, Inc., supplemental type certificate (STC) SE383CH, remove the combustion chamber case assembly from service at the next removal of the combustion chamber case from the engine, not to exceed 3,700 hours time-in-service since last hot section inspection.

After the effective date of this AD, do not install a combustion chamber case assembly,

P/N 869728-1, 869728-3, or 893973-5, in TPE331-3U, -3UW, -5, -5A, -5AB, -5B, -6, and -6A engines or in TPE331-1, -2, and -2UA engines modified by National Flight

Services, Inc., STC SE383CH, unless the combustion chamber case assembly has a one-piece bleed pad with P3 boss.
