Airworthiness Directives; Bombardier Model CL-600-2C10 (Regional Jet Series 700, 701, & 702) Airplanes, Model CL-600-2D15 (Regional Jet Series 705) Airplanes, and Model CL-600-2D24 (Regional Jet Series 900) Airplanes

ACTION: Notice of proposed rulemaking (NPRM).

Bombardier, Inc. (Formerly Canadair):
Docket No. FAA-2006-24074;
Directorate Identifier 2005-NM-213-AD.

(d) This AD results from a report of a main landing gear (MLG) door departing from an airplane. We are issuing this AD to prevent failure of the lower panel of the MLG door, the lower panel's departure from the

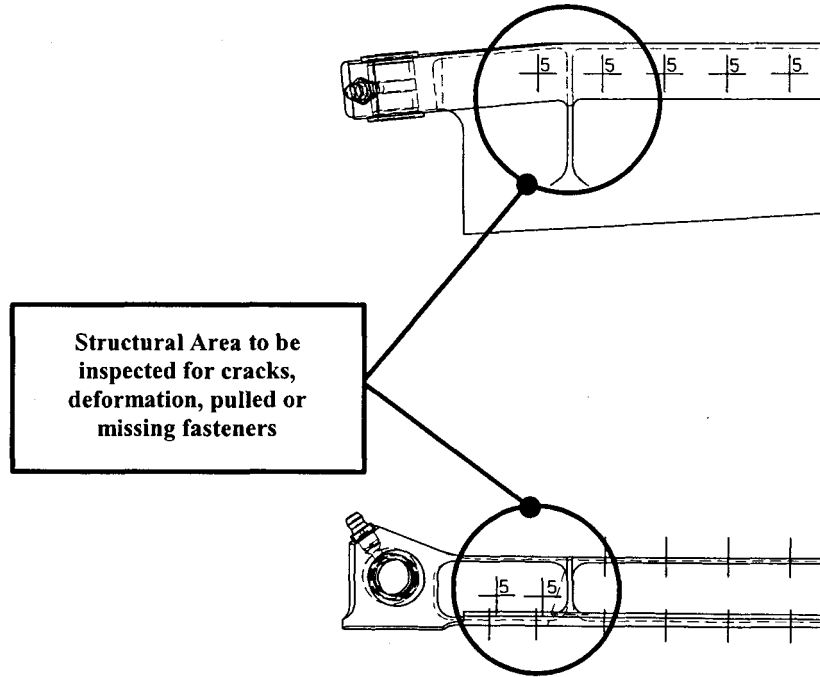
Figure 3
View LKG INBD
LH side Shown
RH side Opp

(4) Inspect the forward member, P/N CC670-10570, and aft member, P/N CC670-10571, of the MLG door lower panel, for cracking or deformation, or pulled or missing fasteners, in accordance with Figure 3 of this AD. Figures 1 through 3 of this AD follow.

(i) If any cracking or deformation, or pulled or missing fastener, as applicable, is found during any inspection done in accordance with paragraph (g) or (h) of this AD: Before

(1) Repair the damage in accordance with a method approved by either the Manager, New York Aircraft Certification Office (ACO), FAA; or Transport Canada Civil Aviation (or its delegated agent); and accomplish repetitive inspections in accordance with a

(2) Replace the lower panel assembly, P/N CC670-10520, of the affected MLG door with a new or serviceable lower panel assembly having the same P/N, in accordance with Task Cards 32-12-01-000-801-A01 and 32-12-01-400-801-A01 of the CRJ 700/900 Series Regional Jet Aircraft Maintenance Manual; and repeat the inspections specified in paragraph (g) of this AD at intervals not to exceed 100 flight cycles.
