[Docket No. FAA-2020-0442; Project Identifier AD-2020-00260-E; Amendment 39-21640; AD 2021-14-13]

Airworthiness Directives; Pratt & Whitney Turbofan Engines

SUMMARY: The FAA is adopting a new airworthiness directive (AD) for all Pratt & Whitney (PW) PW2037, PW2037M, PW2040, and F117-PW-100 model turbofan engines. This AD was prompted by a report of an uncontained engine failure resulting from cracks in the knife edge of the high-pressure turbine (HPT) 2nd-stage air seal assembly. This AD requires fluorescent penetrant inspections (FPIs) and visual inspections of the HPT 2nd-stage air seal assembly and, depending on the results of the inspections, replacement of the HPT 2nd-stage air seal assembly with a part eligible for installation. This AD also requires replacement of the affected HPT 2nd-stage air seal assembly, depending on the engine model, at either the next engine shop visit or the next piece-part opportunity. The FAA is issuing this AD to address the unsafe condition on these products.

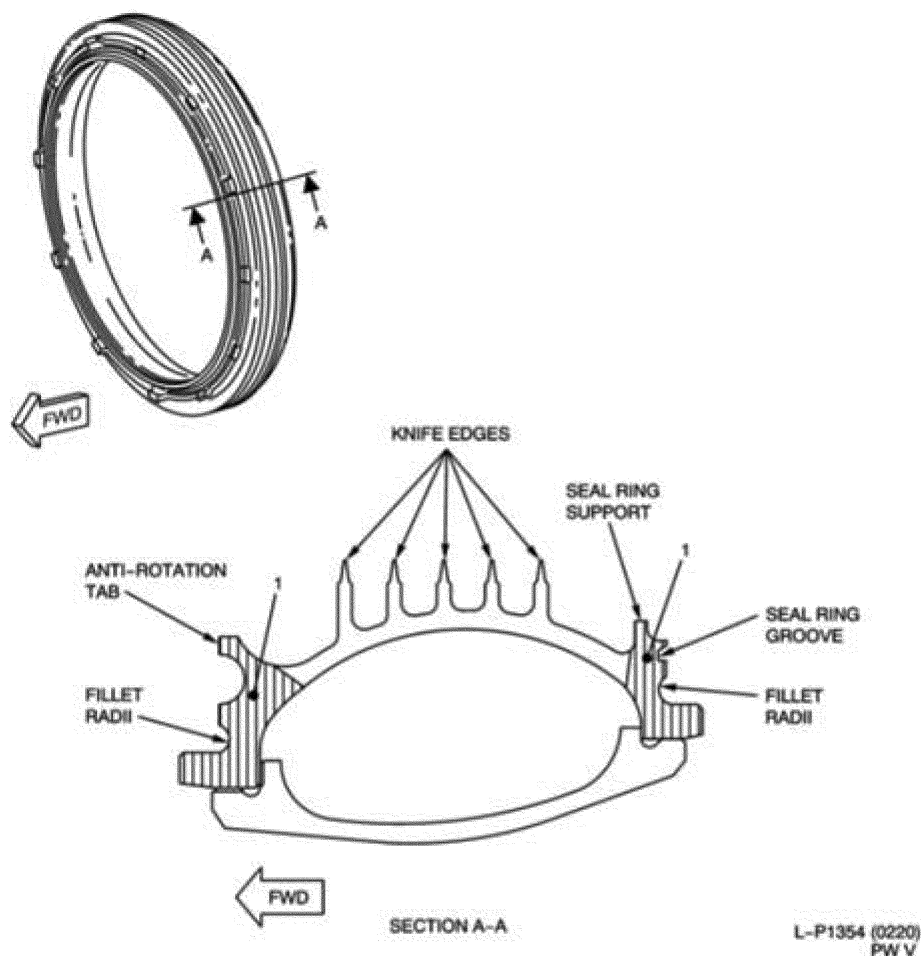
Figure 1 to Paragraph (g)(1)(iii) – Crack Inspection Critical Areas

The FAA did not revise this AD in response to this comment. A crack, as identified in the shaded regions of Figure 1 to paragraph (g)(1)(iii) of this AD (Figure 1), which extends towards the knife-edge region of the HPT 2nd-stage air seal assembly, impacts the serviceability of the mating HPT 1st-stage disk and the HPT 2nd-stage hub. A crack identified in the shaded region of Figure 1 of this AD of the HPT 2nd-stage air seal assembly results in the

If a crack is found as identified in the shaded region of Figure 1 to paragraph (g)(1)(iii) of this AD (Figure 1) that

extends toward the knife-edge region of the HPT 2nd-stage air seal assembly, this AD requires replacement of the HPT 2nd-stage air seal assembly, mating HPT 1st-stage disk, and HPT 2nd-stage hub.

This AD was prompted by a report of an uncontained engine failure resulting from cracks originating in the knife edge of the high-pressure turbine (HPT) 2nd-stage air seal assembly. The FAA is issuing this AD to prevent failure of the HPT 2nd-stage air seal assembly. The unsafe condition, if not addressed, could result in uncontained HPT 2nd-stage air seal assembly release, damage to the engine, and damage to the airplane.

(iii) During the visual inspection or FPI required by paragraph (g)(1)(i) of this AD, if a crack is found in the shaded regions of the HPT 2nd-stage air seal assembly identified in Figure 1 to paragraph (g)(1)(iii) of this AD (Figure 1), which extends towards the knife-

disk and HPT 2nd-stage hub to service, the inspections of the HPT 2nd-stage air seal assembly cannot reveal a crack identified in the shaded regions of Figure 1, which extends towards the knife-edge region.

(ii) If a crack is found in the HPT 2nd-stage air seal assembly during the visual inspection or FPI required by paragraph (g)(1)(i) of this AD, remove the HPT 2nd-stage air seal assembly from service and replace it with a part eligible for installation.

edge region of the HPT 2nd-stage air seal assembly, remove the HPT 2nd-stage air seal assembly, mating HPT 1st-stage disk, and HPT 2nd-stage hub from service, and replace the parts with parts eligible for installation. In order to return the mating HPT 1st-stage
