[Docket No. FAA-2006-25513; Directorate Identifier 99-NE-61-AD; Amendment 39-14753; AD 2006-18-14]

#### Airworthiness Directives; Rolls-Royce Deutschland Ltd & Co KG Tay 650-15 and Tay 651-54 Turbofan Engines

#### **ACTION:** Final rule.

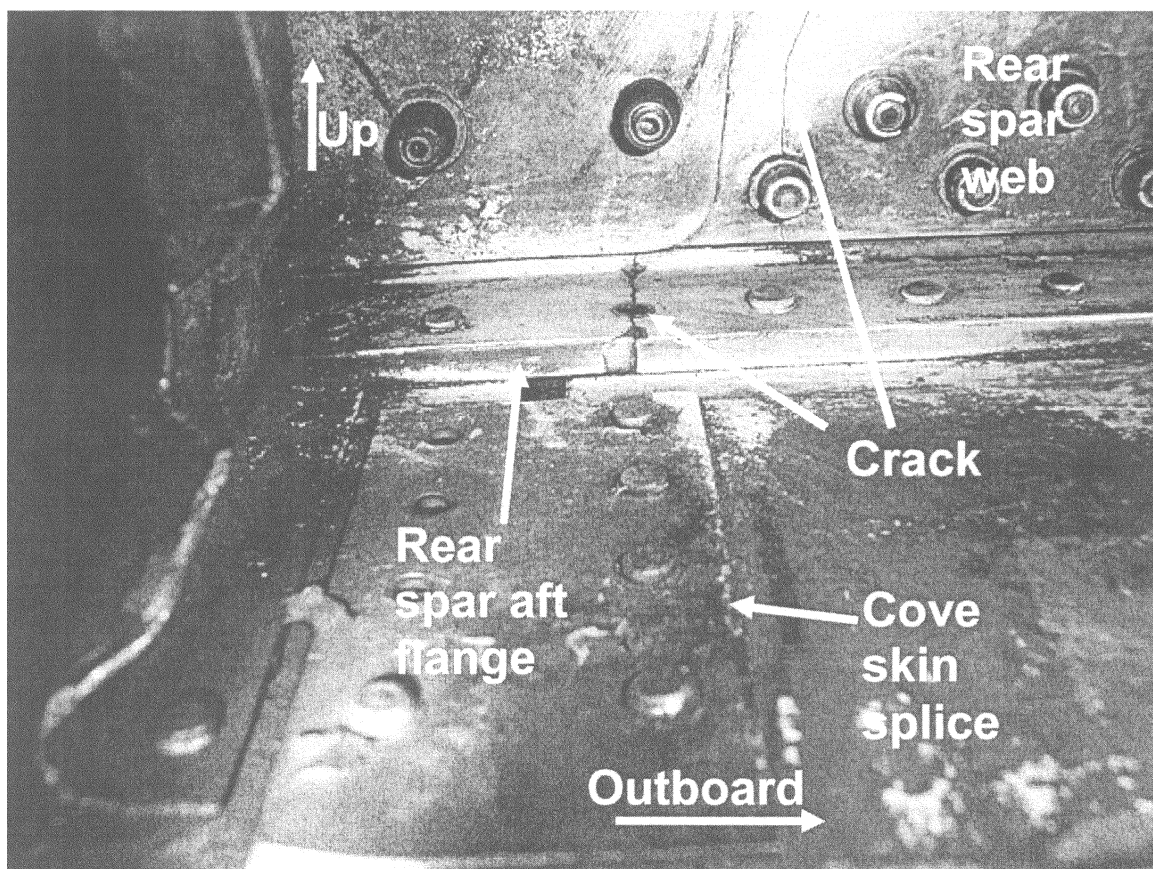
Figure 3: Closeup view of R/H wing rear spar cracks at BL 114 area looking forward (The inboard flap is removed in this figure, but removal of the flap is not required to do the inspection).
