[Docket No. 2002-SW-25-AD]

#### Airworthiness Directives; Schweizer Aircraft Corporation Model 269A, 269A-1, 269B, 269C, and TH-55A Helicopters

**ACTION:** Notice of proposed rulemaking (NPRM).

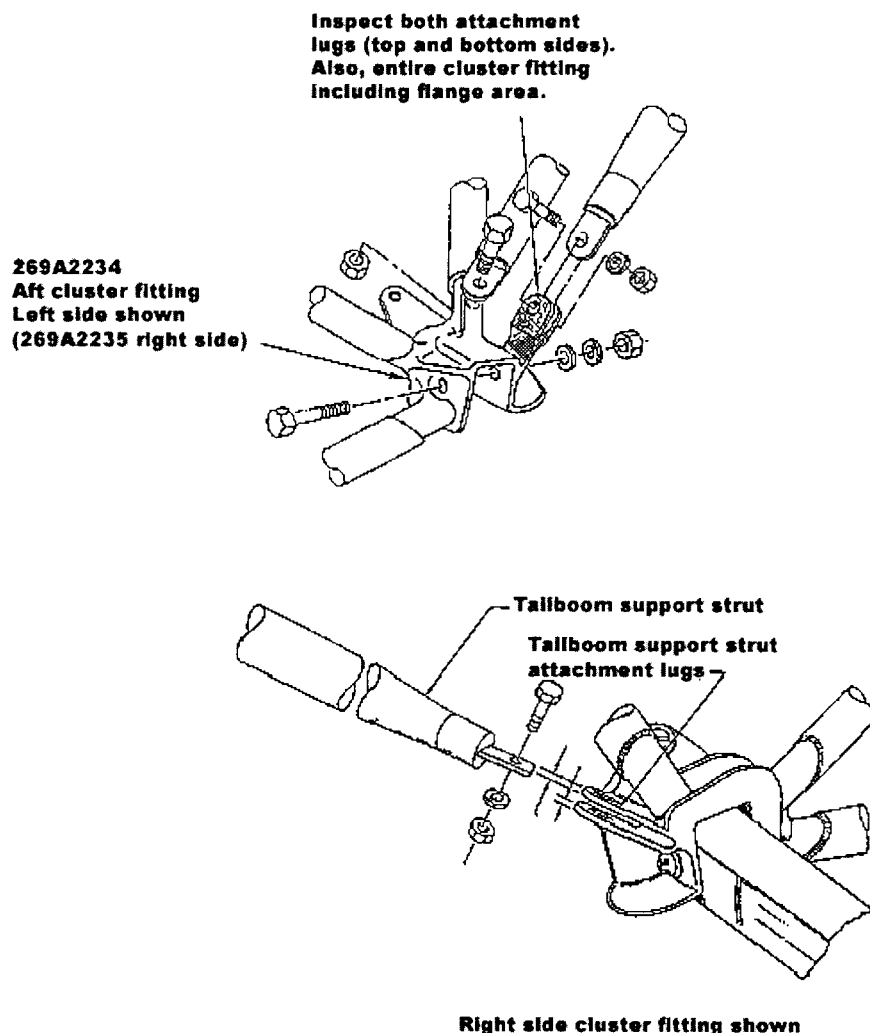
Figure 1

(2) Dye-penetrant inspect the lugs on each cluster fitting. See the following Figure 1:

(3) If a crack is found, before further flight, replace the cracked cluster fitting with an airworthy cluster fitting.
