[Docket No. FAA-2012-0807; Directorate Identifier 2011-NM-191-AD]

#### Airworthiness Directives; Airbus Airplanes

**ACTION:** Supplemental notice of proposed rulemaking (NPRM); reopening of comment period.

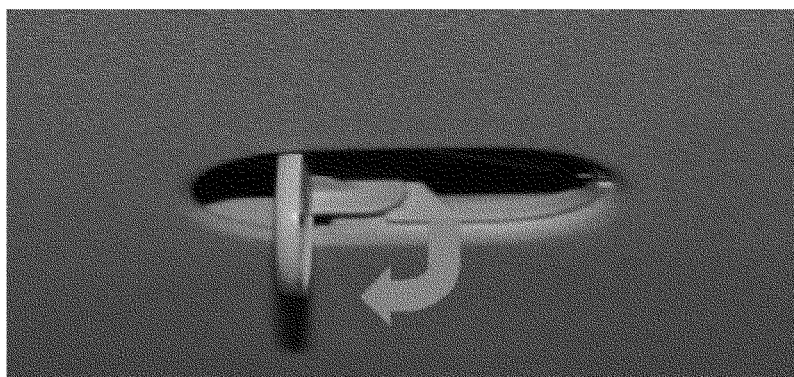
**Picture B:**

(7) The requirements of paragraphs (g) and (h) of this AD apply only to passenger oxygen containers that are Design A, as defined in figure 1 to paragraph (i)(7) of this AD.
