[Docket No. FAA-2011-1035; Directorate Identifier 2011-SW-038-AD; Amendment 39-16817; AD 2011-15-51]

#### **Airworthiness Directives; Bell Helicopter Textron Canada (Bell) Model 407 and 427 Helicopters**

**2011–15–51 Bell Helicopter Textron, Inc. (Bell):** Amendment 39–16817; Docket No. FAA–2011–1035; Directorate Identifier 2011–SW–038–AD.

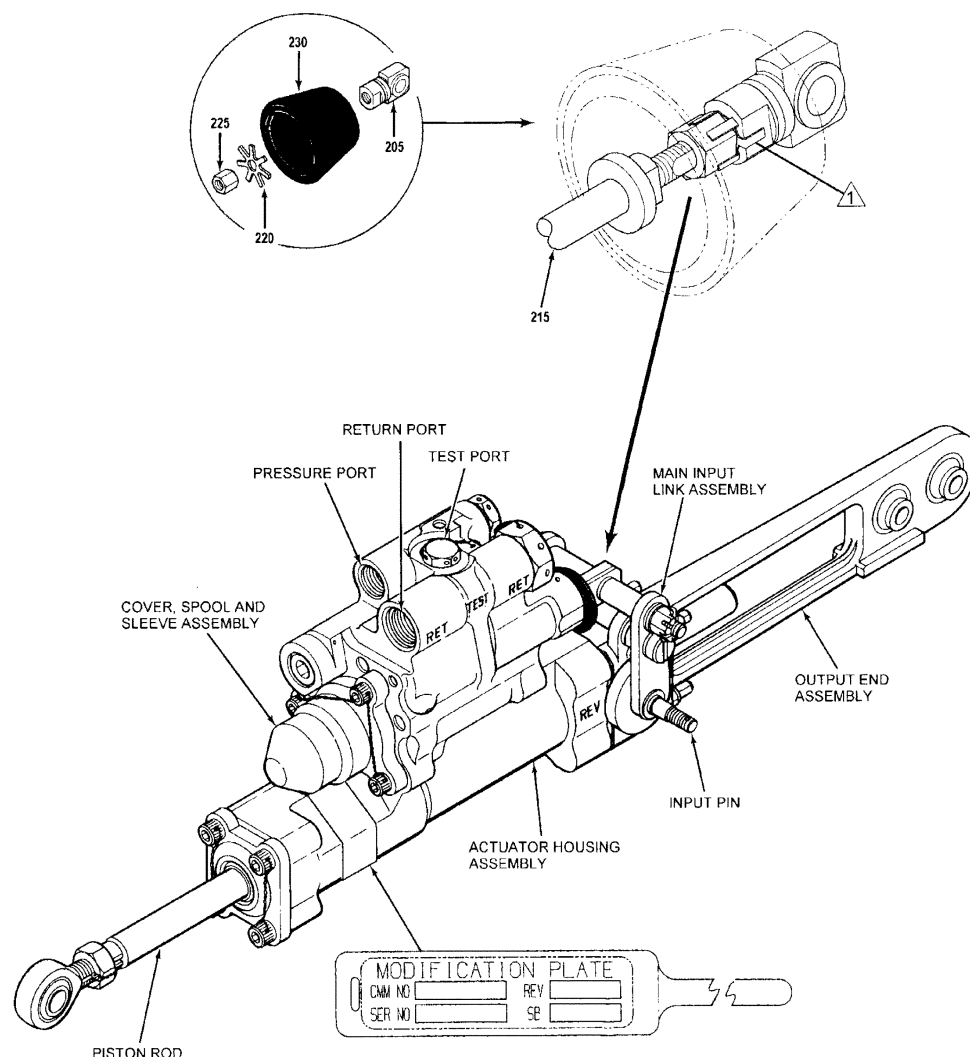
Clevis Assembly  
Figure 1

(1) Retract the boot depicted as “230” in Figure 1 of this AD:

(2) Applying only hand pressure, determine whether the nut, shaft, or clevis assembly, depicted as “225,” “215,” and “205,” respectively, in Figure 1 of this AD, turns independently. If the shaft turns independently of the nut or the clevis assembly, before further flight, replace the servo with an airworthy servo.

(3) If the shaft does not turn independently, inspect to determine whether at least one tab of the lock washer is bent

flush against a flat surface of the nut and at least one tab of the lock washer is bent flush against a flat surface of the clevis assembly.

(i) If at least one lock washer tab is not aligned and bent flush with a nut flat surface and at least one lock washer tab is not aligned and bent flush with a flat surface of the clevis assembly, before further flight, replace the servo with an airworthy servo.

(ii) If any tab of the lock washer is not bent flush against either a flat surface of the nut

or clevis assembly, bend the tab flush against a flat surface.

(4) After accomplishing paragraph (a)(1) through (a)(3) of this AD, reidentify the servo by metal-impression stamping or by vibro-etching “67-01” onto the modification plate.
