[Docket No. 2002–SW–15–AD; Amendment 39–12817; AD 2002–14–17]

Airworthiness Directives; Eurocopter Deutschland GmbH Model EC135 Helicopters

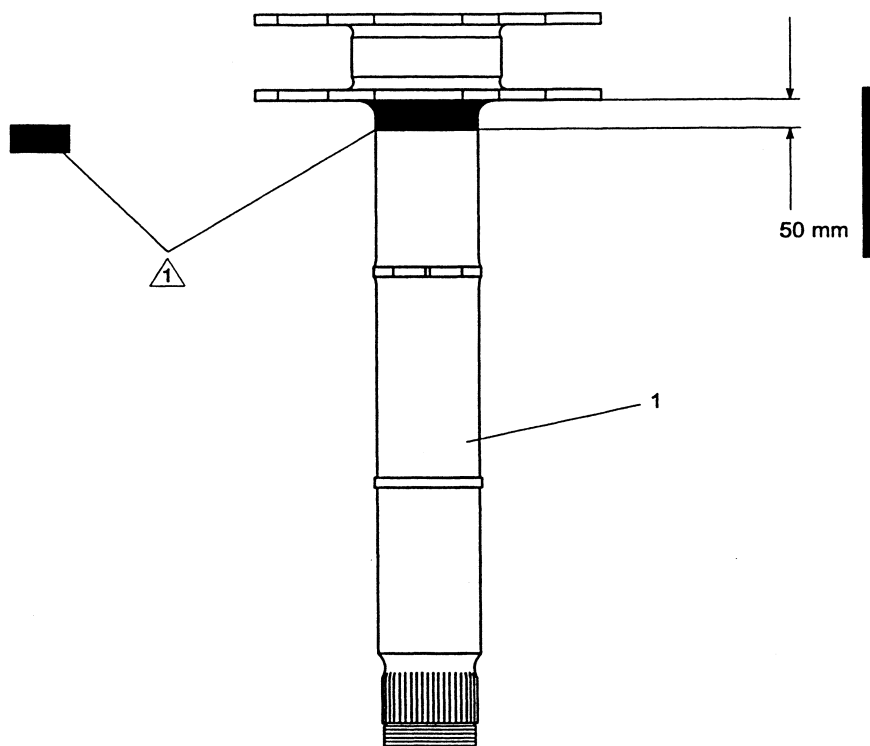
Crack inspection on main rotor hub-shaft
Figure 1

(a) Before further flight, clean and visually inspect the shaft for cracks in the area as shown in the following Figure 1:

△ 1 Inspect marked area i.a.w. crack inspection procedure described.

1 Main Rotor Hub-Shaft

(b) Within 10 hours time-in-service (TIS) after accomplishing the visual inspection required by paragraph (a) of this AD, clean and dye-penetrant inspect the shaft for cracks in the area as shown in Figure 1 of this AD.

(c) Thereafter, visually inspect the shaft for cracks in accordance with paragraph (a) of this AD at intervals not to exceed 15 hours TIS, or dye-penetrant inspect the shaft for cracks in accordance with paragraph (b) of this AD at intervals not to exceed 100 hours TIS.

(d) If a crack is discovered during any shaft inspections, remove the shaft and replace it with an airworthy shaft.
