[Docket No. FAA-2008-0071; Directorate Identifier 2006-SW-27-AD]

### Airworthiness Directives; Bell Helicopter Textron Canada Model 222, 222B, 222U, 230, and 430 Helicopters

**ACTION:** Notice of proposed rulemaking (NPRM).

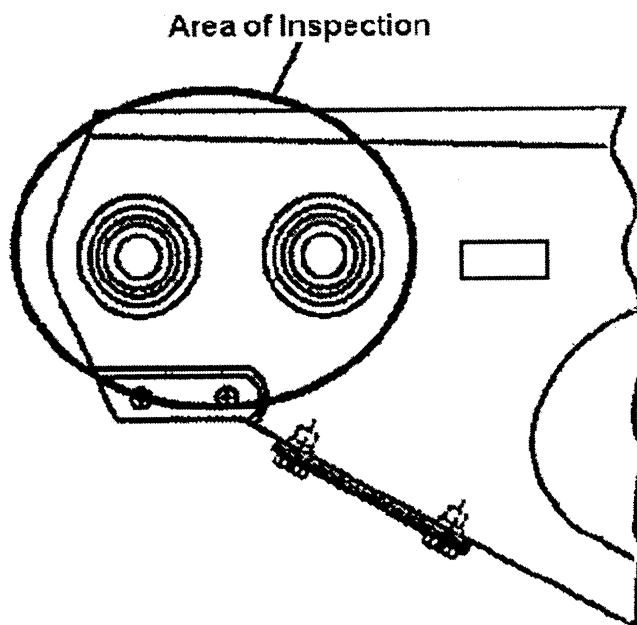
Transport Canada, the airworthiness authority for Canada, notified the FAA that an unsafe condition may exist on the specified BHTC model helicopters. Transport Canada advises of the discovery of cracked blades during scheduled inspections on three occasions. Two cracks originated from the outboard feathering bearing bore underneath the flanged sleeves. The third crack started from the inboard feathering bearing bore. Investigation found that the cracks originated from either a machining burr or a corrosion site in the bearing bore underneath the flanged sleeves.

P/N 222-016-001 – all dash numbers

### Blade Inspection Area

(c) Within the next 50 hours TIS, unless accomplished previously, and thereafter at intervals not to exceed 50 hours TIS, clean the blade by wiping down both surfaces of each blade in the inspection area depicted in Figure 1 of this AD using aliphatic naphtha (C-305) or detergent (C-318) or an equivalent. Using a 10X or higher power magnifying glass, visually inspect both sides of the blade in the areas depicted in Figure 1 of this AD.

(1) If a crack is found, even if only in the paint, before further flight, remove the blade from the helicopter and proceed with the following:

(2) Remove the paint on the blade down to the bare metal in the area of the suspected crack by using plastic media blasting (PMB) or a nylon web abrasive

(3) Using a 10X or higher power magnifying glass, inspect the blade for a crack.

(i) If a crack is found, replace the blade with an airworthy blade before further flight.

(ii) If no crack is found in the blade surface, refinish the blade by applying one coat of epoxy polyamide primer, MIL-P-23377 or MIL-P-85582, so that the primer overlaps the existing coats just beyond the abraded area. Let the area dry for 30 minutes to 1 hour. Then, apply one sealer coat of polyurethane, MILC85285 TYI CL2, color number 27925 (semi-gloss white), per Fed. Std. 595. Reinstall the blade.
