[Docket No. 98-SW-69-AD; Amendment 39-11528; AD 2000-02-09]

**Airworthiness Directives; Agusta S.p.A. (Agusta) Model AB412 Helicopters**

**AD 2000-02-09 Agusta:** Amendment 39-11528. Docket No. 98-SW-69-AD.

**Applicability:** Model AB412 helicopters with rescue hoist, part number BL10300-60 or BL10300-59, installed, certificated in any category.

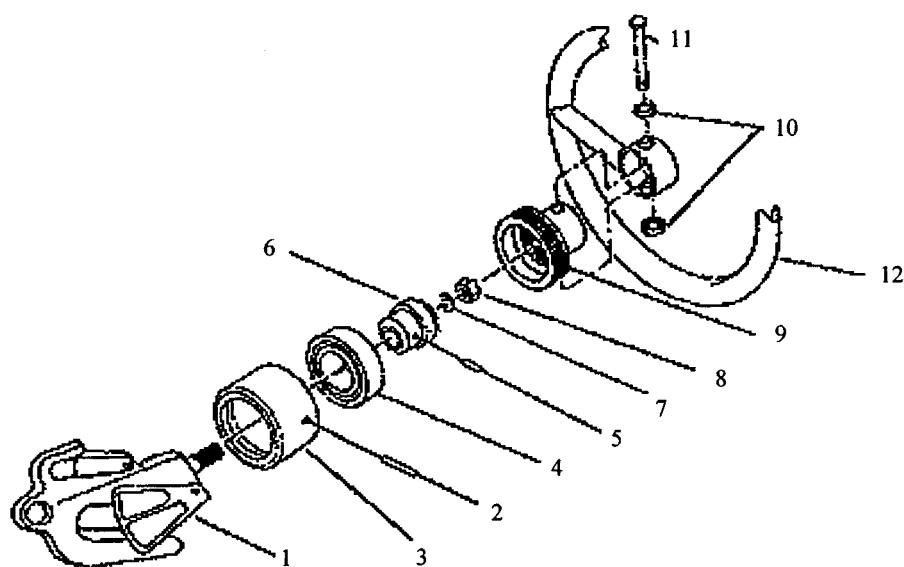
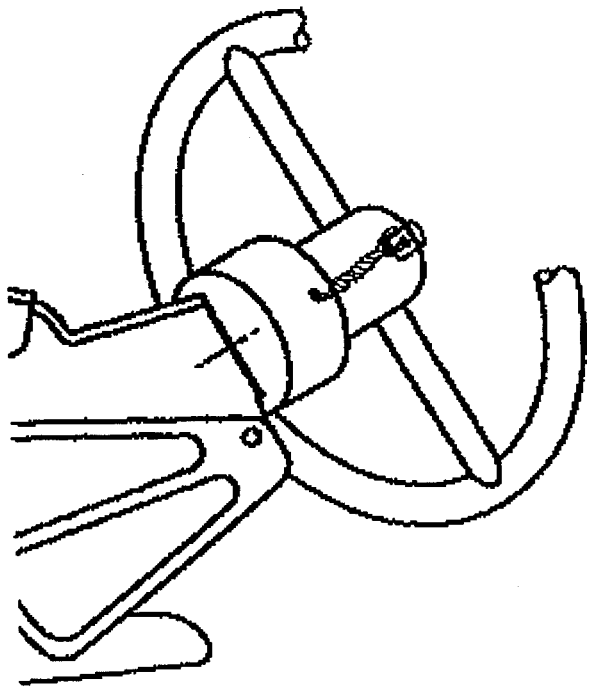
Figure 1

To prevent separation of the rescue hoist hook assembly from the helicopter due failure of the rescue hoist hook assembly retention pin (retention pin), accomplish the following:

(3) Inspect the pin, P/N NAS516C4-6 or P/N MS171524, installed on the housing, P/N BL1357-1, and verify the absence of any rotation between the housing and the adapter, P/N BL1355, (Figure 1).

(4) Inspect the rescue hoist hook to ensure it rotates freely relative to the housing (number 3 on Figure 1).

(2) Remove the safety wire and remove and discard the retention pin. Retain the two washers, P/N AN960C816L, for reuse (Figure 1).

(3) Install a zero-hours time-in-service (TIS) retention pin, P/N BL2395, and the two washers, P/N AN960C816L, (Figure 1). Safety wire the retention pin to the hook assembly using safety wire, P/N MS 20995C32.

(1) Referring to Figure 1, remove the safety wire and the retention pin. Retain the two washers, P/N AN960C816L, for re-use. Inspect the retention pin for scratches or deformations. If a scratch or deformation is found, replace the retention pin with an airworthy retention pin.

(2) Install the retention pin and the two washers, P/N AN960C816L, (Figure 1). Safety wire the retention pin to the hook assembly using safety wire, P/N MS20995C32.
