[Docket No. FAA-2014-0034; Directorate Identifier 2013-SW-006-AD]

Airworthiness Directives; Eurocopter Deutschland GmbH Helicopters

ACTION: Notice of proposed rulemaking (NPRM).

Eurocopter Deutschland GmbH (ECD):

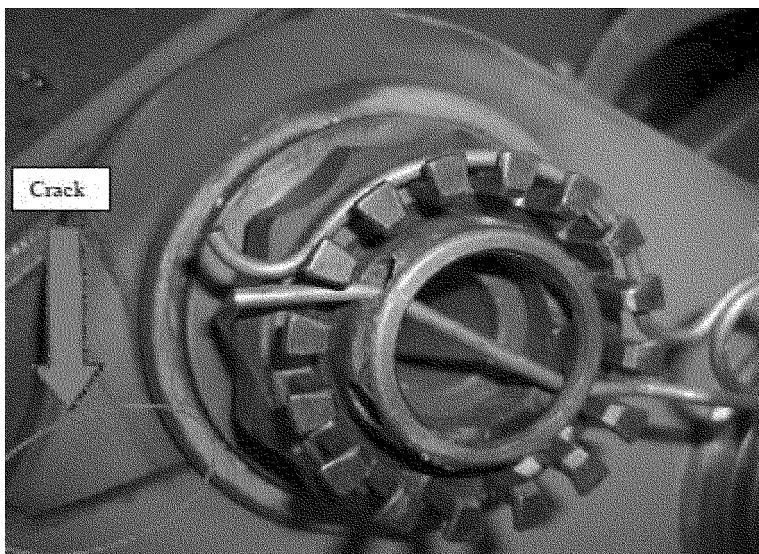
Figure 1 to Paragraph (f)(1)

This AD defines the unsafe condition as a crack in the MRH shaft flange, which could result in failure of the MRH and subsequent loss of control of the helicopter.

(1) Before further flight, and thereafter at intervals not to exceed 6 hours time-in-service (TIS), check the MRH shaft lower flange and the visible area of the MRH shaft upper flange for a crack. Figures 1 and 2 to Paragraph (f)(1) of this AD are examples of cracks that have been discovered in the MRH shaft lower flange. The actions required by this paragraph may be performed by the owner/operator (pilot) holding at least a private pilot certificate, and must be entered into the aircraft records showing compliance with this AD in accordance with 14 CFR 43.9 (a)(1)–(4) and 14 CFR 91.417(a)(2)(v). The record must be maintained as required by 14 CFR 91.417, 121.380, or 135.439.

(3) If there is a crack in the upper or lower MRH shaft flange, before further flight, replace that MRH shaft with an airworthy MRH shaft. Replacing the MRH shaft with an MRH shaft having a P/N listed in the applicability of this AD does not constitute
