[Docket No. 2000-NM-299-AD; Amendment 39-12107; AD 2001-03-04]

### Airworthiness Directives; Bombardier Model CL-600-2B19 Series Airplanes

**2001-03-04 Bombardier, Inc. (Formerly Canadair):** Amendment 39-12107. Docket 2000-NM-299-AD.

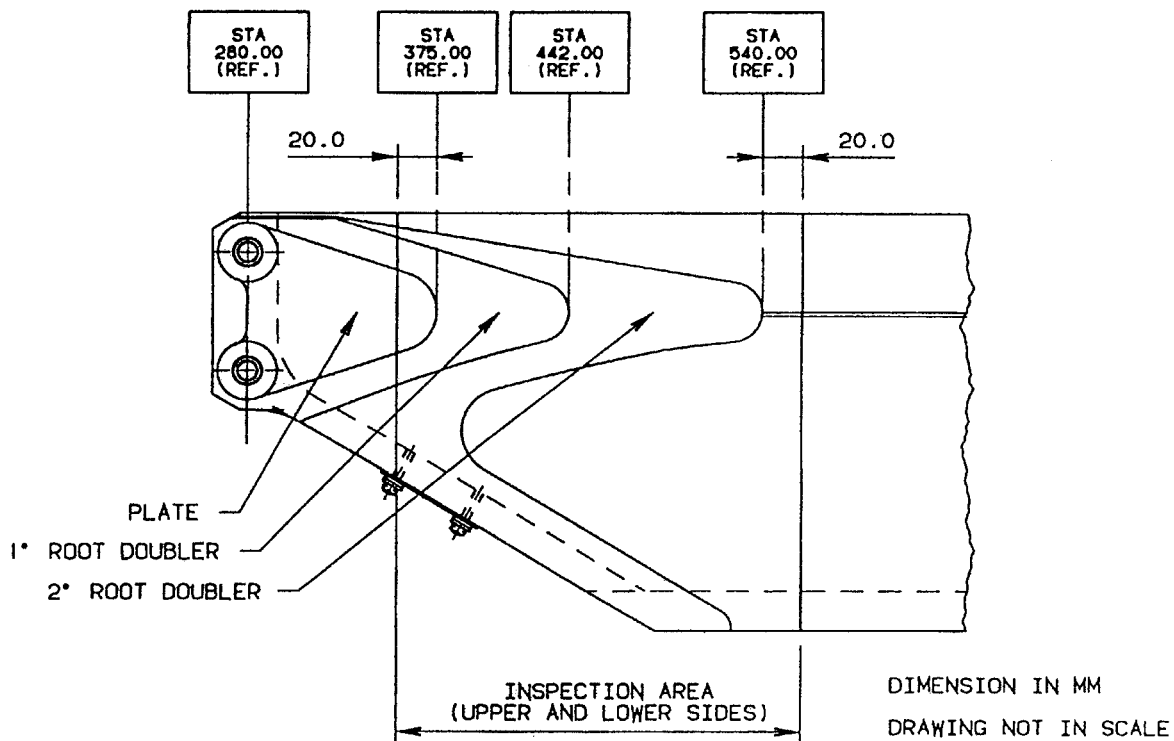
# FIGURE 1

Note: Paint irregularities may be due to cracks.

(b) Within 10 hours time-in-service (TIS) and thereafter at intervals not to exceed 10 hours TIS or before the next flight after any abnormal tail rotor vibration, inspect each blade for a crack using a 5-power or higher magnifying glass in accordance with the Compliance Instructions, Part II, of Agusta S.p.A. Alert Bollettino Tecnico No. 109EP-14, dated October 11, 2000 (ABT).

(c) Within 25 hours TIS and thereafter at intervals not to exceed 25 hours TIS, dye-penetrant inspect each blade for a crack in accordance with the Compliance Instructions, Part III, of the ABT.

(d) If a crack is found, replace the blade with an airworthy blade before further flight.
