[Docket No. FAA-2009-0484; Directorate Identifier 2008-SW-44-AD; Amendment 39-15924; AD 2009-12-01]

**Airworthiness Directives; Bell Helicopter Textron, Inc. Model 47, 47B, 47B3, 47D, 47D1, 47E, 47G, 47G-2, 47G-2A, 47G-2A-1, 47G-3, 47G-3B, 47G-3B-1, 47G-3B-2, 47G-3B-2A, 47G-4, 47G-4A, 47G-5, 47G-5A, 47H-1, 47J, 47J-2, 47J-2A, and 47K Helicopters**

**ACTION:** Final rule; request for comments.

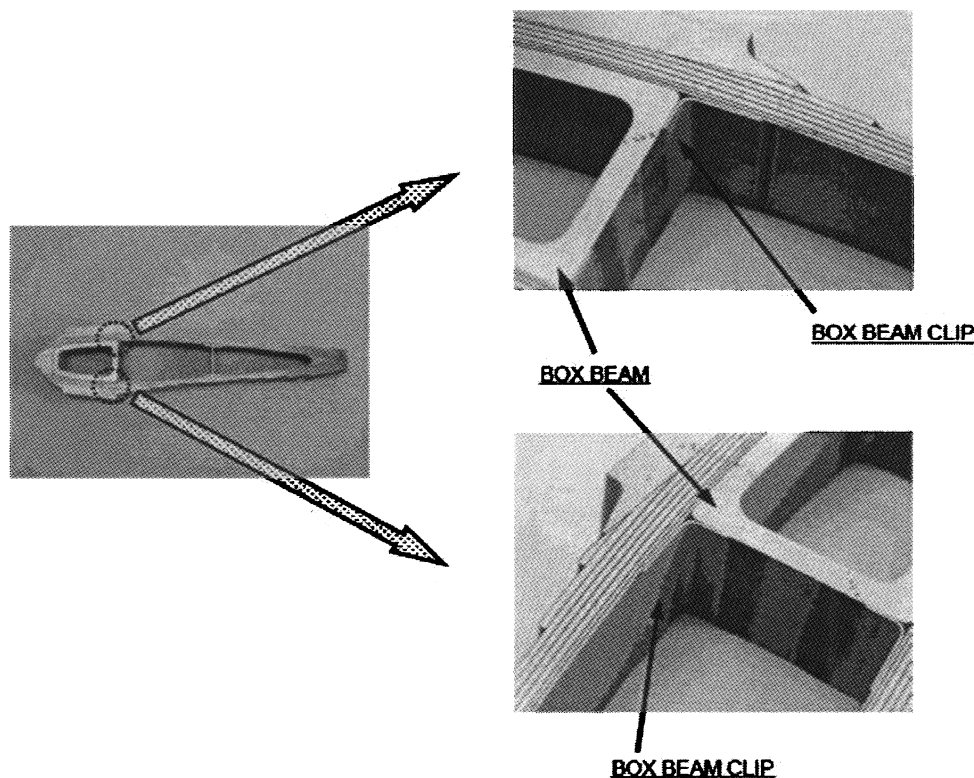
Figure 1 - Correct Installation of Clip for Box Beam

(a) Within 10 hours time-in-service (TIS), visually inspect the entire length of each upper and lower clip of each main rotor blade from the main rotor blade tip to the root by following Part II of the Accomplishment Instructions, paragraphs 1. through 8., of Bell Helicopter Textron, Inc. Alert Service Bulletin No. 47–08–25, dated May 26, 2008 (ASB) and referring to the depictions in Figures 1 and 2 of the ASB and Figure 1 of this AD for correct installation.

**Note:** Figure 3 of the ASB depicts a clip installed incorrectly.

(b) Before further flight, if you find a main rotor blade with an incorrectly installed clip, replace that unairworthy main rotor blade with an airworthy main rotor blade that has a clip that is installed correctly.
