[Docket No. 2001-SW-54-AD; Amendment 39-12770; AD 2002-11-09]

### Airworthiness Directives; Bell Helicopter Textron Canada Model 407 Helicopters

**SUMMARY:** This amendment adopts a new airworthiness directive (AD) for Bell Helicopter Textron Canada (BHTC)

#### 2002-11-09 Bell Helicopter Textron

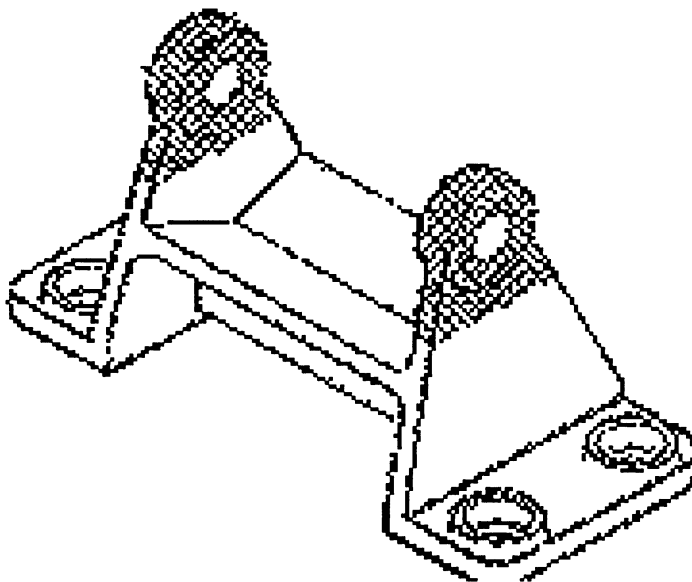
**Figure 1**

Model 407 helicopters that requires visually inspecting the forward hanger bearing bracket (bracket) for a crack. This amendment is prompted by reports of cracks in the bracket. The actions specified by this AD are intended to detect a crack in the bracket, to prevent loss of tail rotor drive or control and subsequent loss of control of the helicopter.

(a) Within 25 hours time-in-service (TIS) and thereafter at intervals not to exceed 25 hours TIS, visually inspect each bracket, P/N 407-040-321-101 or -103, for a crack in the shaded area shown in Figure 1 of this AD. Remove any cracked bracket from service.

## Bracket P/N 407-040-321-101/-103
