[Docket No. 2000-SW-55-AD]

**Airworthiness Directives; Eurocopter France Model AS332C, L, L1, and L2; AS350B, BA, B1, B2, B3, and D; AS355E, F, F1, F2, and N; AS-365N2; AS 365 N3; SA330F, G, and J; SA-360C; SA-365C, C1, and C2; SA.316B and C; and SA.319B Helicopters**

**ACTION:** Notice of proposed rulemaking (NPRM).

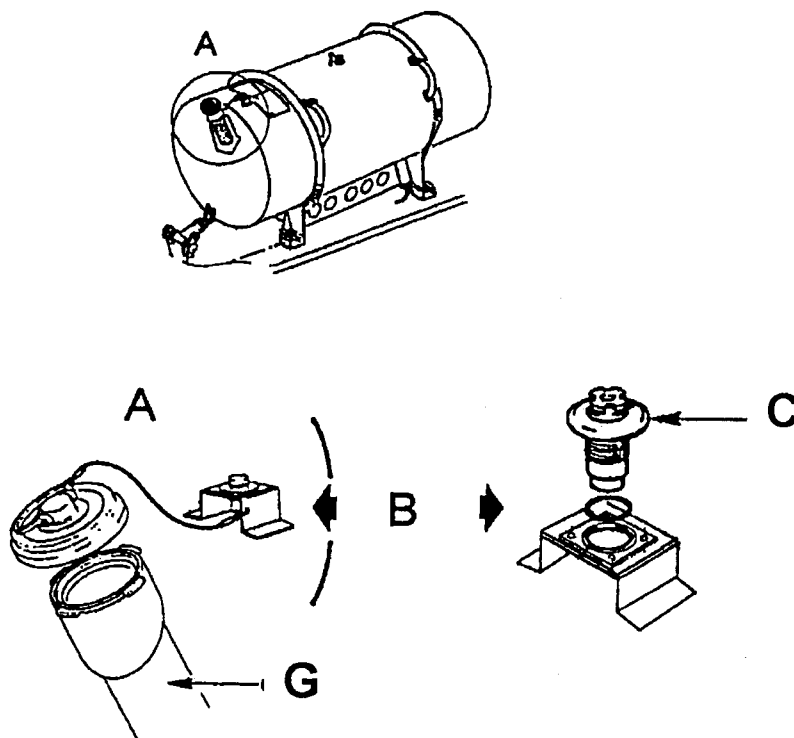
FIGURE 1 FERRY FUEL TANK

and SA.319B helicopters. The DGAC advises of the absence on several tanks of an electric bond between the electrostatic ground connector and its support. During refueling of a tank, the inadequate electrical bonding could generate an electric arc between the refueling nozzle of the tanker and the tank and could cause the tank to explode.

To prevent refueling a tank that is not adequately electrically bonded, which could generate an electric arc between the refueling nozzle and the tank, causing a fuel tank explosion, accomplish the following:

(a) Measure the electrical resistance between the tank electrostatic ground connector (item C) and the tank filler neck (item G) as shown in Figure 1 of this AD. If the value of the electrical resistance is more than 1.5 milliohms, refueling the tank is prohibited. See Figure 1 as follows:
