Federal Register

[Docket No. FAA-2019-0715; Product Identifier 2019-NM-151-AD; Amendment 39-19760; AD 2019-20-07]

Airworthiness Directives; The Boeing Company Airplanes

SUMMARY: The FAA is adopting an airworthiness directive (AD) for all The Boeing Company Model 787-8, 787-9, and 787-10 airplanes. This AD requires repetitive operational checks of the leading edge (LE) outboard (OB) slats and applicable on-condition actions. This AD also requires revising the airplane flight manual (AFM) to prohibit flap retraction under icing conditions and revising the existing maintenance or inspection program, as applicable, to incorporate a new operation check. This AD was prompted by a determination that the LE OB slat system could be out of position without flight deck annunciation. The FAA is issuing this AD to address the unsafe condition on these products.

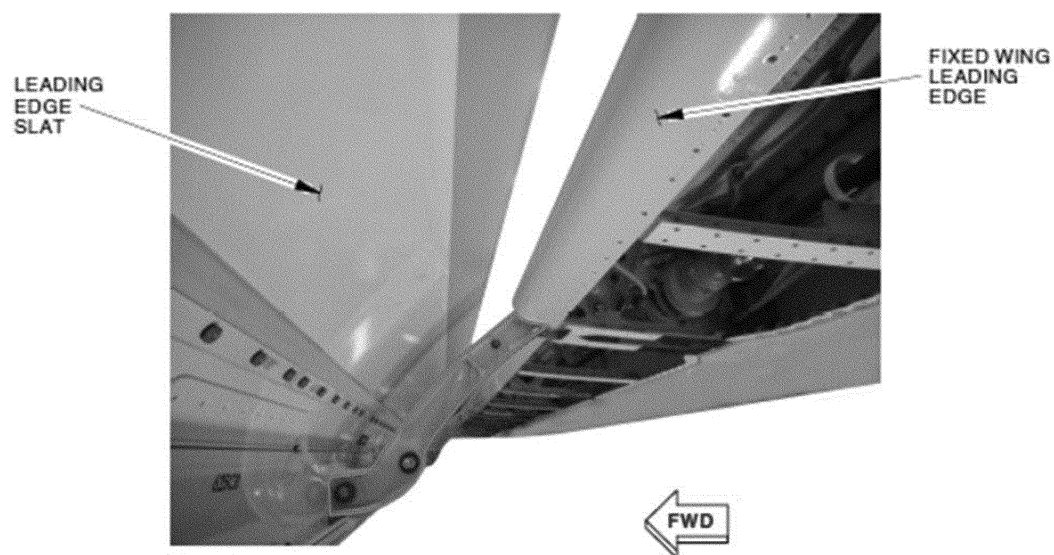
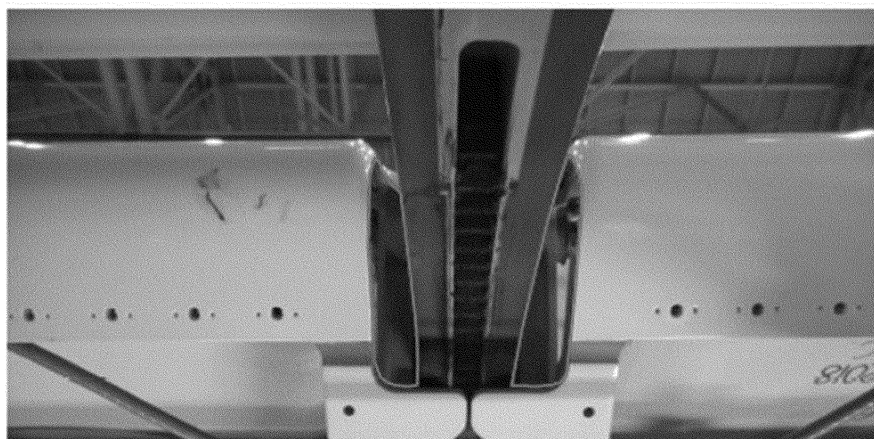
Figure 2 (Sheet 2 of 3) Slat and Flap Inspection

ACTUATION AREAS
(TYPICAL)
A-A

SLAT TRACK CAVITY
(TYPICAL)
(VIEW IN THE AFT DIRECTION)
A-A

- (a) Examine these areas for contaminants (ice, snow, slush):

- 3) Slat actuation areas, including exposed areas of the slat track cavity, and slat cove
- 4) Flap tracks, hinges, seals

- (b) Remove the contamination that you find.
