[Docket No. FAA–2013–0725; Directorate Identifier 98–CE–01–AD; Amendment 39–17690; AD 98–15–18 R1]

#### Airworthiness Directives; Maule Aerospace Technology, Inc. Airplanes

**98–15–18 R1 Maule Aerospace Technology, Inc.:** Amendment 39–17690; Docket No.

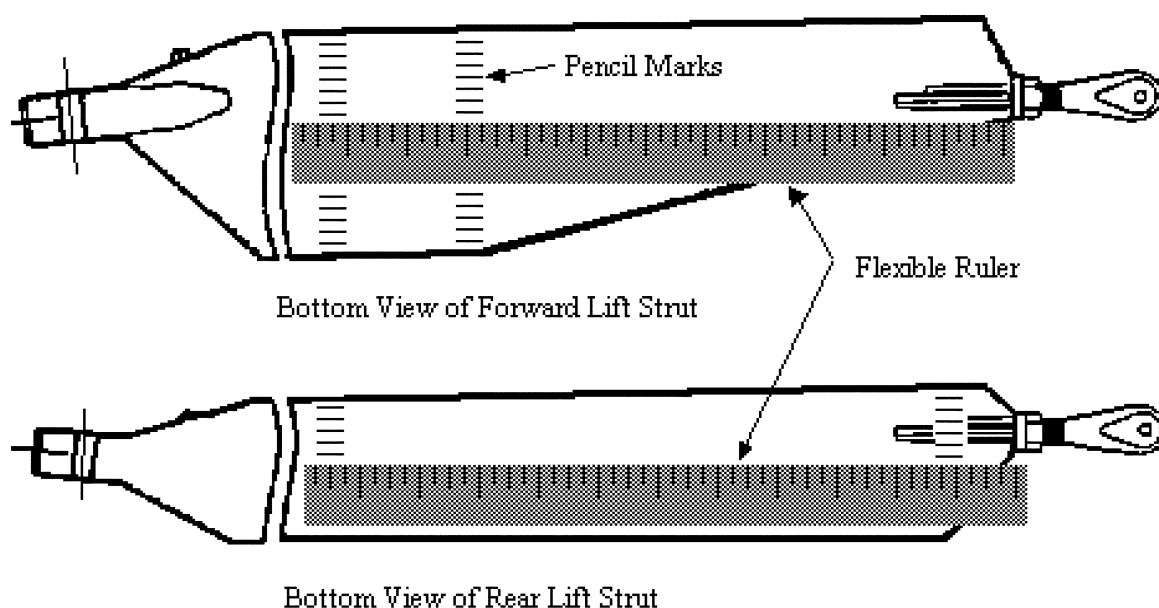
**Figure 1**

8. A measurement of 0.024 inch or less shall require replacement of the strut prior to further flight.
