[Docket No. 99–SW–81–AD; Amendment 39–11901; AD 2000–18–14]

### Airworthiness Directives; Sikorsky Aircraft-Manufactured Model CH–54A Helicopters

**2000-18-14 Siller Helicopters; Aviation International Rotors, Inc. (AIR, INC); Columbia Helicopters, Inc.; Chet Raspberry, Inc. (CRI); Silver Bay Logging, Inc.:** Amendment 39-11901. Docket No. 99-SW-81-AD. Supersedes AD 99-07-16, Amendment 39-11102, Docket No. 97-SW-60-AD.

**Applicability:** Model CH-54A helicopters with lower planetary plate, part number (P/N) 6435-20229-102, installed, certificated in any category.

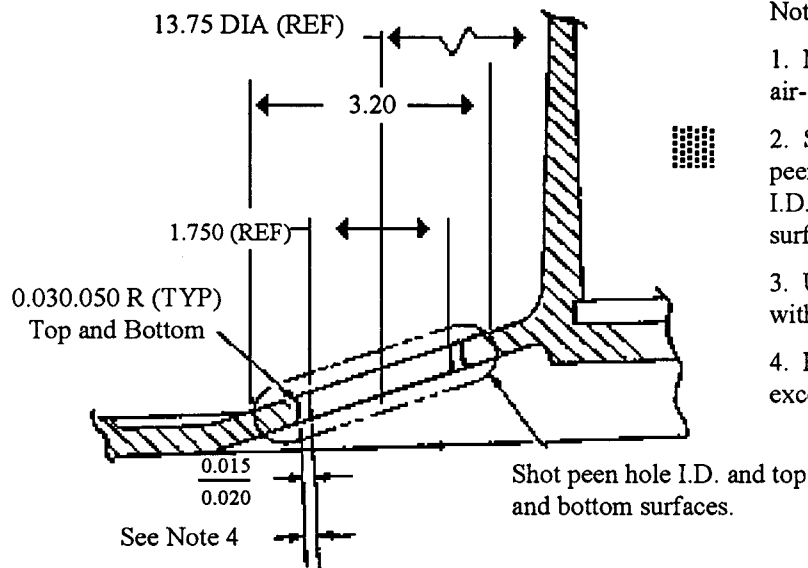
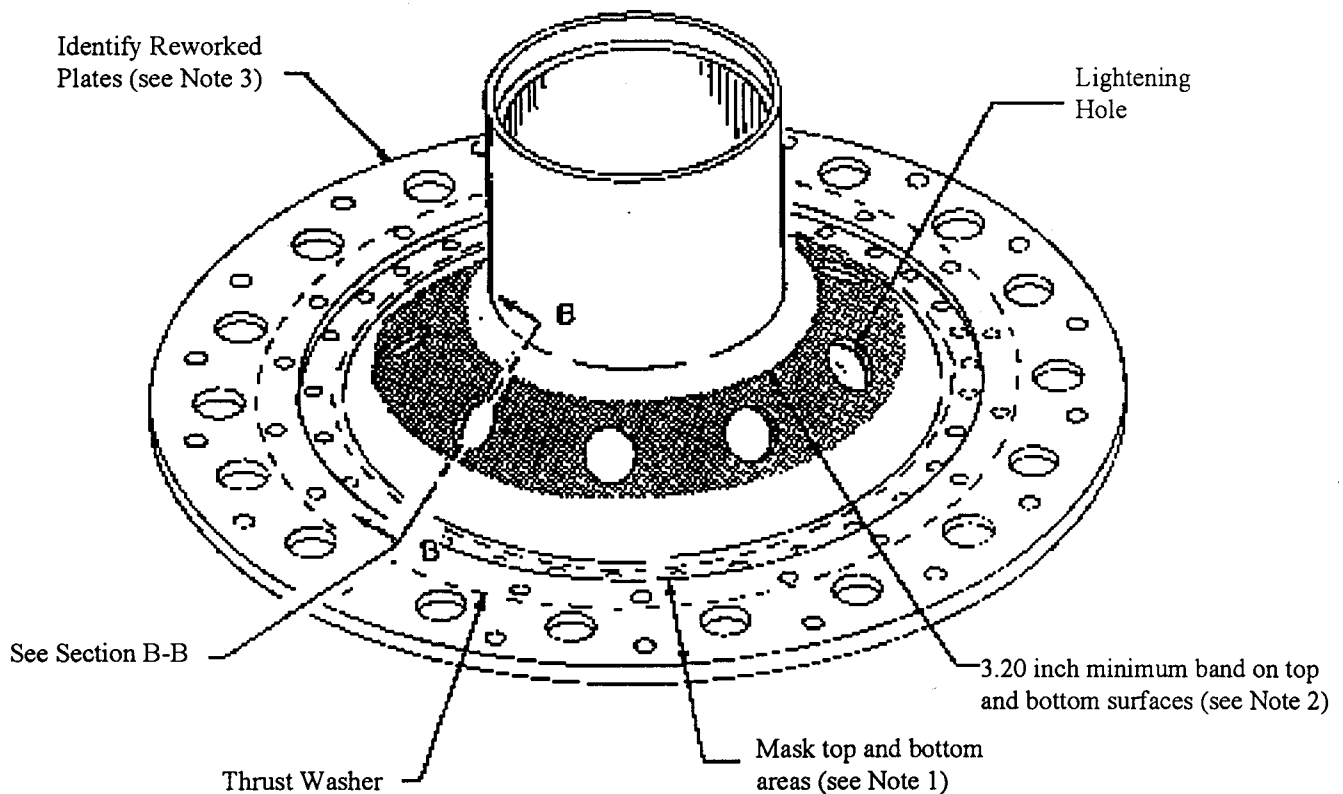
Rework of Second Stage  
Lower Planetary Plate (6435-20229-102)  
Figure 1

To prevent failure of the second stage lower planetary plate (plate), P/N 6435-20229-102, due to fatigue cracking, which could lead to failure of the main gearbox, failure of the drive system, and subsequent loss of control of the helicopter, accomplish the following:

(a) On or before accumulating 1,300 hours time-in-service (TIS), conduct a fluorescent magnetic particle inspection of the plate, P/N 6435-20229-102, in the circumferential and longitudinal directions using the wet continuous method. Pay particular attention to the area around the 9 lightening holes.

(i) Locate the center of each 1.750 inch-diameter lightening hole and machine holes 0.015 to 0.020 oversize on a side (0.030 to 0.040 diameter oversize). Machined surface roughness must not exceed 63 microinches AA rating (see Figure 1).

(ii) Radius each hole 0.030 to 0.050 inches on each edge as shown in Figure 1.

(iii) Mask the top and bottom surfaces of the plate to expose 3.20 inch minimum width circumferential band as shown in Figure 1.

(viii) Identify the reworked plate by adding "TS-107" after the part number using a low-stress depth-controlled impression-stamp with a full fillet depth of not more than 0.003 inch (see Figure 1).

1. Mask top and bottom areas to protect from liquid air-grit and shot peen.
2. Shaded area to be liquid air-grit blasted and shot peened includes plate top and bottom surfaces and I.D. of all lightening holes. Feather shot peened surface edges.
3. Use low-stress depth controlled impression-stamp with full fillet depth of no more than 0.003 inch.
4. Reworked machined surface roughness shall not exceed 63 microinches AA rating.

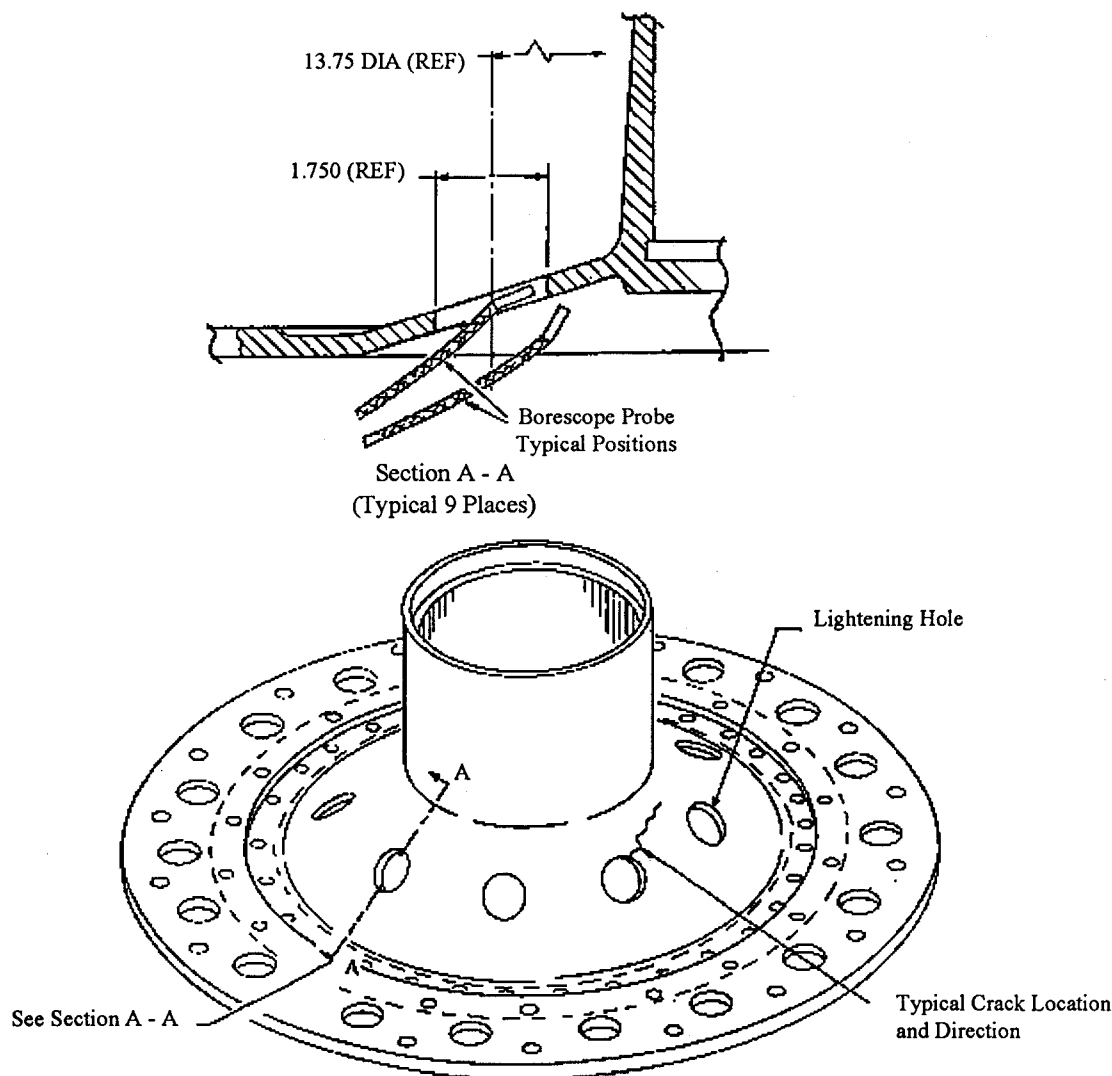
**Borescope Inspection of  
Second Stage Lower Planetary Plate  
Figure 2**

(1) Inspect the plate for a crack in the area around all nine lightening holes using a Borescope or equivalent inspection method (see Figure 2).

(2) If a crack is found, replace the plate with an airworthy plate prior to further flight.
