## DEPARTMENT OF TRANSPORTATION

[Docket No. FAA-2011-0994; Directorate Identifier 2010-NM-143-AD]

**Airworthiness Directives; Bombardier, Inc. Model CL-600-2C10 (Regional Jet Series 700, 701, & 702), CL-600-2D15 (Regional Jet Series 705), and CL-600-2D24 (Regional Jet Series 900) Airplanes**

**ACTION:** Notice of proposed rulemaking (NPRM).

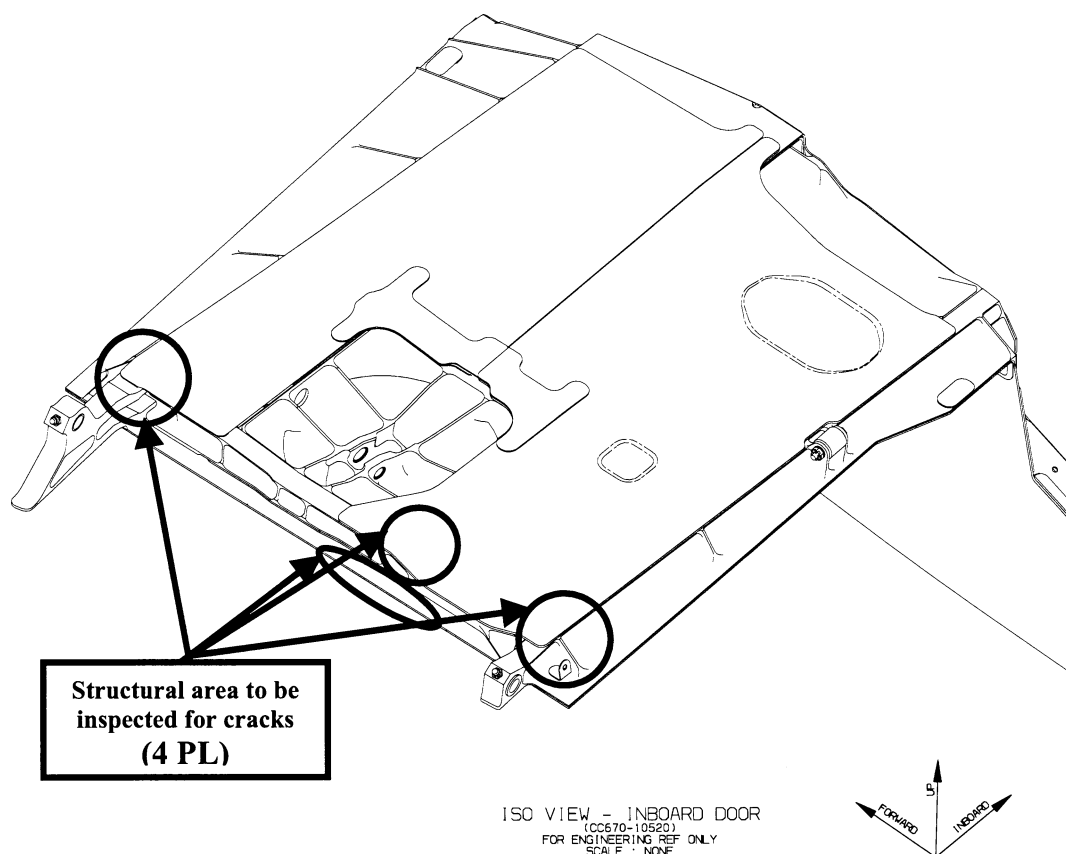
**Figure 1**  
LH side shown  
RH side opposite

(h) For Model CL–600–2C10 (Regional Jet series 700 & 701) series airplanes, S/Ns 10003 through 10230 inclusive; and Model CL–600–2D24 (Regional Jet series 900) series airplanes, S/Ns 15002 through 15053 inclusive, 15055 and 15056: At the applicable time specified in paragraph (g) of this AD, perform detailed inspections of the lower panel, part number (P/N) CC670–10520, of the left- and right-hand MLG doors for the conditions and in the areas specified in paragraphs (h)(1), (h)(2), (h)(3), and (h)(4) of this AD; and Figures 1, 2, and 3 of this AD.

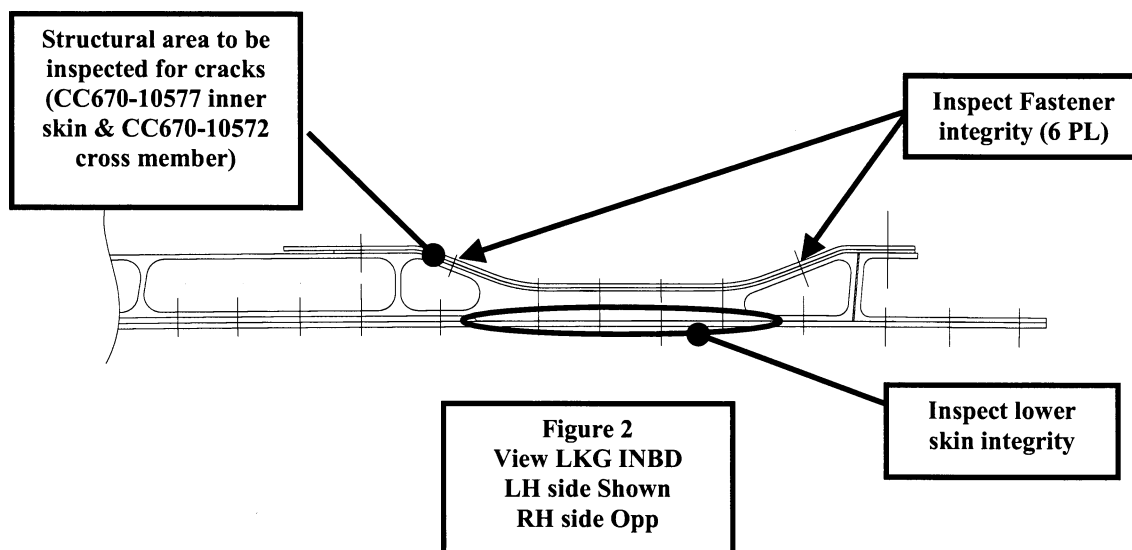
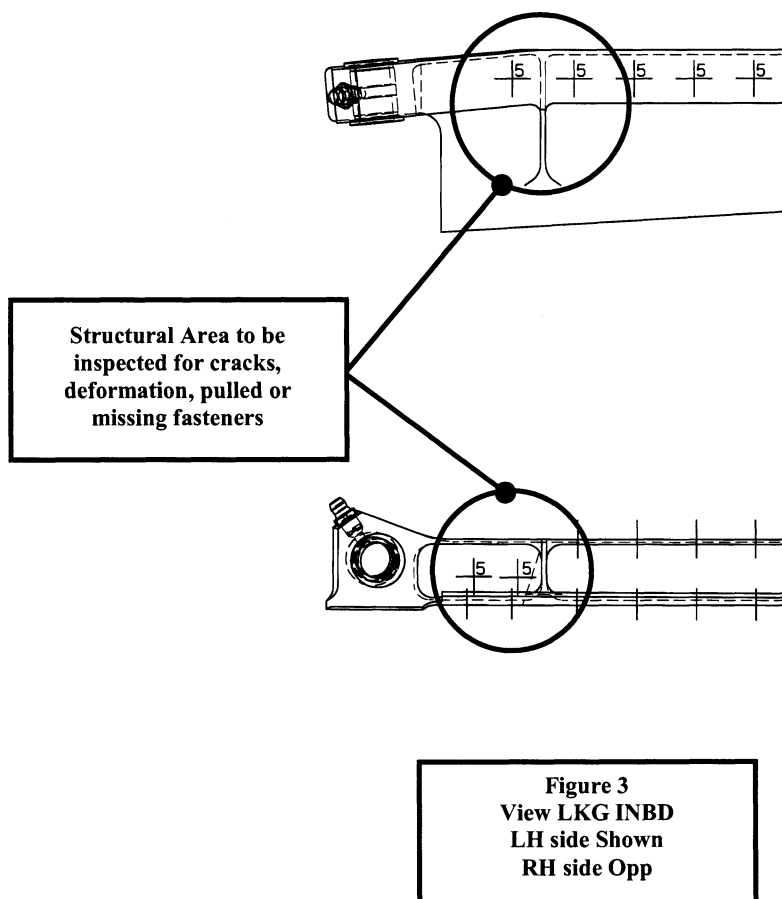
(1) Inspect the cross member, P/N CC670–10572, of the MLG door lower panel for cracking or deformation, in accordance with Figure 2 of this AD.

(2) Inspect the inner skin, P/N CC670–10577, of the MLG door lower panel at the cross member (P/N CC670–10572) for cracking or deformation, or pulled or missing fasteners, in accordance with Figure 2 of this AD.

(3) Inspect the outer skin, P/N CC670–10574, of the MLG door lower panel at the cross member (P/N CC670–10572) for cracking or deformation, or pulled or missing fasteners, in accordance with Figure 2 of this AD.

(4) Inspect the forward member, P/N CC670–10570, and aft member, P/N CC670–10571, of the MLG door lower panel for cracking or deformation, or pulled or missing fasteners, in accordance with Figure 3 of this AD. Figures 1 through 3 of this AD follow.

(j) If any cracking or deformation, or pulled or missing fastener, as applicable, is found during any inspection done in accordance with paragraph (h) or (i) of this AD: Before further flight, accomplish paragraph (j)(1), (j)(2), or (j)(3) of this AD.

(2) Replace the lower panel assembly, P/N CC670-10520, of the affected MLG door with a new or serviceable lower panel assembly having the same P/N, according to a method approved by either the Manager, New York ACO, FAA; or TCCA (or its delegated agent).
