[Docket No. FAA-2005-21680; Directorate Identifier 2004-SW-48-AD; Amendment 39-14341; AD 2005-21-03]

#### Airworthiness Directives; Bell Helicopter Textron Canada Model 206A, A-1, B, B-1, L, L-1, L-3, L-4 Helicopters

**ACTION:** Final rule.

#### 2005-21-03 Bell Helicopter Textron

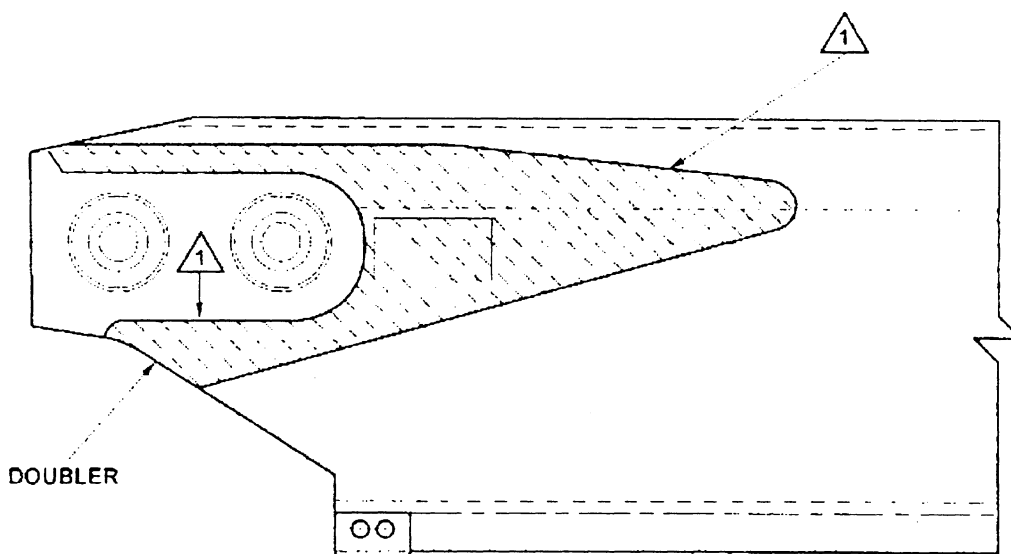
Transport Canada, the airworthiness authority for Canada, notified the FAA that an unsafe condition may exist on Model 206A, B, and L series helicopters. Transport Canada advises that an inadequate surface preparation on a limited number of blades resulted in two reported instances of blade root doubler de-bond. They also advise that to ensure blade integrity all suspected blades are to be checked daily until removed from service.

(a) Before the first flight of each day, clean each blade and visually check the blade root doublers for an edge void or de-bond on both sides of each blade as depicted in Figure 1 of this AD. An owner/operator (pilot), holding at least a private pilot certificate, may perform this visual check and must enter compliance with this paragraph into the helicopter maintenance records by following 14 CFR sections 43.11 and 91.417(a)(2)(v).

**1** Inspect the doubler for an edge void or de-bond on both sides of each blade.

(b) If an edge void or a de-bond is found, before further flight, replace the blade with an airworthy blade with a serial number other than those to which this AD applies.

(c) Within 100 hours time-in-service, replace all affected, serial-numbered blades with airworthy blades with a serial number other than those to which this AD applies.
