[Docket No. 99-SW-34-AD; Amendment 39-11732; AD 2000-10-08]

#### **Airworthiness Directives; Eurocopter France Model SA-365N1, AS-365N2, and SA-366G1 Helicopters**

**AD 2000-10-08 Eurocopter France:**

Amendment 39-11732. Docket No. 99-SW-34-AD.

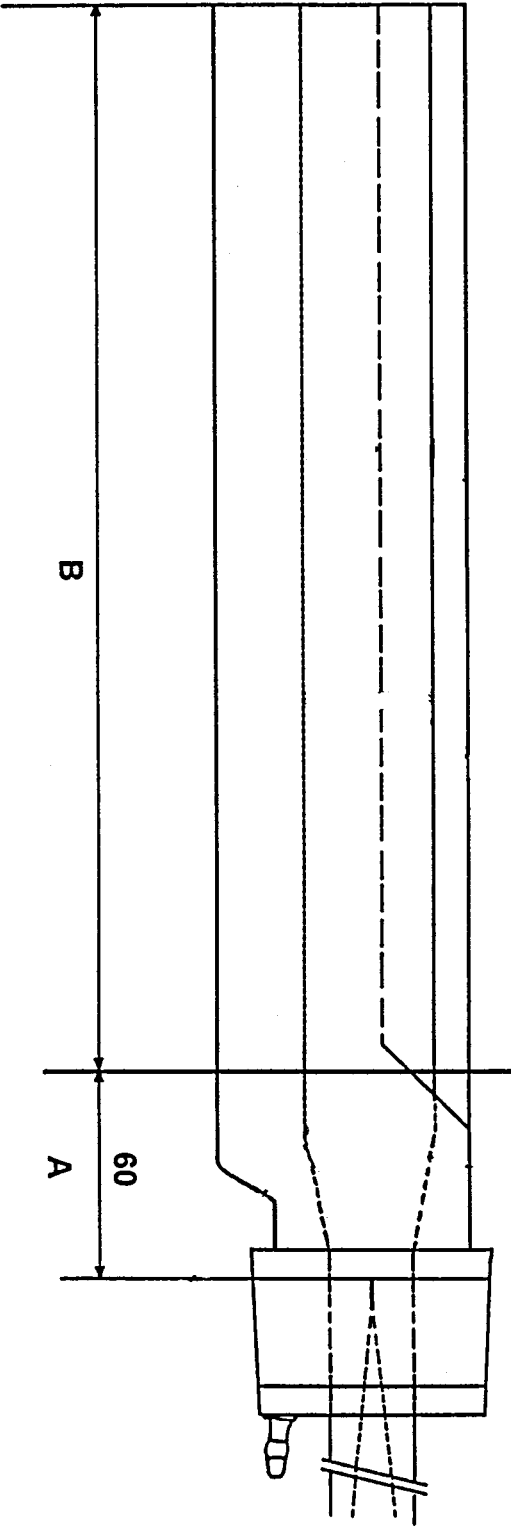
FIGURE 1

(1) Zone A: If a blister is detected on the blade suction face, conduct a tapping test inspection on the whole blade for bonding separation. If bonding separation or a crack is found, replace the blade with an airworthy blade before further flight.

(2) Zone B: If a crack, wrinkling, or a blister is found, replace the blade with an airworthy blade before further flight.

(a) Within 10 hours time-in-service (TIS) and thereafter prior to the first flight of each day, conduct the following visual inspection of each blade (see Figure 1):
