[Docket No. 99-SW-80-AD]

#### Airworthiness Directives; Bell Helicopter Textron Canada Model 206L, L-1, L-3, and L-4 Helicopters

**ACTION:** Notice of proposed rulemaking (NPRM).

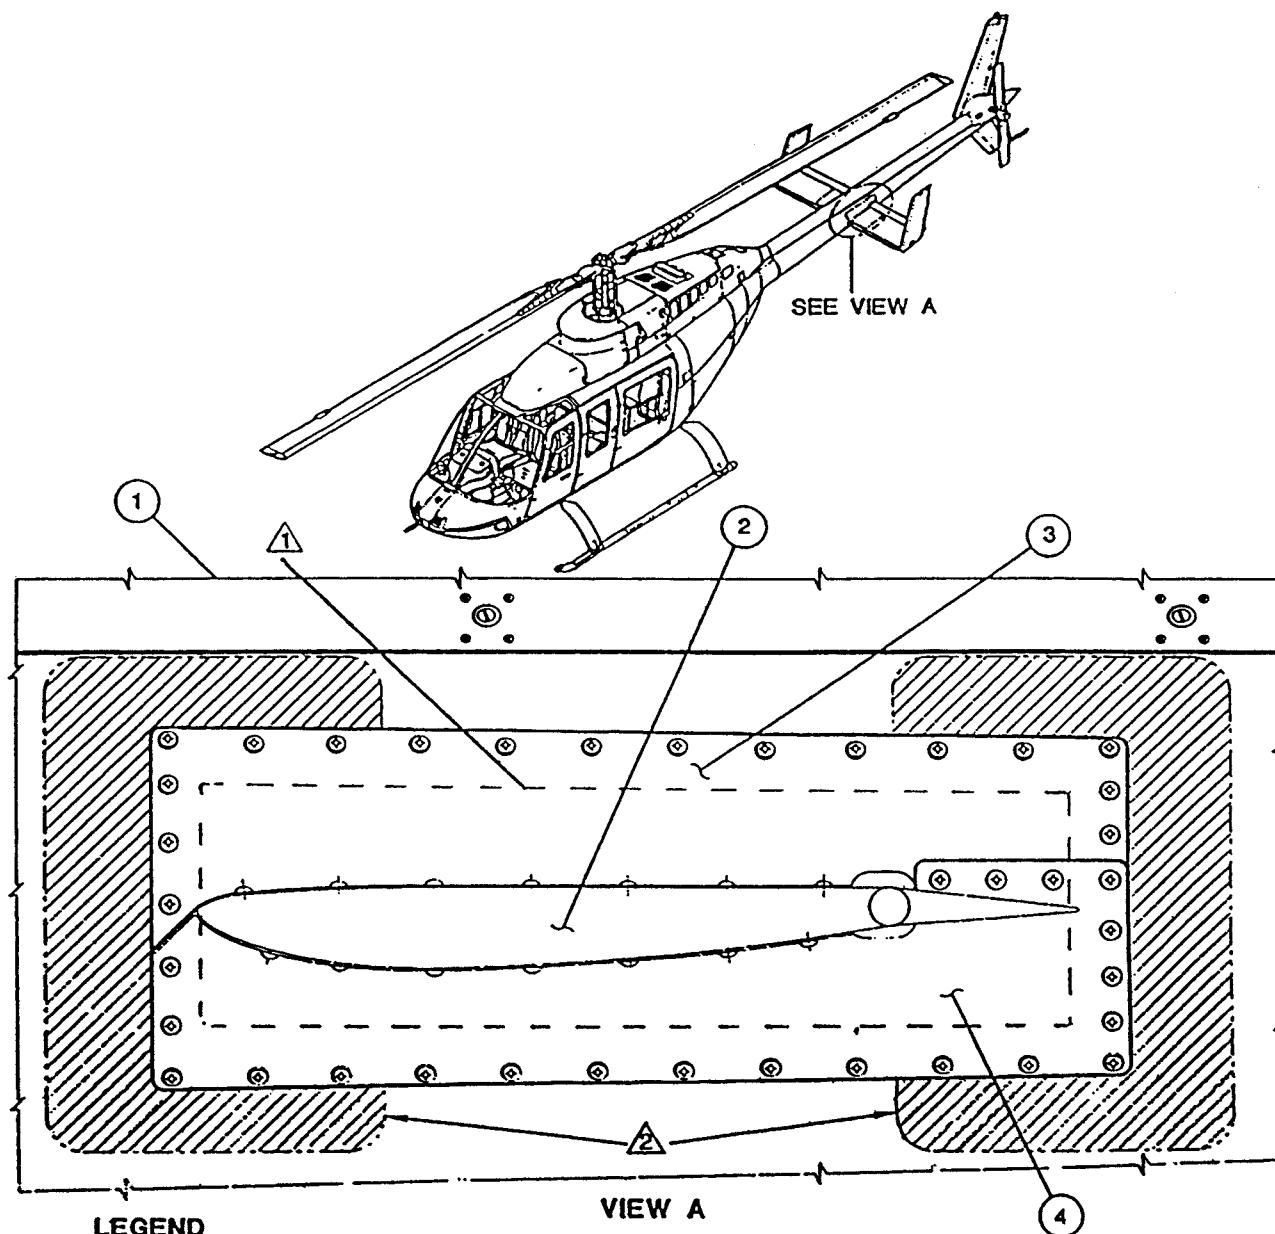
**Figure 1**

(a) Before further flight and thereafter at intervals not to exceed 10 hours time-in-service (TIS) until accomplishing the one-time fluorescent-penetrant inspection (FPI) required by paragraph (c)(2) of this AD, visually inspect for any crack in the shaded areas shown in Figure 1. Use a 10-power or higher magnifying glass. If a crack is found, replace the tailboom with an airworthy

(2) Perform a one-time FPI of the edges of the tailboom skins for any crack around the left and right horizontal stabilizer openings (Figure 1). Remove paint and primer to inspect the edges and exterior skin surface in the skin area at least  $\frac{3}{4}$  inch around the edges of the horizontal stabilizer openings.

- △ 2 Inspect for a crack in these two areas on both sides of the tailboom.
- △ 1 Inspect entire edge of stabilizer opening on both sides of the tailboom.

(2) Visually inspect the entire edge of the horizontal stabilizer opening on both sides of the tailboom for any crack using a 10-power or higher magnifying glass.

(3) If a crack is found, replace the tailboom with an airworthy tailboom modified according to the requirements of paragraph (e) of this AD before further flight.

(e) Within the next 300 hours TIS, inspect and modify the tailboom in accordance with Parts I, II, and III of Bell Helicopter Textron Canada (BHTC) Alert Service Bulletin 206L-99-115, Revision D, dated January 26, 2000 (ASB). If a crack is found while accomplishing Part I of the ASB, replace the tailboom with an airworthy tailboom modified as required by this paragraph before further flight. After accomplishing the modification, inspect the modified tailboom at intervals not to exceed 1200 hours TIS in accordance with Part IV of the ASB.
