[Docket No. 2003-SW-21-AD; Amendment 39-13424; AD 2004-01-10]

#### **Airworthiness Directives; Eurocopter Deutschland Model MBB-BK-117 A-1, A-3, A-4, B-1, B-2, and C-1 Helicopters**

##### 2004-01-10 Eurocopter Deutschland:

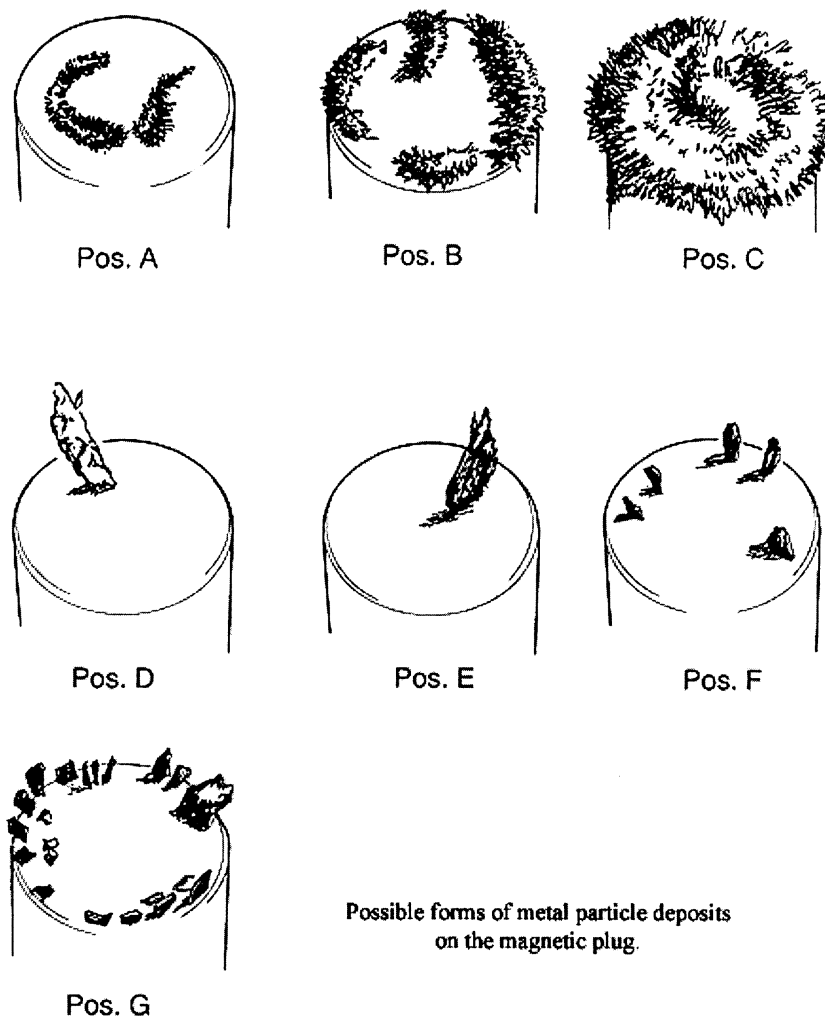
day. If a small amount of fuzz is found on the magnetic plug, the magnetic plug must be cleaned and may be reinstalled. If there is an amount of fuzz that exceeds the amount depicted in "Pos. A" of Figure 1 of this AD, then replacing the INT gearbox, TR transmission, or bearing, part number (P/N) 4639310006, with serial number (S/N) 3246 through 3598, is required within 30 days after the effective date of this AD. The short compliance time involved is required because the previously described critical unsafe condition can adversely affect the controllability and structural integrity of the helicopter. Therefore, the inspections and replacement, if necessary, are required before further flight and this AD must be issued immediately.

(a) Until you do paragraph (b) of this AD, before the first flight of each day, inspect the magnetic plugs of the TR transmission and INT gearbox for metal particles deposits by reference to Figure 1 of this AD.

(1) If you find a small amount of fine fuzz as shown in "Pos. A" of Figure 1 of this AD, clean the magnetic plug and reinstall it after ensuring that the O-ring is correctly positioned and there is no other damage.

(2) If you find an amount of fuzz as depicted in "Pos. B" or "Pos. C" or metal chip(s) as depicted in "Pos. D" through "Pos. G" or a combination of both fuzz and chips, do paragraph (b) of this AD.

(b) No later than February 23, 2004, replace bearing, P/N 4639310006 with S/N 3246 through 3598, with an airworthy bearing or replace the affected TR transmission or INT gearbox with an airworthy TR transmission and INT gearbox that does not contain the affected bearing.
