#### **Airworthiness Directives; Eurocopter France Model AS350B, BA, B1, B2, B3, C, D, and D1; EC–130B4; and AS355E, F, F1, F2, and N Helicopters**

**ACTION:** Notice of proposed rulemaking (NPRM).

**Eurocopter France:** Docket No. FAA-2007-27495; Directorate Identifier 2005-SW-14-AD.

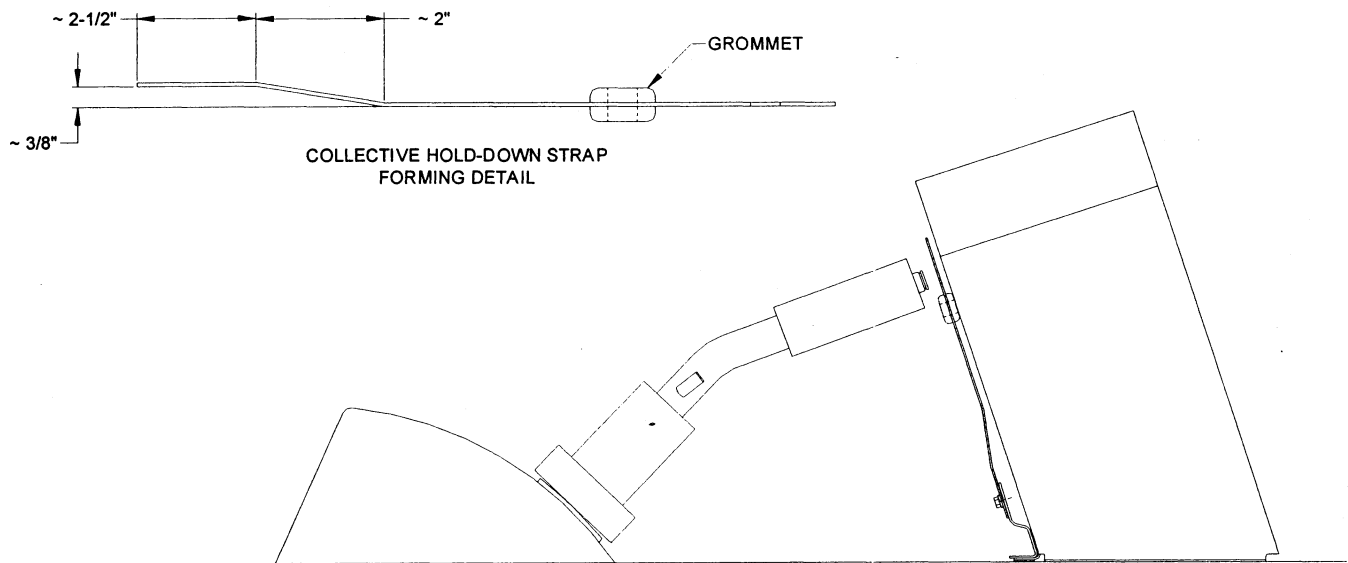
To prevent inadvertent locking of a collective stick in the lowered position during flight and the flight crew not being aware of the locked condition leading to a subsequent loss of control of the helicopter, do the following:

To ensure that the strap does not inadvertently lock the collective during normal operation, the strap must be formed by joggling it as shown in the figure. When formed correctly, the strap will naturally touch the console aft wall, requiring it to be flexed in order to lock the collective.

- (a) Within the next 30 days, unless accomplished previously, modify the strap by forming the strap as depicted in Figure 1 of this AD. Install the modified strap so that the rubber grommet rests against the console. Thereafter, at intervals not to exceed 100 hours time-in-service, inspect the strap to ensure that the rubber grommet is resting against the console.
