[Docket No. 2001-SW-13-AD; Amendment 39-12408; AD 2001-17-17]

**Airworthiness Directives; Bell Helicopter Textron, Inc. Model 47B, 47B-3, 47D, 47D-1, 47G, 47G-2, 47G2A, 47G-2A-1, 47G-3, 47G-3B, 47G-3B-1, 47G-3B-2, 47G-3B-2A, 47G-4, 47G-4A, 47G-5, 47G-5A, 47H-1, 47J, 47J-2, 47J-2A, and 47K Helicopters**

**ACTION:** Final rule.

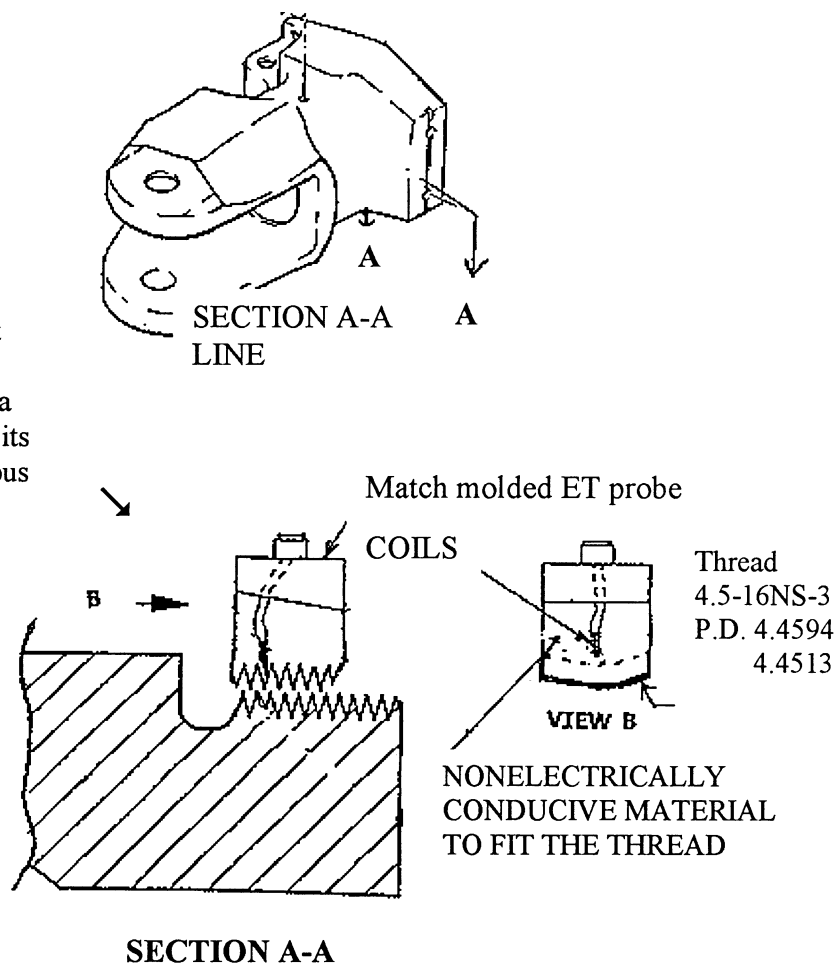
Figure 3, Appendix 1

2.2 Match molded ET probe SPC-193 (100kHz) or equivalent. (See Figure 3.)

A special eddy current probe shaped to fit the thread and containing a coil positioned so that its ferrite core is contiguous with the root of the thread.
