[Docket No. 2000–NM–93–AD; Amendment 39–11711; AD 2000–09–03]

#### Airworthiness Directives; Boeing Model 747–400 Series Airplanes Equipped With General Electric CF6–80C2 Series Engines

**2000-09-03 Boeing:** Amendment 39-11711.

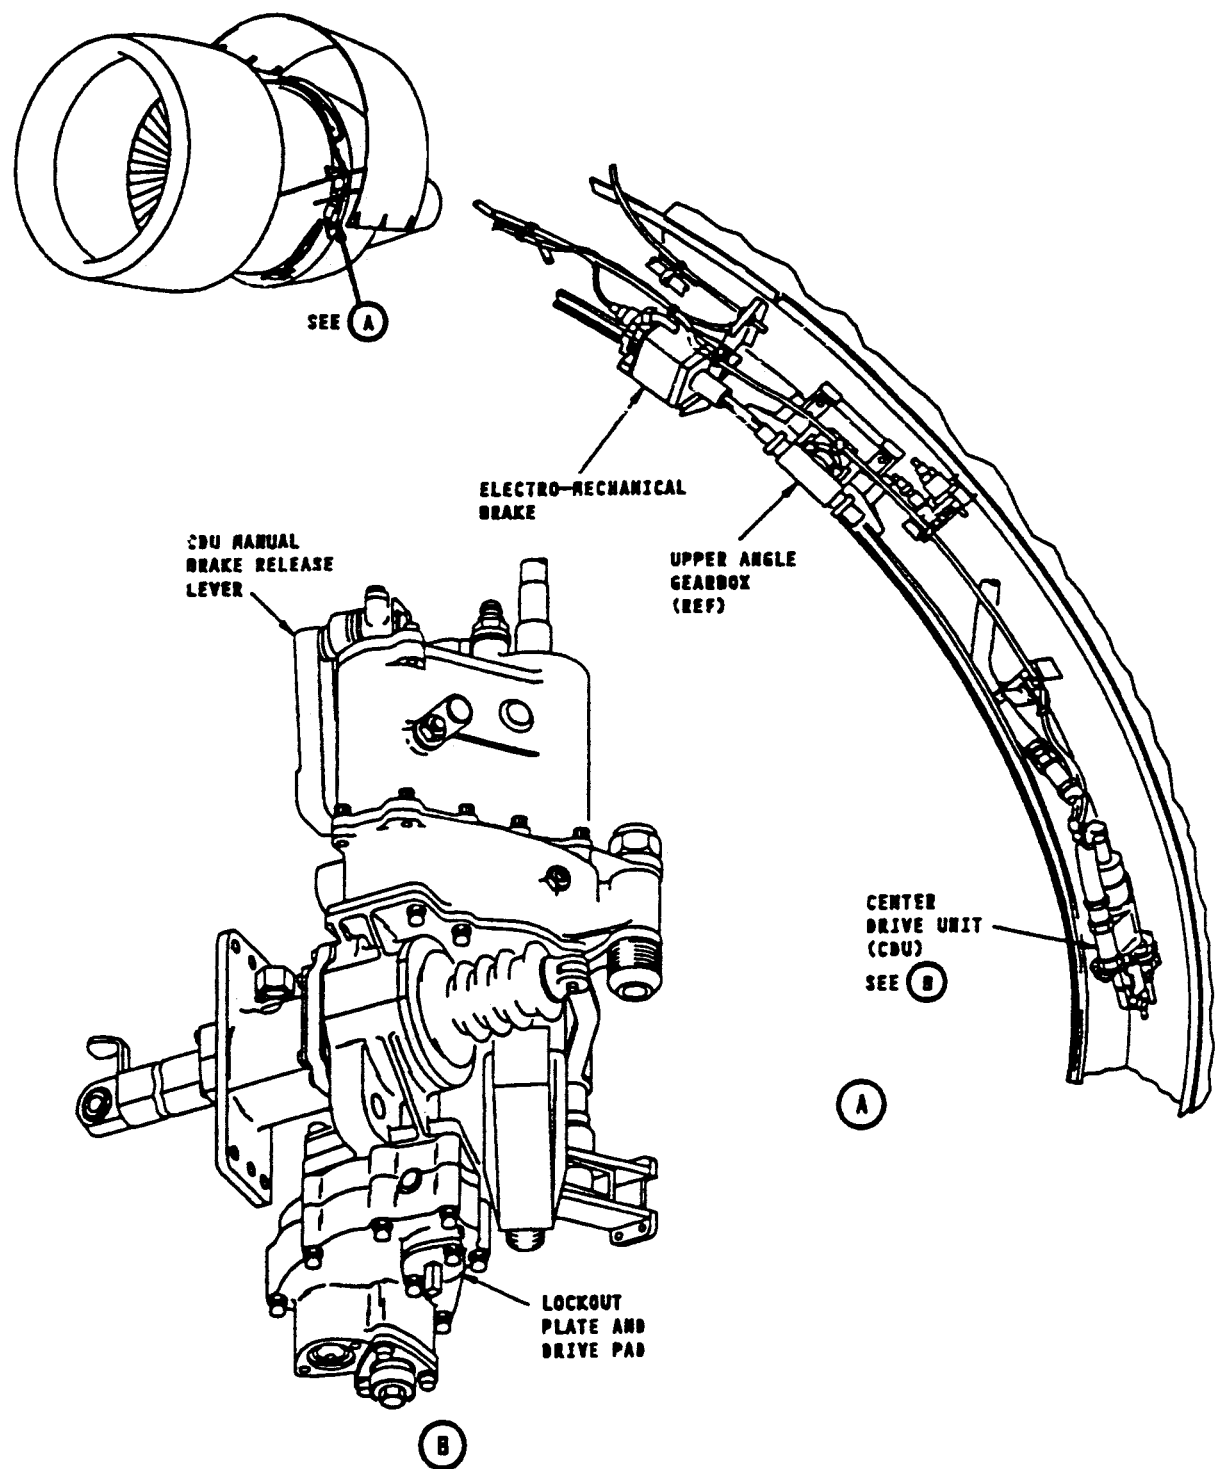
Electro-Mechanical Brake and CDU Cone Brake Torque Check  
Figure 1

- Completion of the functional test of the CDU cone brake as referenced in the existing AD is ineffective for Model 747–400 series airplanes having a third locking system installed on the thrust reversers. The test for those airplanes

requires an additional step to unlock the electro-mechanical brake prior to accomplishment of the functional test of the cone brake of the center drive unit. This step was omitted from the functional test described in the service bulletins and referenced in paragraph (a) of the existing AD. Therefore, Appendix 1 (including Figure 1) has been added to this AD to provide accurate instructions for airplanes that have a third locking system installed. Paragraph (a) of this AD has been revised to reference Appendix 1 (including Figure 1) as the appropriate source of service information for those airplanes.

**Note:** The cone brake prevents movement in the extend direction only. If you try to measure the holding torque in the retract direction, you will get a false reading.

1. This procedure contains steps to do a check of the holding torque of the CDU cone brake.

(2) Pull up on the manual release handle to unlock the electro-mechanical brake.

(3) Pull the manual brake release lever on the CDU to release the cone brake.

(6) Install a 1/4-inch drive and a dial-type torque wrench into the CDU drive pad.

**CAUTION:** DO NOT USE MORE THAN 100 POUND-INCHES OF TORQUE WHEN YOU DO THIS CHECK. EXCESSIVE TORQUE WILL DAMAGE THE CDU.

(7) Turn the torque wrench to try to manually extend the translating cowl until you get at least 15 pound-inches.

(8) If the torque is less than 15 pound-inches, you must replace the CDU.
