[Docket No. FAA–2023–2232; Project Identifier AD–2023–00943–R; Amendment 39–22681; AD 2024–04–02]

**Airworthiness Directives; Robinson Helicopter Company Helicopters**

**ACTION:** Final rule.

**SUMMARY:** The FAA is adopting a new airworthiness directive (AD) for certain Robinson Helicopter Company Model R22, R22 Alpha, R22 Beta, R22 Mariner, R44, R44 II, and R66 helicopters. This AD was prompted by reports of helicopters losing a tail rotor blade (TRB) tip cap. This AD requires visually checking and inspecting certain part-numbered and serial-numbered TRB tip caps for evidence of corrosion and, depending on the results, removing the corrosion. This AD also requires removing all affected TRBs from service and prohibits installing them on any helicopter. The FAA is issuing this AD to address the unsafe condition on these products.

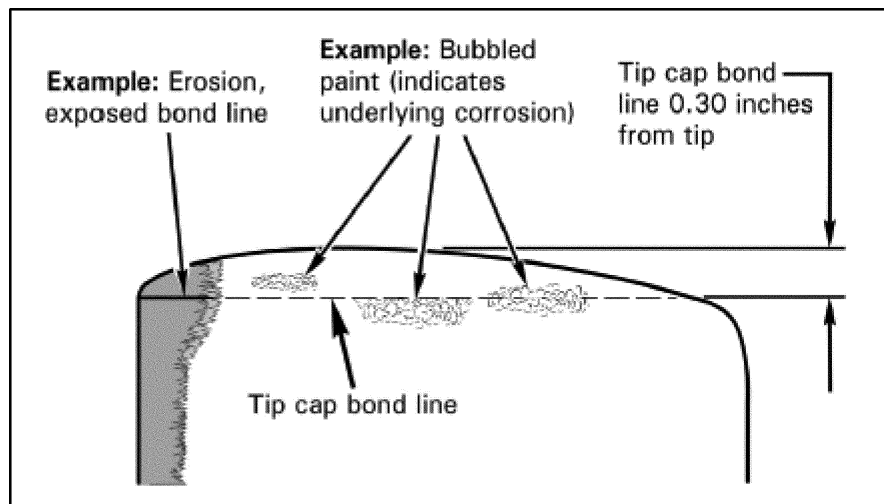
Figure 1 to Paragraph (g)(1)—TRB Tip Cap Check/Inspection

A debonded TRB tip cap can cause severe vibration and possible failure of the tail rotor gearbox housing. This condition, if not addressed, could result in increased vibrations, reduced controllability, and subsequent loss of control of the helicopter. The FAA is issuing this AD to address the unsafe condition on these products.

(1) Within 10 hours time-in-service (TIS) after the effective date of this AD and thereafter before the first flight of each day, visually check each TRB tip cap area (at and adjacent to the tip cap bond line on each surface and edge of the TRB) for an exposed tip cap bond line or bubbled paint, as depicted in Figure 1 to paragraph (g)(1) of this AD. These items may indicate evidence of corrosion. The owner/operator (pilot) holding at least a private pilot certificate may accomplish this TRB tip cap check and must enter compliance with this paragraph of the AD into the helicopter maintenance records in accordance with 14 CFR 43.9(a) and 91.417(a)(2)(v). The record must be maintained as required by 14 CFR 91.417, 121.380, or 135.439.

(2) Within 100 hours TIS or during the next 100 hour or annual inspection after the effective date of this AD, whichever occurs first, and thereafter at intervals not to exceed 100 hours TIS or during the next 100 hour or annual inspection, whichever occurs first, visually inspect each TRB tip cap area (at and adjacent to the tip cap bond line on each surface and edge of the TRB) for evidence of corrosion, which may be indicated by an exposed tip cap bond line or bubbled paint, as depicted in Figure 1 to paragraph (g)(1) of this AD.

(3) As a result of the actions required by either paragraph (g)(1) or (2) of this AD, if there is evidence of corrosion, an exposed tip cap bond line, or bubbled paint, before further flight, remove all of the corrosion.

(4) Within 10 months of the effective date of this AD, remove all TRBs identified in paragraph (c) of this AD from service.
