[Docket No. FAA–2024–1896; Project Identifier MCAI–2023–00978–T; Amendment 39–22966; AD 2025–04–08]

**Airworthiness Directives; MHI RJ Aviation ULC (Type Certificate Previously Held by Bombardier Inc.) Airplanes**

**ACTION:** Final rule.

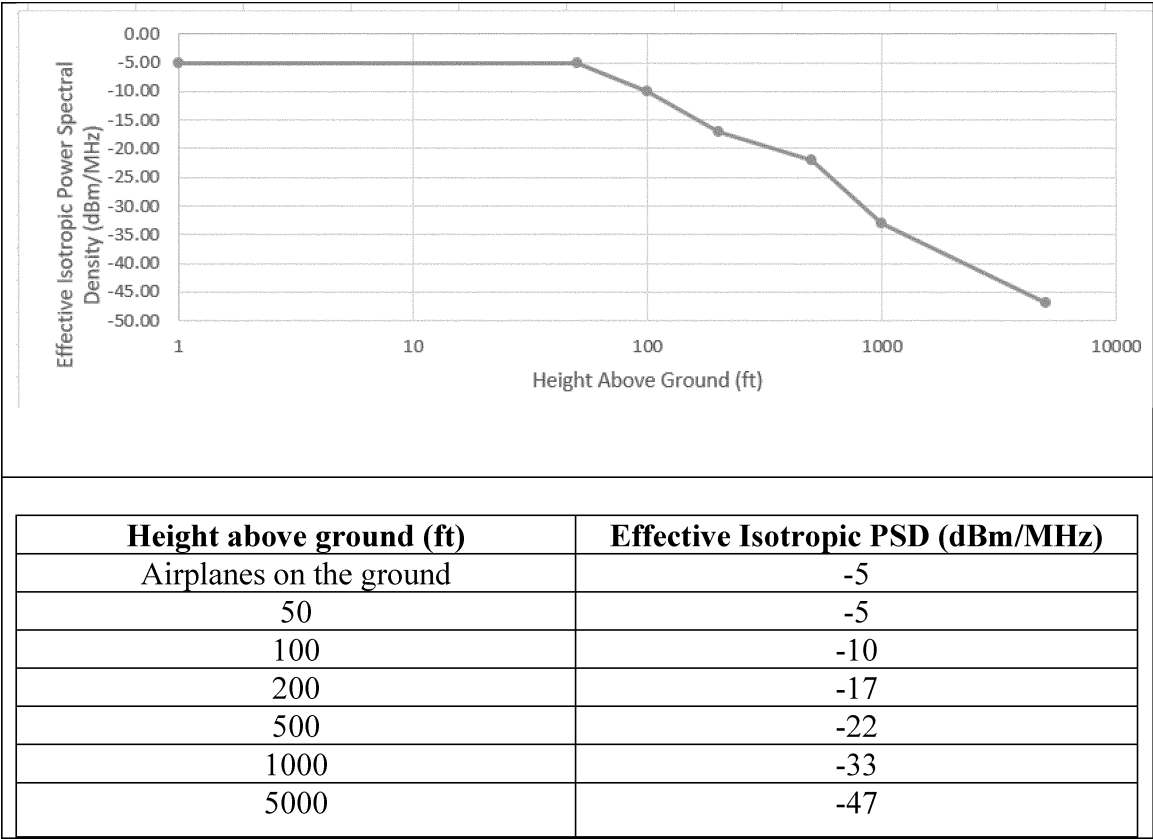
Figure 1 to Paragraph (g)(1)—Fundamental Effective Isotropic PSD at Outside Interface of Airplane Antenna

(1) Tolerance to radio altimeter interference, for the fundamental emissions (3.7–3.98 GHz), at or above the power

spectral density (PSD) curve threshold specified in figure 1 to paragraph (g)(1) of this AD.

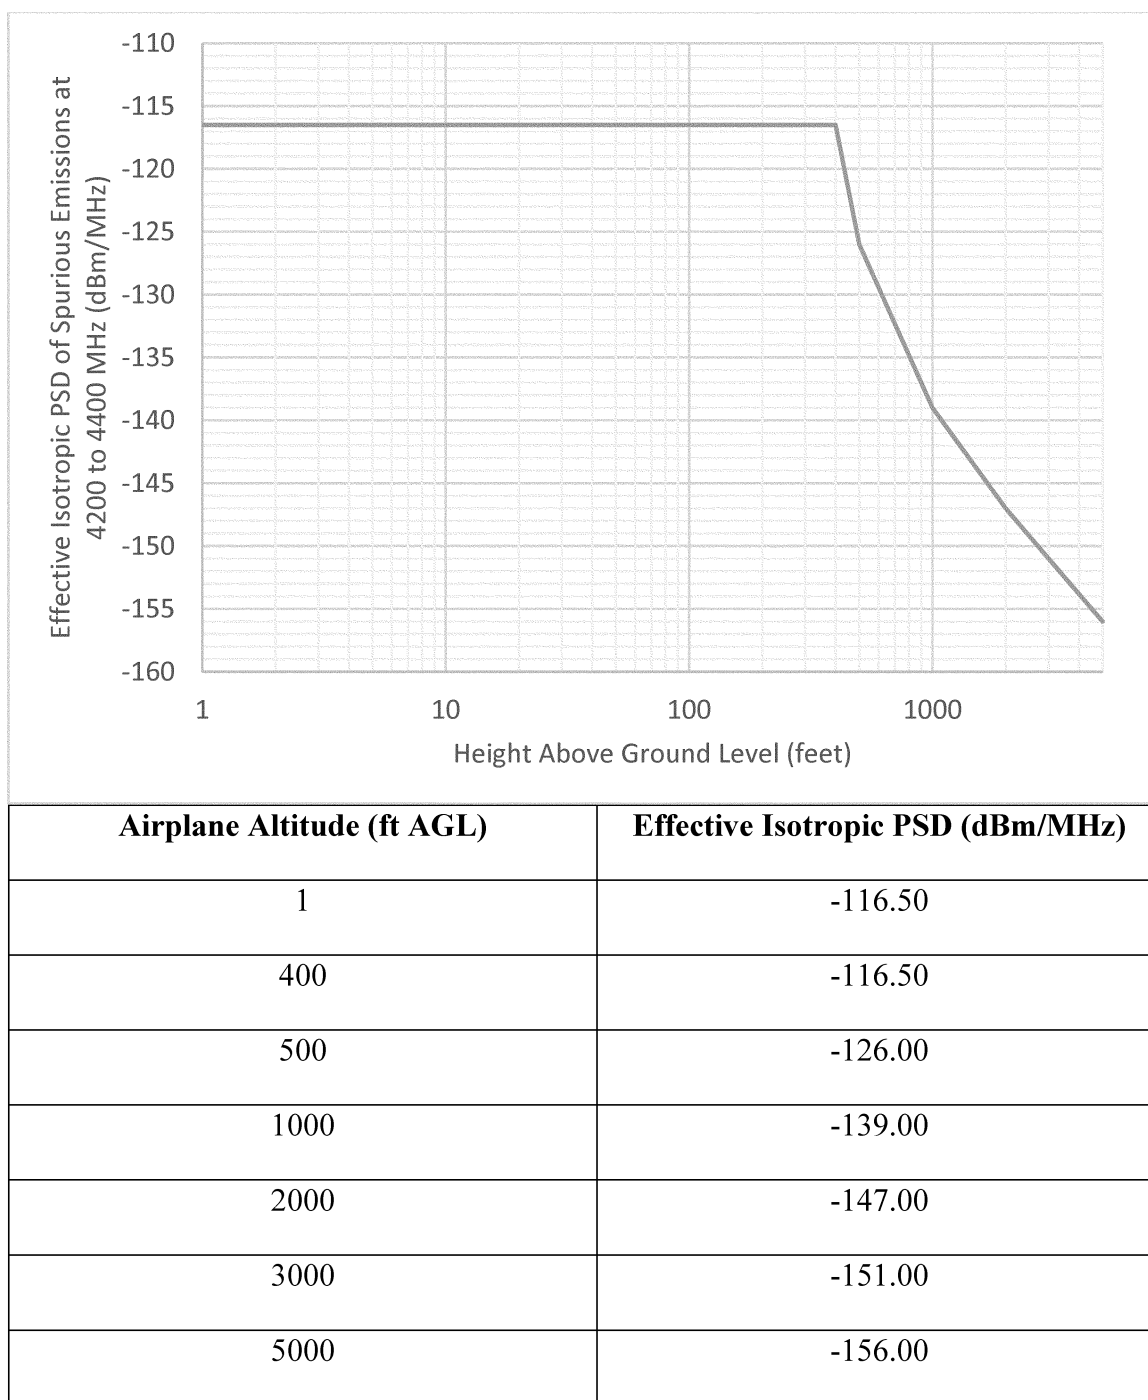
Figure 2 to Paragraph (g)(2)—Spurious Effective Isotropic PSD at Outside Interface of Airplane Antenna

(2) Tolerance to radio altimeter interference, for the spurious emissions (4.2–4.4 GHz), at or above the PSD curve threshold

specified in figure 2 to paragraph (g)(2) of this AD.
