[Docket No. 99-SW-75-AD; Amendment 39-11651; AD 2000-06-10]

#### **Airworthiness Directives; Bell Helicopter Textron Canada Model 407 Helicopters**

**AD 2000-06-10 Bell Helicopter Textron Canada:** Amendment 39-11651. Docket No. 99-SW-75-AD.

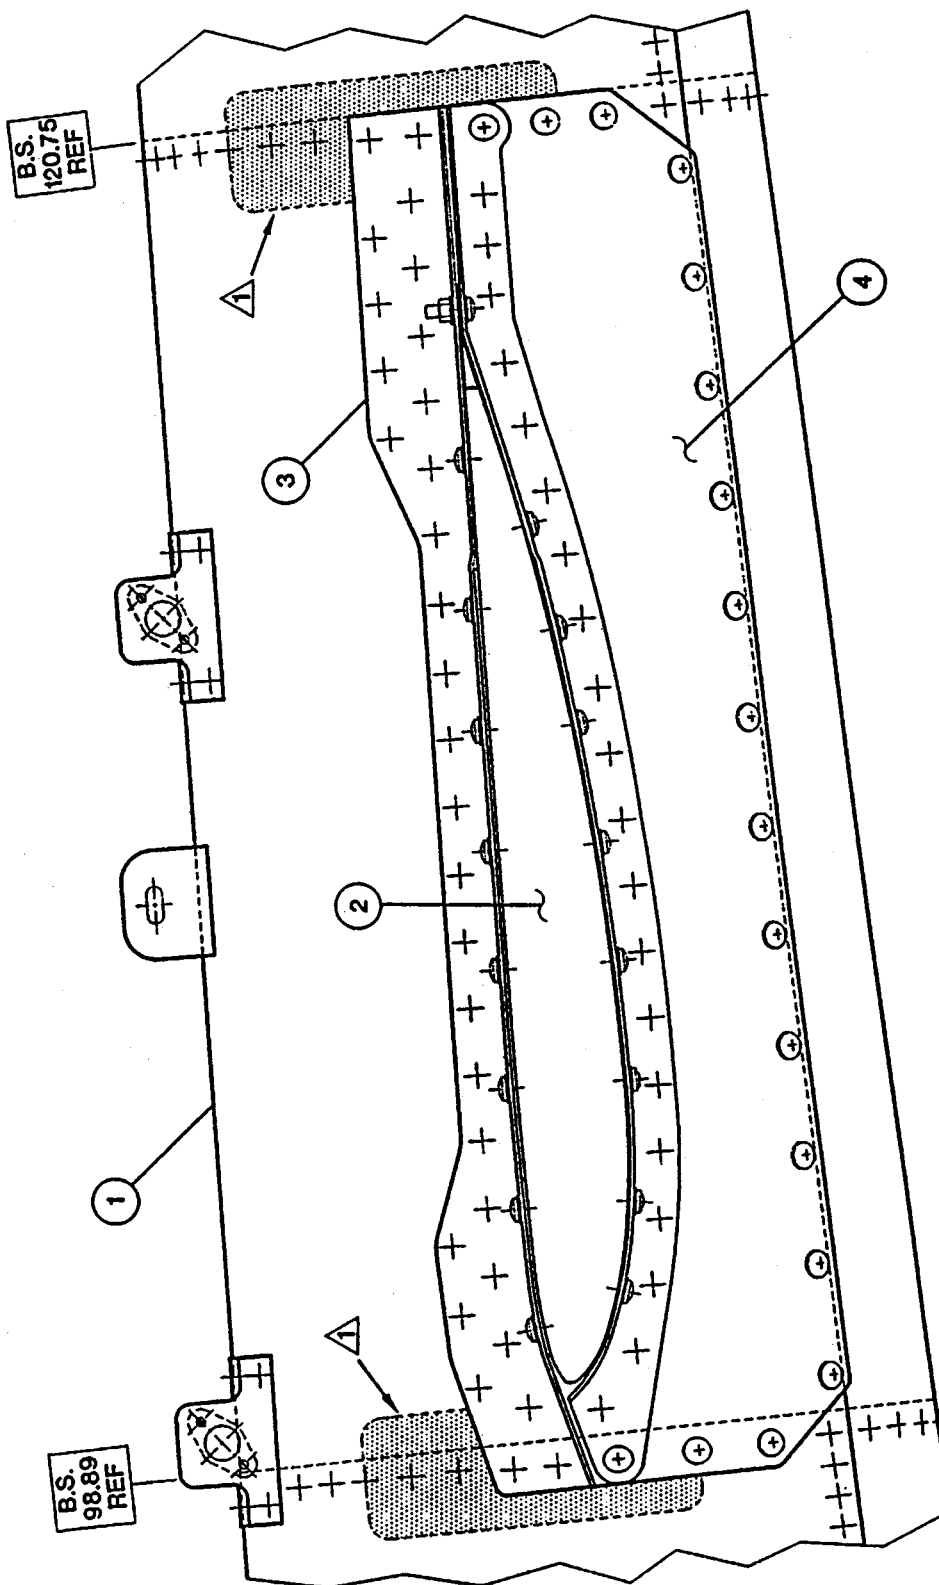
**Figure 1. Preflight Check of the Tailboom**

**SUPPLEMENTARY INFORMATION:** Transport Canada, the airworthiness authority for Canada, notified the FAA that an unsafe condition may exist on the BHTC Model 407 helicopters. Transport Canada advises that there have been several reports of cracks to the tail boom skin in the area of the horizontal stabilizer.

1. Examine these areas for cracks on left side of tailboom only.
2. Horizontal stabilizer not shown for clarity.

(a) Before further flight and thereafter before the first flight of each day, check the left side of the tail boom for a crack in the areas shown in Figure 1. If a crack is found, replace the tail boom with an airworthy tail boom before further flight.

(c) Within 25 hours time-in-service (TIS) and thereafter at intervals not to exceed 50 hours TIS, visually inspect any tail boom with 600 or more hours TIS for a crack using a 10X or higher magnifying glass, in accordance with the Accomplishment Instructions, Part II, of Bell Helicopter Textron Canada Alert Service Bulletin 407-99-26, dated April 13, 1999, except that you are not required to contact Bell Helicopter Product Support Engineering. If a crack is found, replace the tail boom with an airworthy tail boom before further flight.
