[Docket No. FAA–2022–0891; Project Identifier AD–2022–00585–A,E,R; Amendment 39–22432; AD 2023–09–09]

Airworthiness Directives; Various Airplanes, Helicopters, and Engines

ACTION: Final rule.

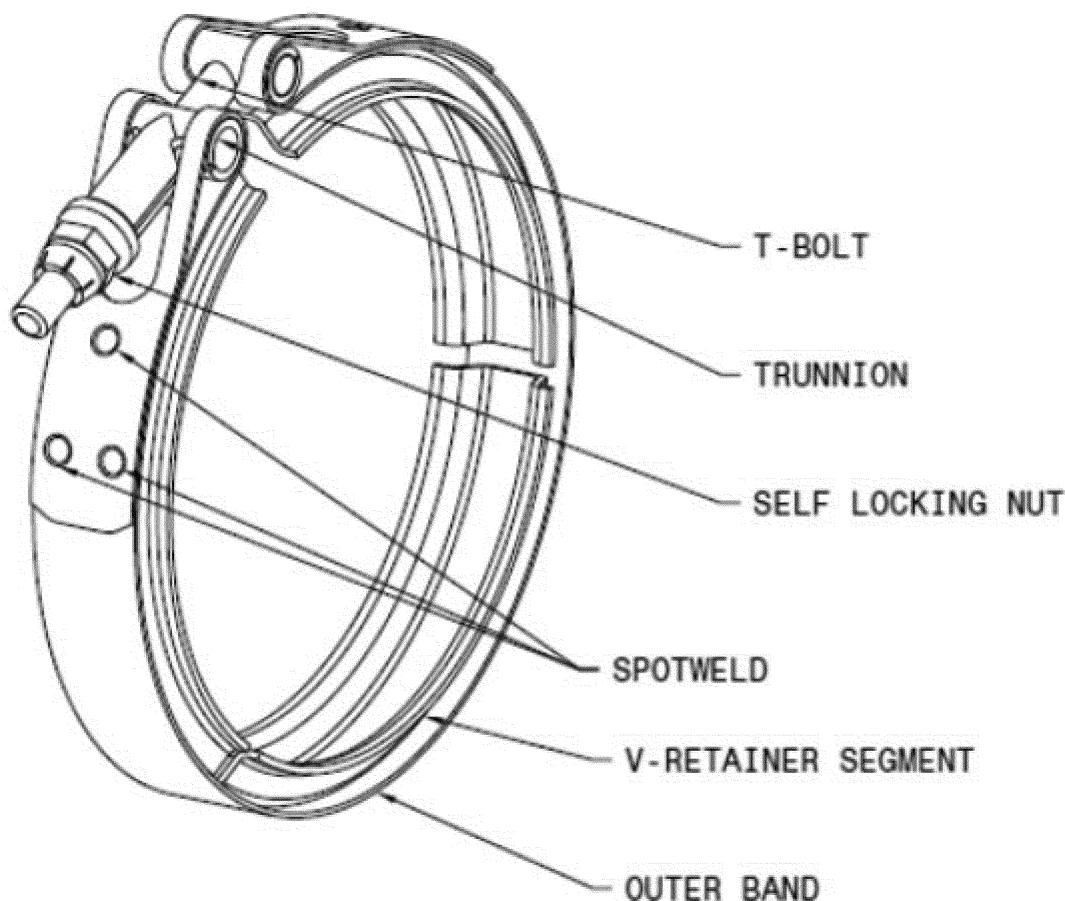
**Figure A**

The final report concluded that the common denominator in the incidents and accidents reviewed is the spot-welded, multi-segment exhaust tailpipe v-band coupling (see Figure A). These couplings come in either two or three segment varieties. The segments are the number of v-retainer segments, which are attached to the outer band via spot welds. Although multi-segment exhaust tailpipe couplings can also be riveted, the riveted couplings do not create an unsafe condition.

### **Spot-welded, multi-segment exhaust tailpipe v-band coupling**

The majority of the events studied by the working group indicated fatigue failure of spot-welded, multi-segment exhaust tailpipe v-band couplings as a

result of stress corrosion cracking that originated at or near a spot weld. This is the same unsafe condition identified in the other v-band coupling AD actions

previously referenced. The data studied by the working group contained evidence of pre-existing cracking of the couplings, known embrittlement at the

spot weld locations simply due to that manufacturing method, and outer band cupping on the multi-segment couplings (which is the result of age, over-use, and potential over-torqueing). The working group also found that many of the couplings had safety wire across the bolt end. The safety wire could be helpful if there was a bolt or nut failure (extremely rare events) or the nut was missing. However, the safety wire was of no value when the failure was transverse band cracking and total separation at the spot weld. The data studied by the working group indicated many accidents were due to v-band couplings that were of the multi-segment, spot-welded design, when used in a specific location (the tailpipe to the turbocharger exhaust housing flange on turbocharged reciprocating engine-powered aircraft).

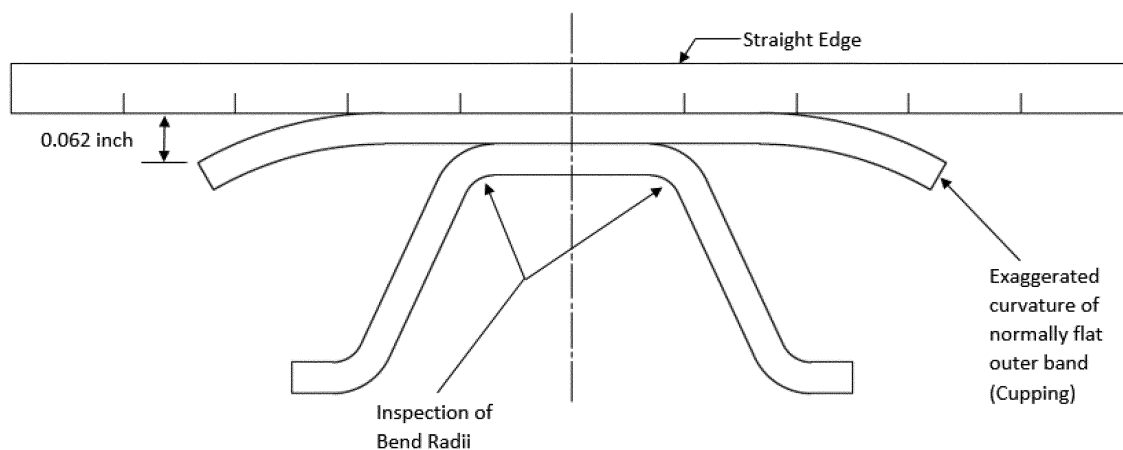
Figure 1 to paragraph (l)(1)(iii) – Inspection Depiction

(iii) Visually inspect the flatness of the outer band using a straight edge. Lay the straight edge across the width of the outer band as depicted in figure 1 to paragraph (l)(1)(iii) of this AD. If the gap between the outer band and the straight edge exceeds 0.062 inch, before further flight, remove the v-band coupling from service and install a new v-band coupling.

(v) Visually inspect the bend radii of the v-retainer coupling segments, throughout the length of the segment, as depicted in figure 1 to paragraph (l)(1)(iii) of this AD, for cracks. If there are any cracks, before further flight, remove the v-band coupling from service and install a new v-band coupling.
