[Docket No. FAA–2013–0146; Directorate Identifier 2012–SW–060–AD]

Airworthiness Directives; Agusta S.p.A. Helicopters

ACTION: Notice of proposed rulemaking (NPRM).

AGUSTA S.p.A. (Agusta): Docket No. FAA–2013–0146; Directorate Identifier 2012–SW–060–AD.

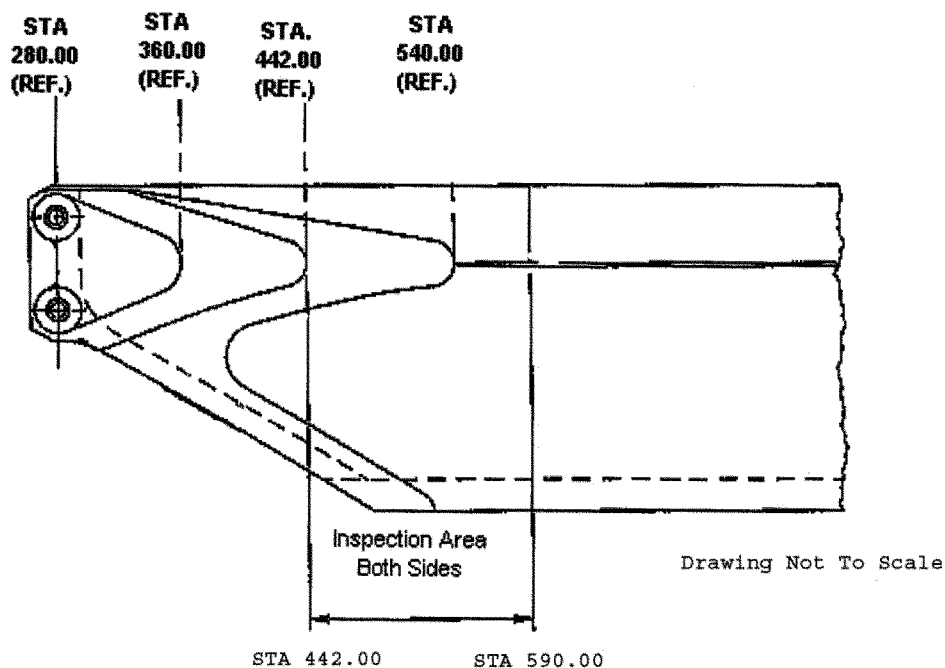
(1) Before each start of the helicopter engines, visually check both sides of each T/R blade for a crack in the inspection area depicted in Figure 1 to paragraph (f) of this AD. This action may be performed by the owner/operator (pilot) holding at least a private pilot certificate, and must be entered into the aircraft records showing compliance with this AD in accordance with 14 CFR 43.9 (a)(1)–(4) and 14 CFR 91.417(a)(2)(v). The record must be maintained as required by 14 CFR 91.173, 121.380, or 135.439.

Part Number 109-8132-01-111 Tail Rotor Blade

(5) If there is a crack in a T/R blade, before further flight, replace the cracked T/R blade.
