### Federal Aviation Administration

[Docket No. FAA-2006-24074; Directorate Identifier 2005-NM-213-AD; Amendment 39-14676; AD 2006-14-05]

**Airworthiness Directives; Bombardier Model CL-600-2C10 (Regional Jet Series 700, 701, and 702) Airplanes, Model CL-600-2D15 (Regional Jet Series 705) Airplanes, and Model CL-600-2D24 (Regional Jet Series 900) Airplanes**

**2006–14–05 Bombardier, Inc. (Formerly Canadair):** Amendment 39–14676. Docket No. FAA–2006–24074; Directorate Identifier 2005–NM–213–AD.

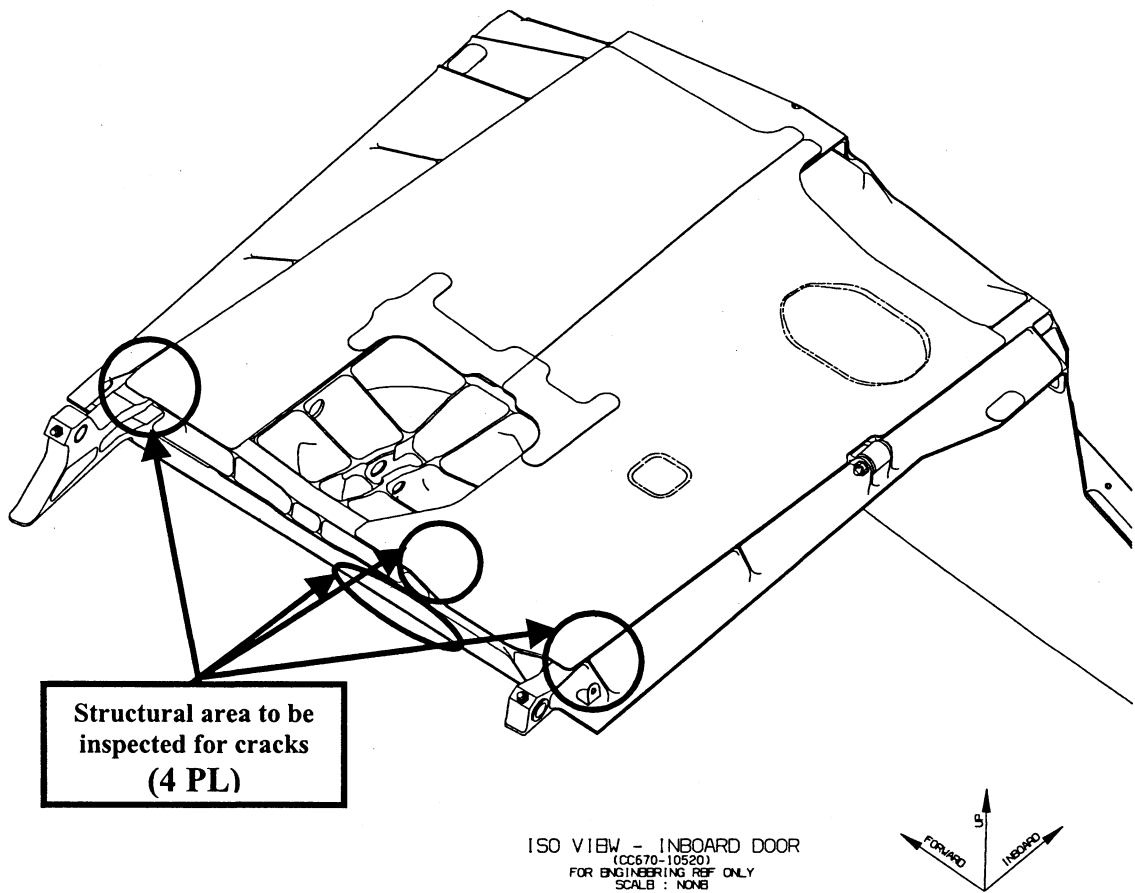
**Figure 1**  
LH side shown  
RH side opposite

2D24 (Regional Jet series 900) series airplanes, S/Ns 15002 through 15990 inclusive: At the applicable time specified in paragraph (f) of this AD, perform detailed inspections of the lower panel, part number (P/N) CC670–10520, of the left- and right-hand MLG doors for the conditions and in the areas specified in paragraphs (g)(1), (g)(2), (g)(3), and (g)(4) of this AD; and Figures 1, 2, and 3 of this AD.

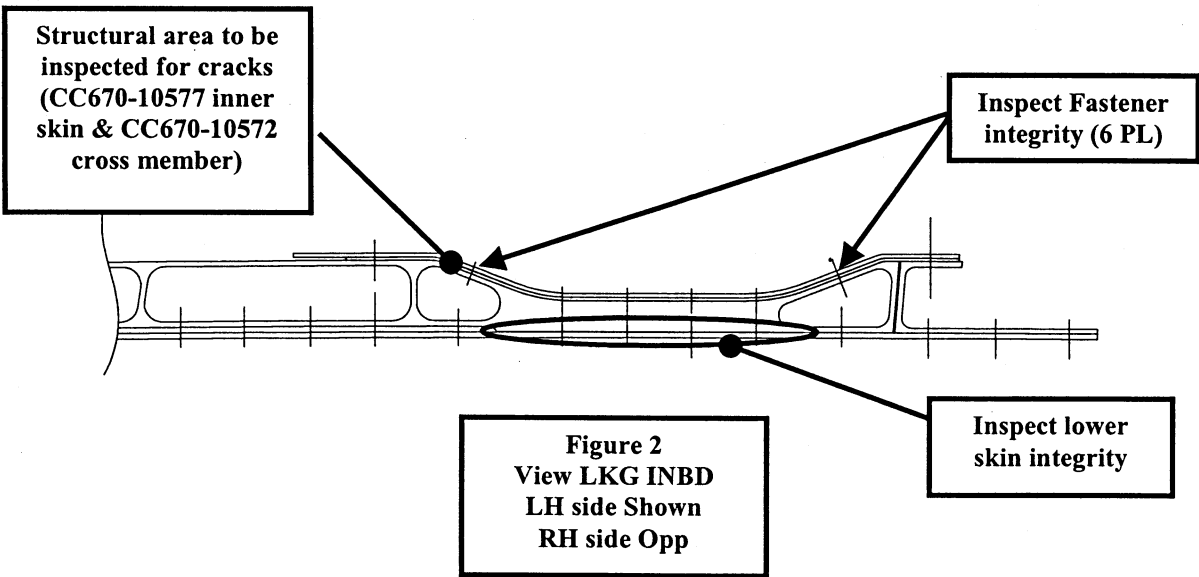
(1) Inspect the cross member, P/N CC670–10572, of the MLG door lower panel for cracking or deformation, in accordance with Figure 2 of this AD.

(2) Inspect the inner skin, P/N CC670–10577, of the MLG door lower panel at the cross member (P/N CC670–10572) for cracking or deformation, or pulled or missing fasteners, in accordance with Figure 2 of this AD.

(3) Inspect the outer skin, P/N CC670–10574, of the MLG door lower panel at the cross member (P/N CC670–10572) for cracking or deformation, or pulled or missing fasteners, in accordance with Figure 2 of this AD.

(i) If any cracking or deformation, or pulled or missing fastener, as applicable, is found during any inspection done in accordance with paragraph (g) or (h) of this AD: Before further flight, accomplish paragraph (i)(1), (i)(2), or (i)(3) of this AD.

(1) Repair the damage in accordance with a method approved by either the Manager, New York Aircraft Certification Office (ACO), FAA; or Transport Canada Civil Aviation (TCCA) (or its delegated agent); and accomplish repetitive inspections in accordance with a method and at a repetitive interval approved by same.

(2) Replace the lower panel assembly, P/N CC670-10520, of the affected MLG door with a new or serviceable lower panel assembly having the same P/N, according to a method approved by either the Manager, New York ACO, FAA; or TCCA (or its delegated agent). Task Cards 32-12-01-000-801-A01 and 32-12-01-400-801-A01 of the CRJ 700/900
