**2007-05-51 MD Helicopters Inc. (MDHI):**  
Amendment 39-15030. Docket No. FAA-2007-27343; Directorate Identifier 2007-SW-05-AD.

**Applicability:** Model MD600N helicopters, with a lateral mixer output link assembly (mixer link), part number (P/N) 600N7636-1, -3, -9, or -11 installed, certificated in any category.

**Airworthiness Directives; Cessna Aircraft Company Models 182H, 182J, 182K, 182L, 182M, 182N, 182P, 182Q, and 182R Airplanes**

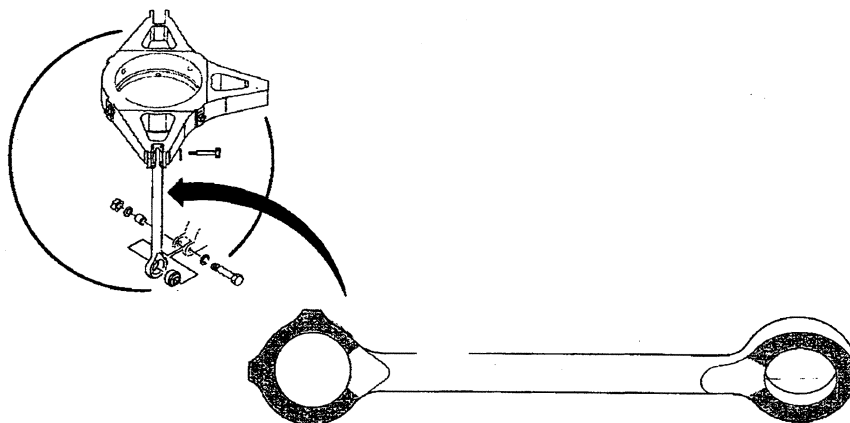
Figure 1

(1) Remove each mixer link and visually inspect, with a bright light and a 10x or higher magnifying glass, the shaded areas around the bearing bore for any crack as depicted in the following Figure 1:

Bearings have been removed for clarity.

(2) Perform an eddy current inspection of each mixer link in the bearing end areas.

(3) Replace any cracked mixer link with an airworthy mixer link on which an eddy current inspection has been performed.
