[Docket No. 83-ANE-14-AD; Amendment 39-14043; AD 83-08-01R2]

**Airworthiness Directives; Hartzell Propeller Inc. (Formerly TRW Hartzell Propeller) Models HC-B3TN-2, HC-B3TN-3, HC-B3TN-5, HC-B4TN-3, HC-B4TN-5, HC-B4MN-5, and HC-B5MP-3 Turbopropellers**

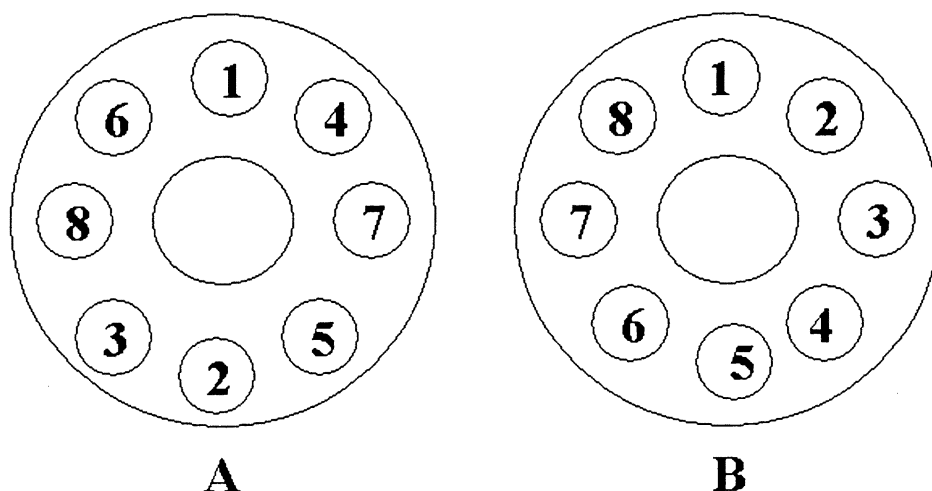
(5) Torque all attaching bolts with a torque wrench and an appropriate adapter, to 40 ft.-lbs., and then to 80 ft.-lbs., following sequence "A" (shown below). Final torque all attaching bolts using sequence "B" (shown below) to 100 ft.-lbs. to 105 ft.-lbs. Safety wire all attaching bolts in an FAA-approved manner.
