[Docket No. 2001-SW-40-AD; Amendment 39-13022; AD 2002-13-05 R1]

**Airworthiness Directives; MD Helicopters, Inc. Model 369D, 369E, 369F, and 369FF Helicopters**

**ACTION:** Final rule.

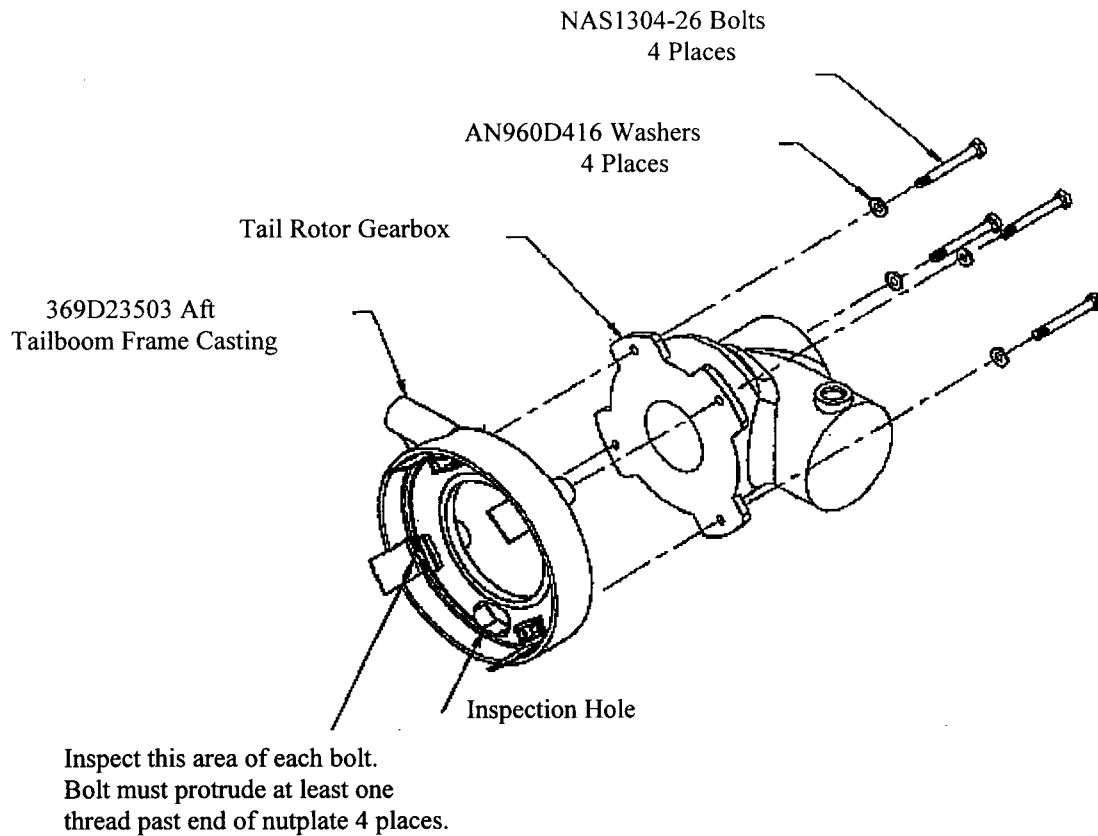
**Figure 1 - Inspection Location**

To prevent loss of the tail rotor gearbox due to attaching bolts of inadequate grip length and subsequent loss of control of the helicopter, accomplish the following:

(2) Remove the tailboom control rod and determine the number of bolt threads protruding from each nutplate on the internal surface of the aft tailboom frame casting, P/N 369D23503, as shown in Figure 1 of this AD. At least one thread must protrude. If more than four threads protrude, add an additional washer, P/N AN960D416, under the bolt head. Torque the bolt to 100–110 in-lbs, and reapply a slippage mark. *See Figure 1:*

(b) Between 2 and 10 hours TIS after accomplishing the requirements of paragraph (a) of this AD, inspect the torque on each bolt by applying 100 in-lbs. If any bolt movement occurs, retorquing the bolt to 100–110 in-lbs. Reapply a slippage mark to the bolt regardless of the outcome of the torque test. Reinspect the torque between 2 and 10 hours TIS thereafter until no bolt movement occurs.
