[Docket No. 2002-SW-48-AD; Amendment 39-12982; AD 2002-21-51]

Airworthiness Directives; Eurocopter France Model AS355E, F, F1, F2, and N Helicopters

2002-21-51 Eurocopter France:

Amendment 39-12982. Docket No. 2002-SW-48-AD.

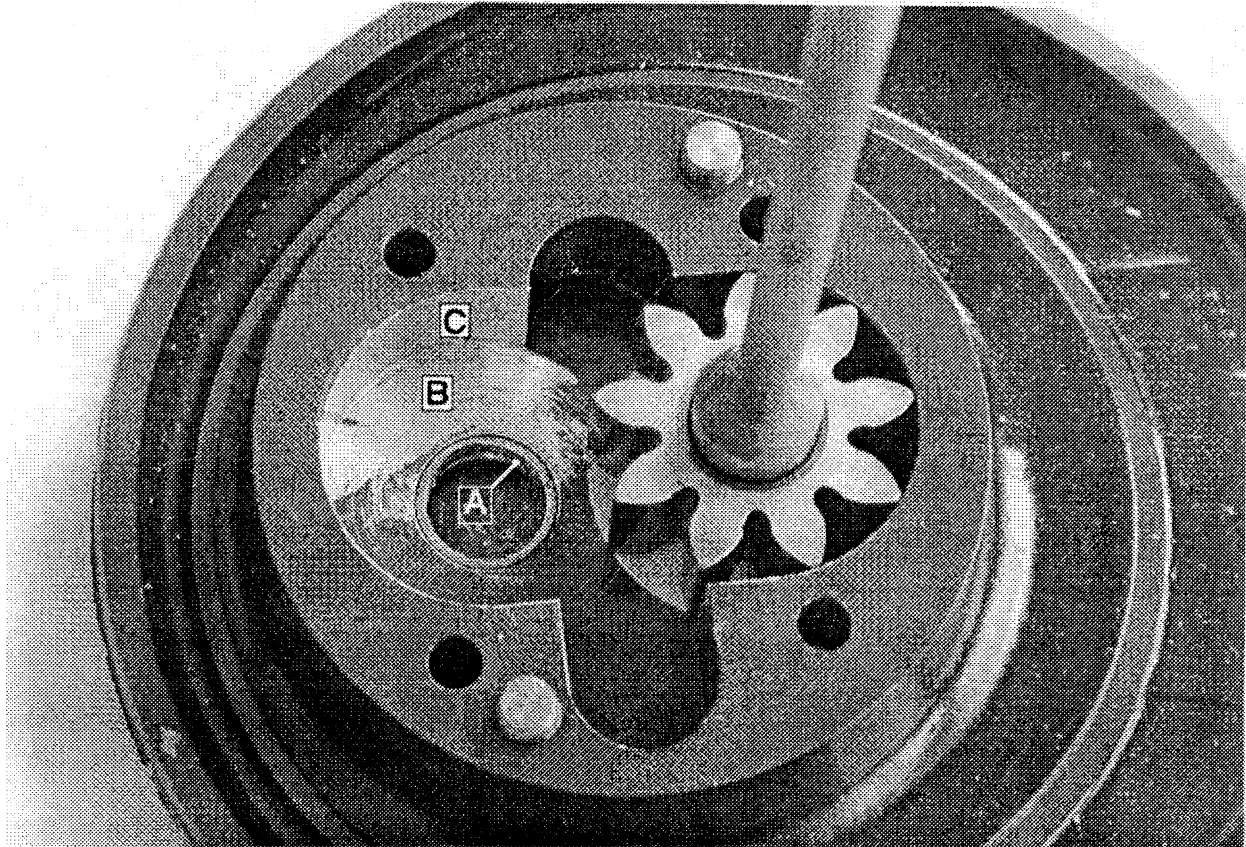
Figure 1

(3) While inspecting the pump, if you find any of the following, replace the MGB and the pump with an airworthy MGB and pump before further flight:

- (i) Crank pin play,
- (ii) Out of round bronze bushing (A of Figure 1),

- (iii) Offset of the driven gear pinion,
- (iv) Metal chips, or
- (v) Wear (C of Figure 1).

Note 3: If wear occurs in B only in Figure 1, replacing the MGB and the pump is not necessary.
