[Docket No. 2003–SW–10–AD; Amendment 39–13344; AD 2003–21–09]

#### Airworthiness Directives; Eurocopter France Model AS355E, F, F1, F2, and N Helicopters

#### 2003-21-09 Eurocopter France:

Amendment 39-13344. Docket No. 2003-SW-10-AD. Supersedes AD 2002-21-51, Amendment 39-12982, Docket No. 2002-SW-48-AD.

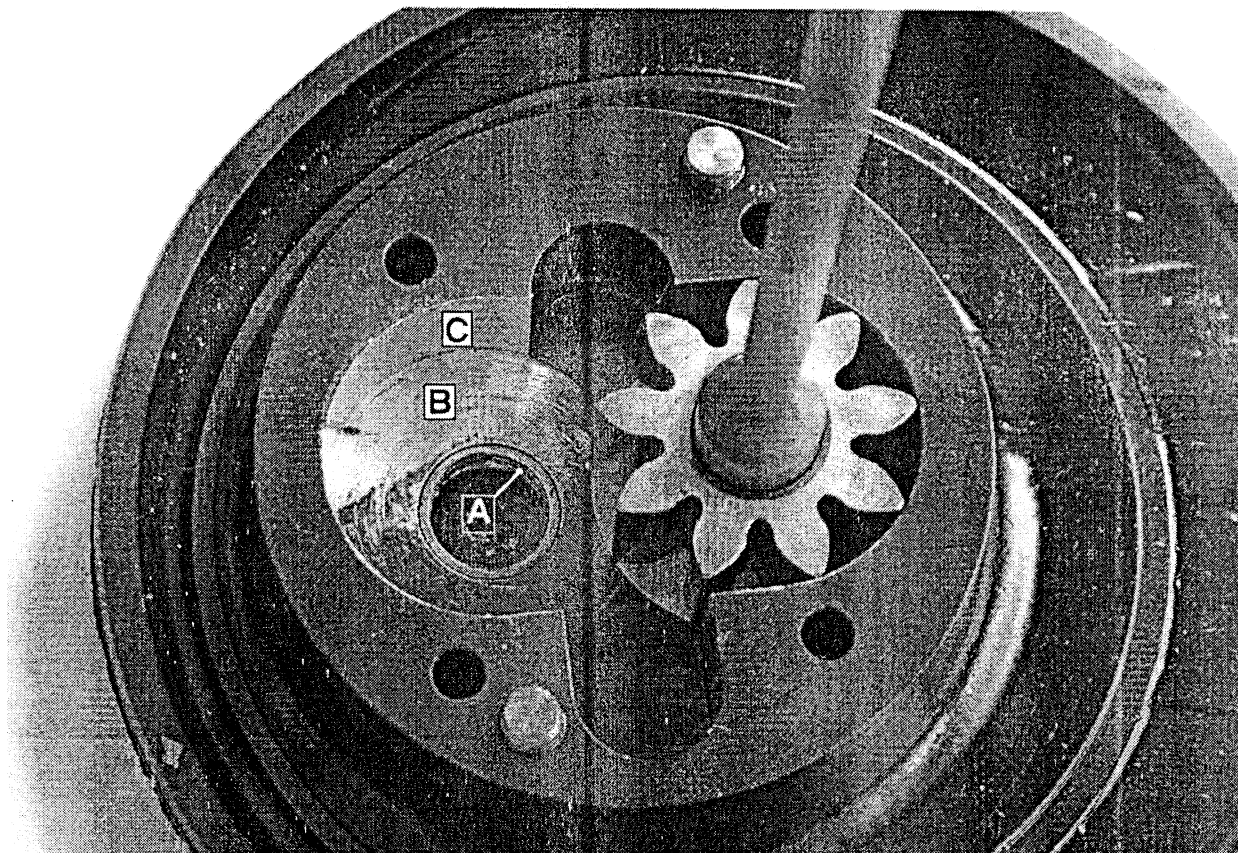
Figure 1

(d) While inspecting the pump, if you find any of the following, replace the MGB and the pump with an airworthy MGB and pump before further flight:

- (1) Crank pin play,
- (2) Out of round bronze bushing (A of Figure 1),

- (3) Offset of the driven gear pinion,
  - (4) Metal chips, or
  - (5) Wear (C of Figure 1).
- See the following Figure 1:

**Note 2:** If wear is present in the B area only as depicted in Figure 1, replacing the MGB and the pump is not required.
