[Docket No. FAA-2012-0773; Directorate Identifier 2009-SW-71-AD]

Airworthiness Directives; Eurocopter Deutschland GmbH Helicopters

ACTION: Notice of proposed rulemaking (NPRM).

Eurocopter Deutschland GmbH: Docket No. FAA-2012-0773; Directorate Identifier 2009-SW-71-AD.

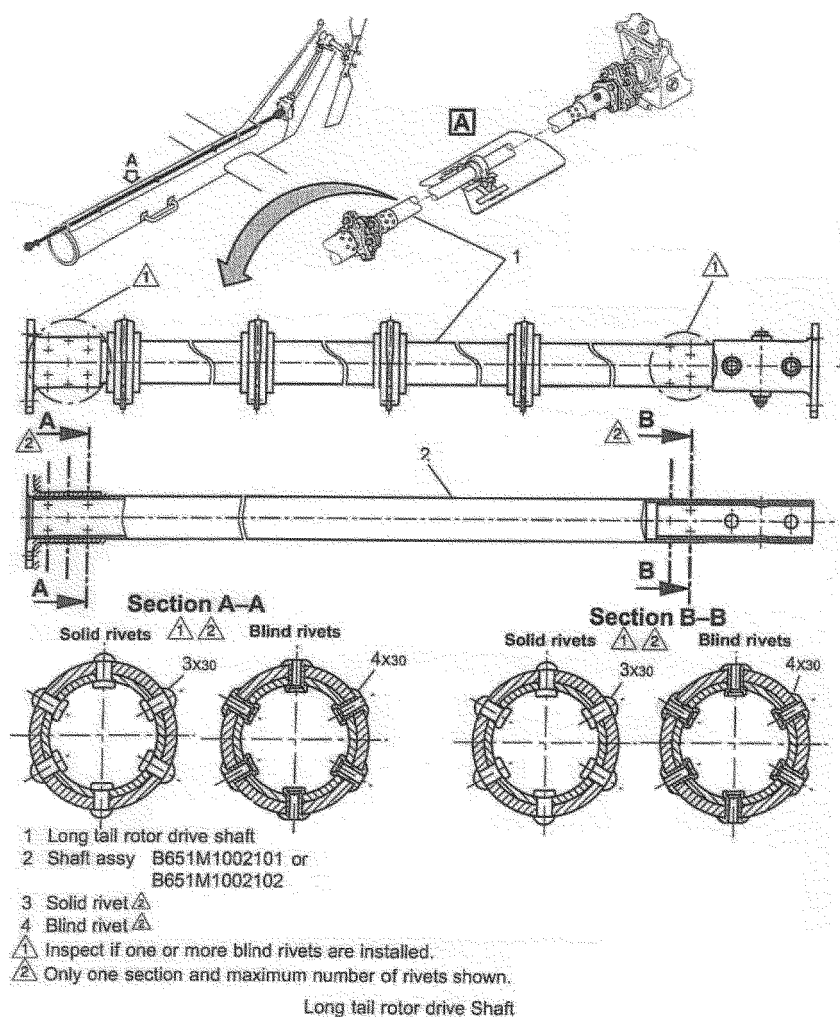
This AD defines the unsafe condition as the installation of blind rivets instead of solid rivets in the long tail rotor drive shaft. This condition could result in failure of the long tail rotor drive shaft and subsequent loss of control of the helicopter.

Within 100 hours time-in-service (TIS), inspect the long tail rotor drive shaft assembly for blind rivets as indicated in sections A-A and B-B of Figure 1 to Paragraph (d) of this AD.

(2) If there are one or more blind rivets installed on the shaft assembly in the areas depicted in Figure 1 to Paragraph (d) of this AD, before further flight, replace the shaft assembly of the long tail rotor drive shaft with an airworthy shaft assembly that does not have blind rivets installed.
