[Docket No. **FAA-2006-24446**; Directorate Identifier **2005-SW-15-AD**; Amendment **39-14561**; AD **2006-08-06**]

### Airworthiness Directives; Eurocopter France Model SA-360C, SA-365C, SA-365C1, and SA-365C2 Helicopters

#### 2006-08-06 Eurocopter France:

Amendment 39-14561. Docket No. FAA-2006-24446; Directorate Identifier 2005-SW-15-AD.

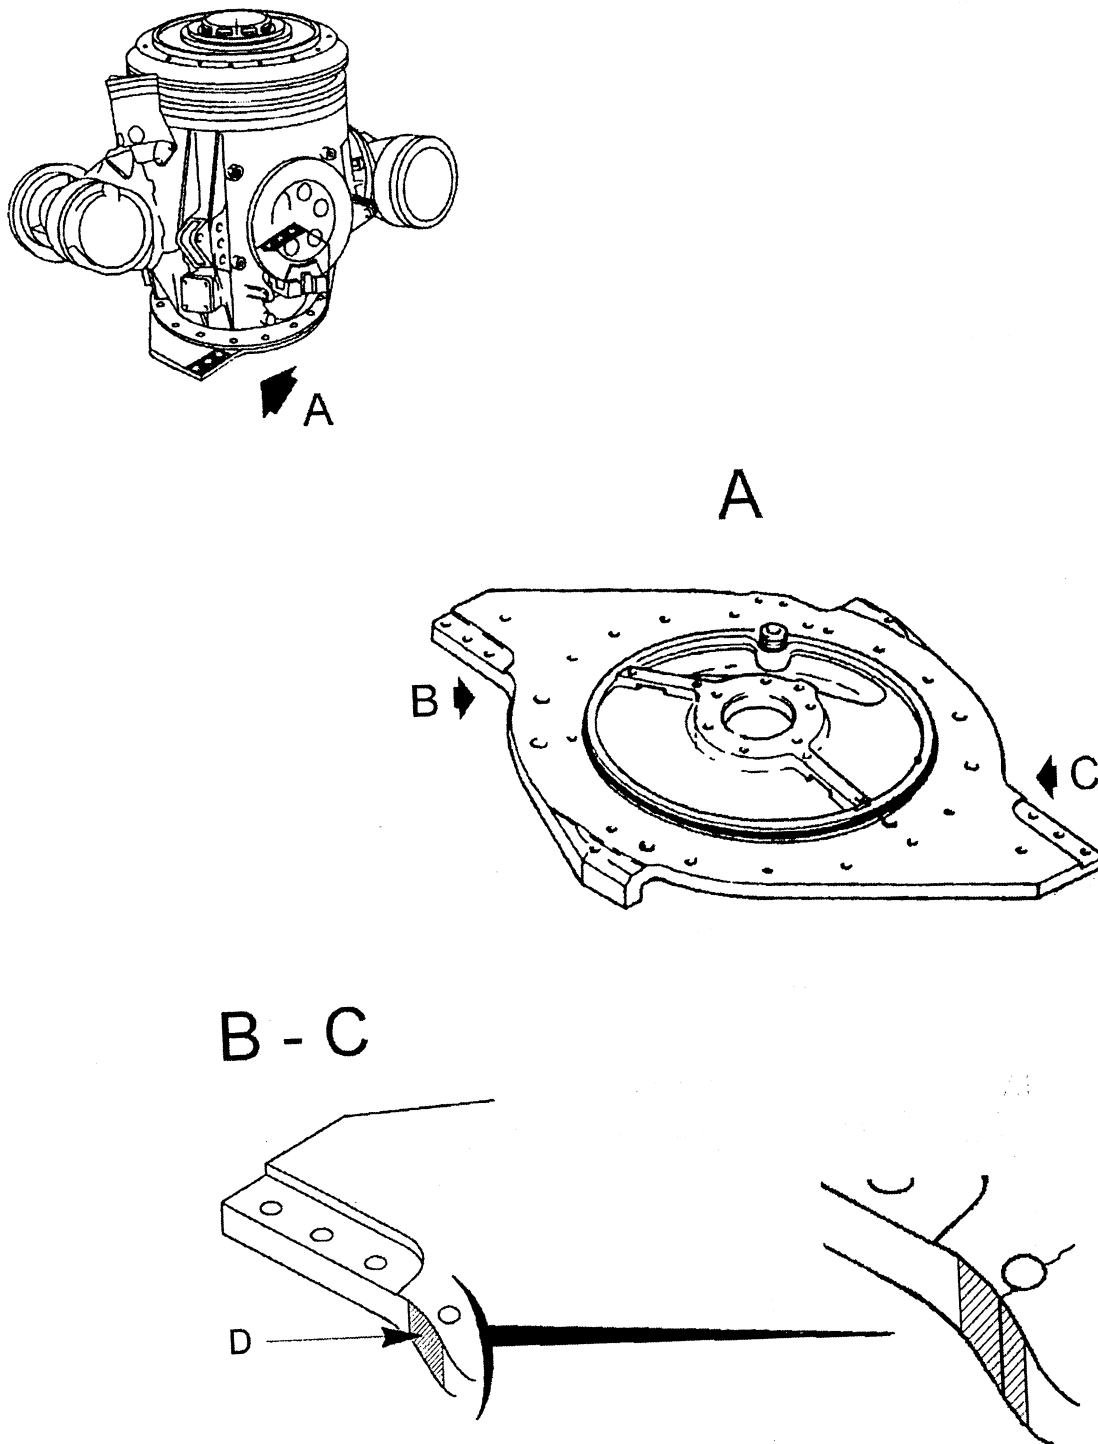
paint from area "D" on both sides ("B" and "C") of the MGB base plate as depicted in Figure 1 of this AD.

(b) At the times indicated in the compliance table, inspect area "D" of the MGB base plate for a crack using a 10x or higher magnifying glass. Area "D" to be inspected is depicted in Figure 1 of this AD.

(c) If a crack is found in a MGB base plate, remove and replace the MGB with an airworthy MGB before further flight.
