[Docket No. FAA-2004-19969; Directorate Identifier 2004-SW-43-AD; Amendment 39-13923; AD 2004-26-11]

#### **Airworthiness Directives; Bell Helicopter Textron Canada Model 222, 222B, 222U, 230, and 430 Helicopters**

**AD 2004-26-11 Bell Helicopter Textron Canada:** Amendment 39-13923. Docket No. FAA-2004-19969; Directorate Identifier 2004-SW-43-AD.

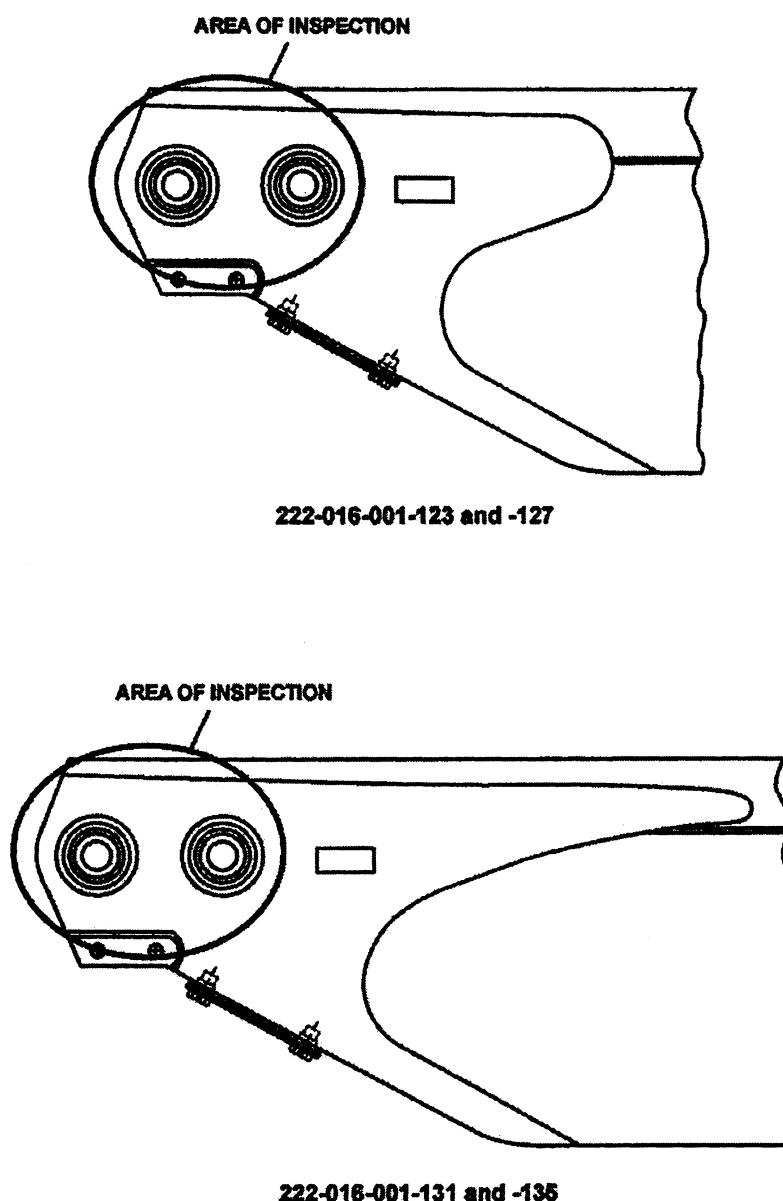
**Figure 1. Blade inspection area**

Transport Canada, the airworthiness authority for Canada, notified the FAA that an unsafe condition may exist on the specified BHTC model helicopters. Transport Canada advises of the discovery of cracked blades during scheduled inspections on three occasions. Two cracks originated from the outboard feathering bearing bore underneath the flanged sleeves. The third crack started from the inboard feathering bearing bore. Investigation found that the cracks originated from either a machining burr or a corrosion site in the bearing bore underneath the flanged sleeves.

- (a) Within 3 hours time-in-service (TIS) and at intervals not to exceed 3 hours TIS, clean and visually check both sides of each blade for a crack in the paint in the areas shown in Figure 1 of this AD. An owner/operator (pilot), holding at least a private

wiping down both surfaces of each blade in the inspection area depicted in Figure 1 of this AD using aliphatic naptha (C-305) or detergent (C-318) or equivalents. Using a 10X or higher power magnifying glass, visually inspect both sides of the blade in the areas depicted in Figure 1 of this AD.

(1) If even a crack is found in the paint, before further flight, remove the blade.

(2) Remove the paint to the bare metal in the area of the suspected crack by using Plastic Metal Blasting (PMB) or a nylon web abrasive pad. Abrade the blade surface in a span-wise direction only.

(3) Using a 10X or higher power magnifying glass, inspect the blade for a crack.

(i) If a crack is found, before further flight, replace the blade with an airworthy blade.

(ii) If no crack is found in the blade surface, refinish the blade by applying one coat of MIL-P-23377 or MIL-P-85582 Epoxy Polyamide Primer so that the primer overlaps

the existing coats just beyond the abraded area. Let the area dry for 30 minutes to 1 hour. Then, apply one sealer coat of Polyurethane MILC85285 TYI CL2, color Number 27925 (semi-gloss white) per Fed. Std. 595. Reinstall the blade.
